# Restoration efforts of the Aso Bridge District affected by a massive landslide

Sand control group, Kumamoto branch office, Kumamoto earthquake counterplan office, Kyushu Regional Development Bureau, MLIT

## Overview of the landslide

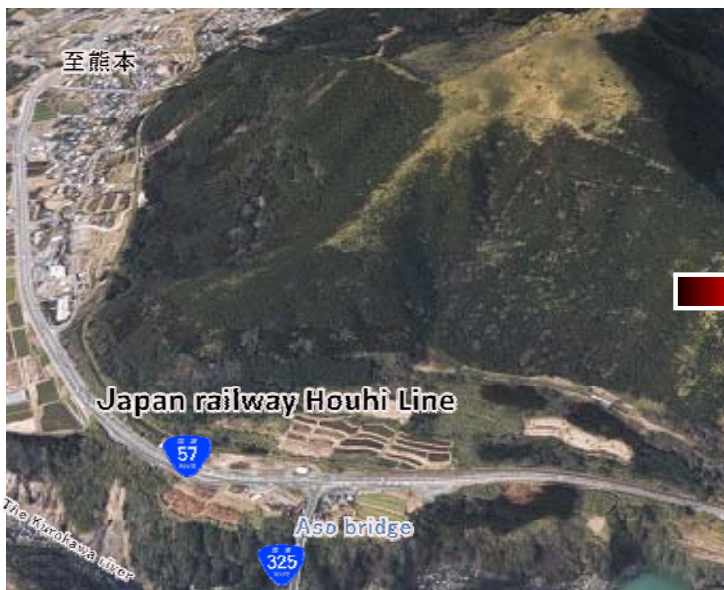
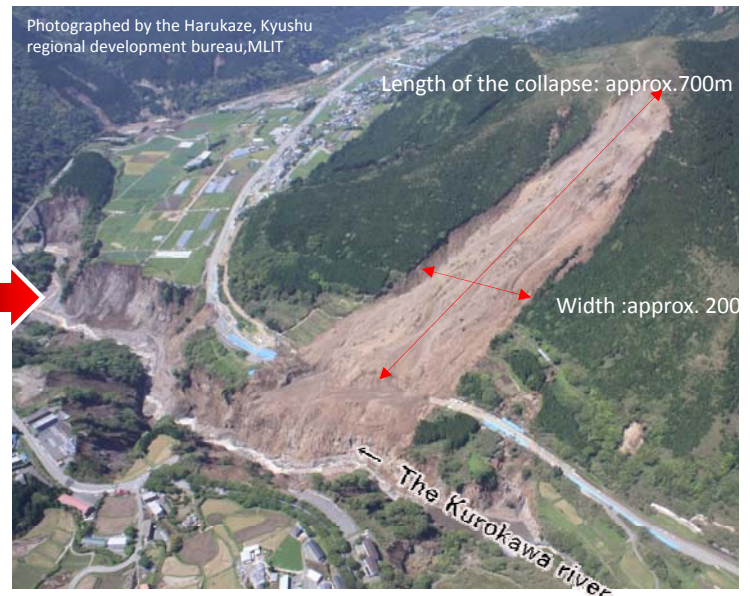
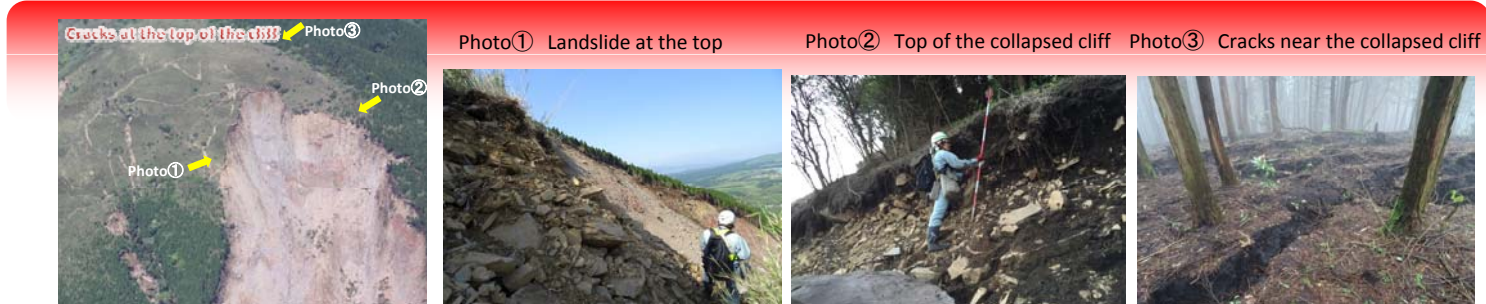
# Status of the collapse of slope

**In regard to the massive collapse of the slope at Aso bridge area triggered by the Kumamoto earthquakes in 2016, emergency construction works are underway to prevent secondary disasters that could be caused by collapse of the remaining large volume of sand at upper area of the slope**

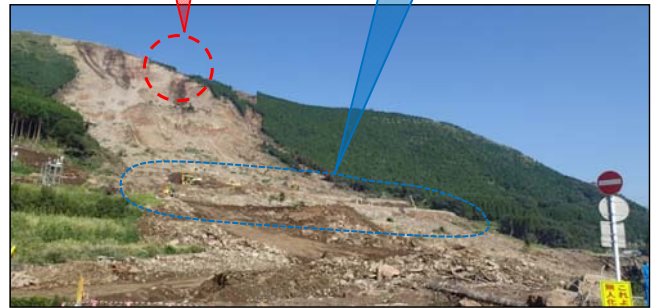
**The cracks identified at the top of the slope**

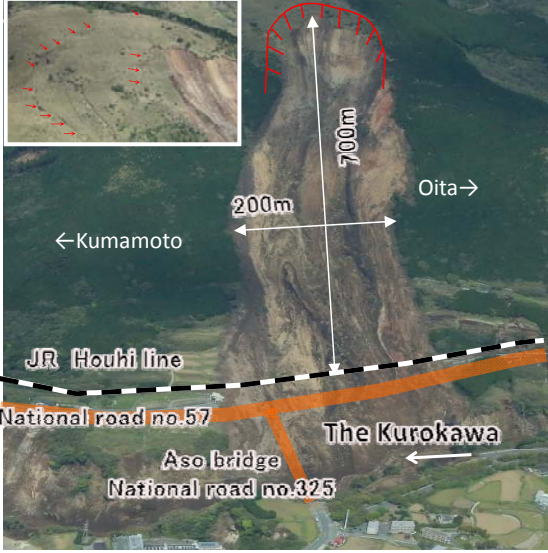
**Elimination of unstable rocks left by gully erosion**

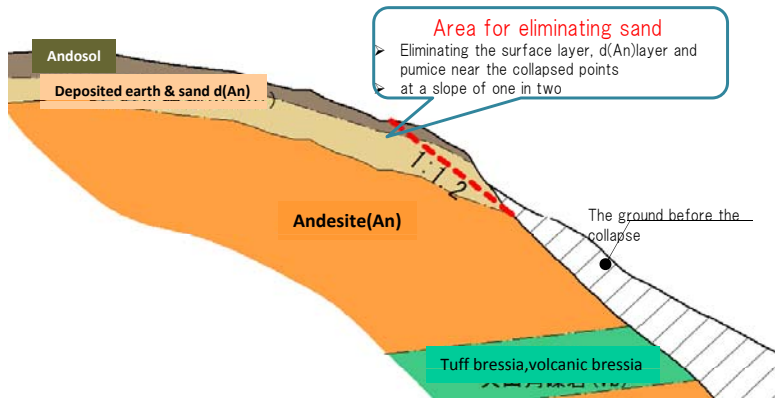
### A cross section for elimination of earth and sand

Surface layer of andosol, deposited earth and sand (d(An)), and pumice found at the areas surrounding the collapsed points where the ground rises

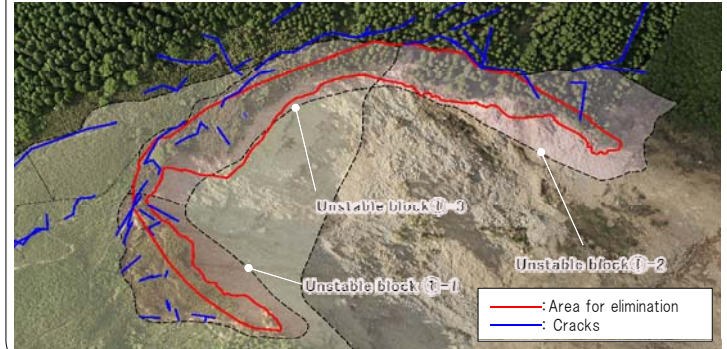
## (2) Upper border of the works

Block ①-2: Upper border is defined up to the crack of the unstable block, due to the changes identified by dynamic observation, and the significant difference in level between the cracks behind.

Block ①-1, Block ①-3: Basically the area cut from the lower border at a stable gradient of one in two, with necessary adjustment depending on the status of the ground at the back during the works.

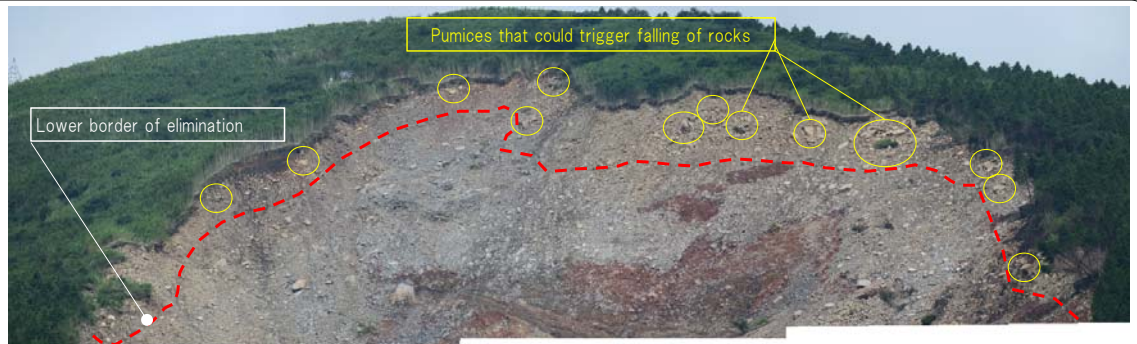
## (1) Lower border of the works

Lower border of elimination was defined by measuring the collapsed surface by UAV, and examining the status of pumice that could trigger falling of stones.

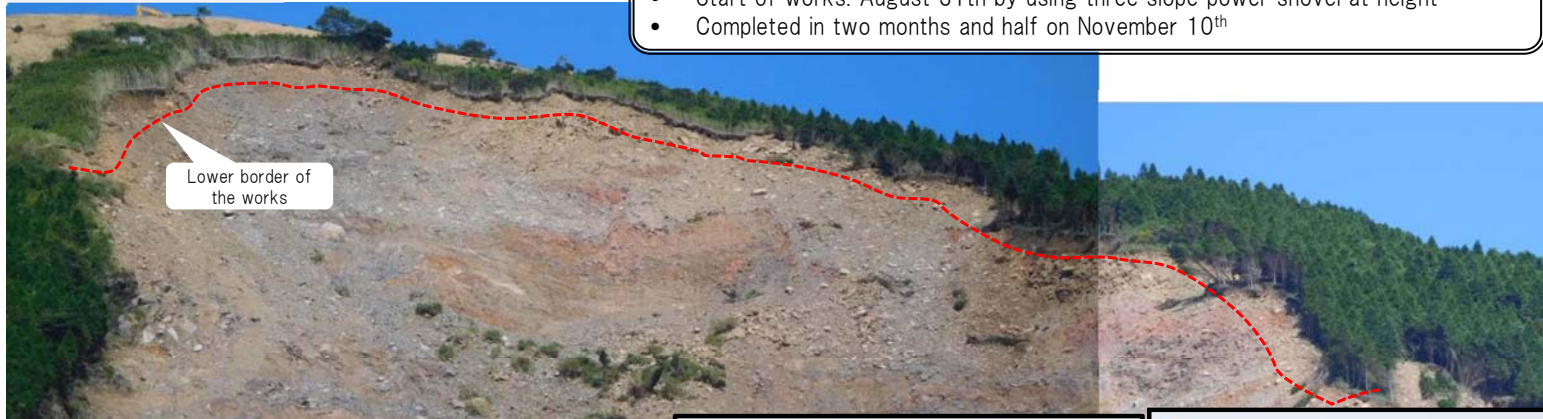
- Elimination of unstable sands, stones that may trigger falling of stones
- Start of works: August 31th by using three slope power shovel at height
- Completed in two months and half on November 10<sup>th</sup>

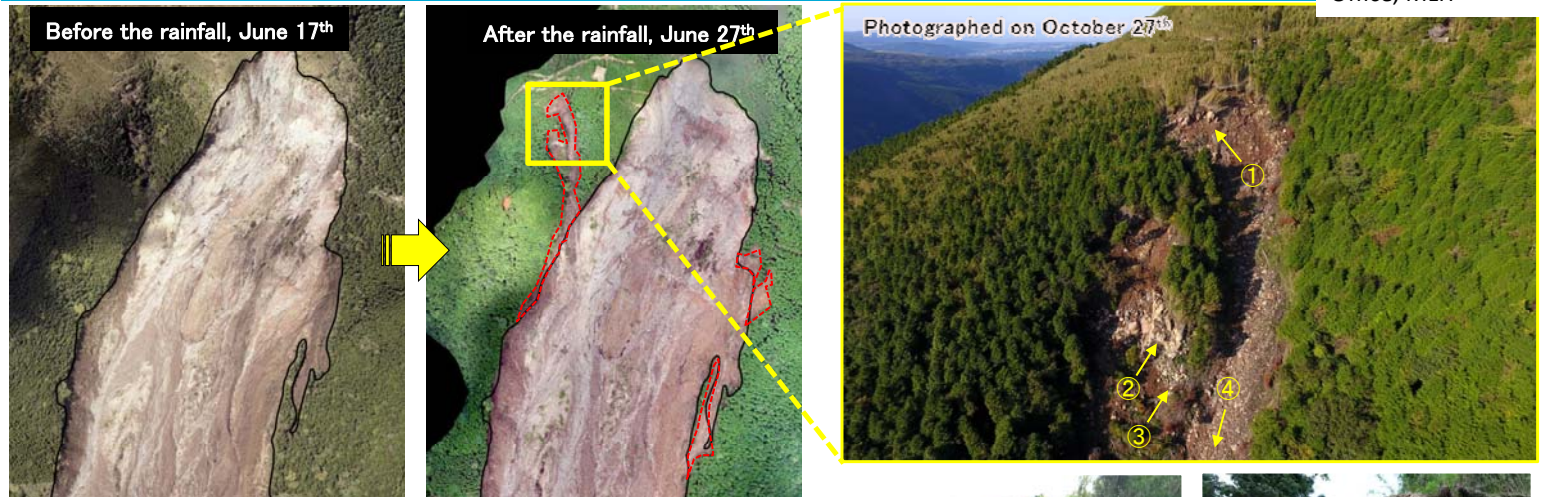
# Elimination of unstable rocks left by gully erosion

Heavy rainfall on June 20<sup>th</sup> accelerated the gully erosion

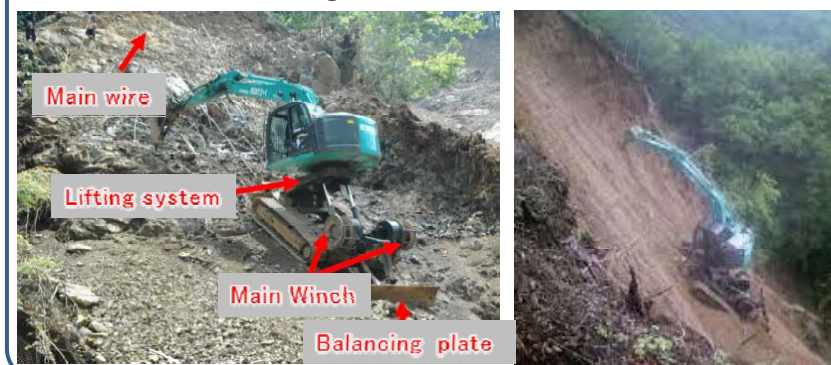
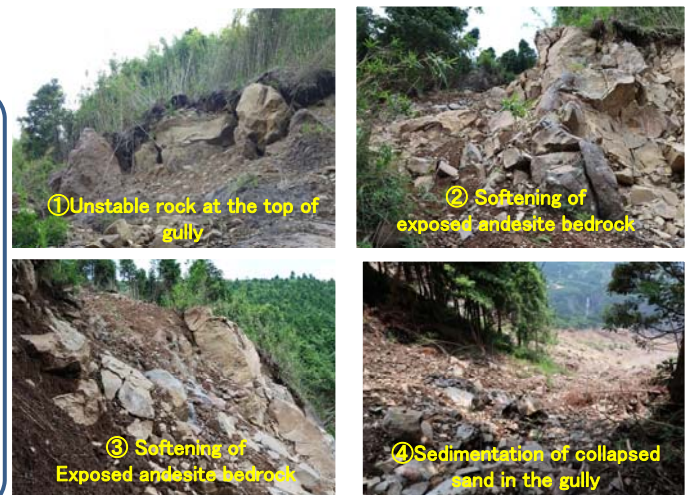
## Rock climbing method of construction

① Unstable rock at the top of gully

② Softening of exposed andesite bedrock

③ Softening of Exposed andesite bedrock

④ Sedimentation of collapsed sand in the gully
