**Wind Induced Damage to Roofs and Mitigations: A Comparative Study on
Roofs in Bhutan and Japan**

A final research report presented

Yeshey Lotay

Asian Disaster Reduction Center

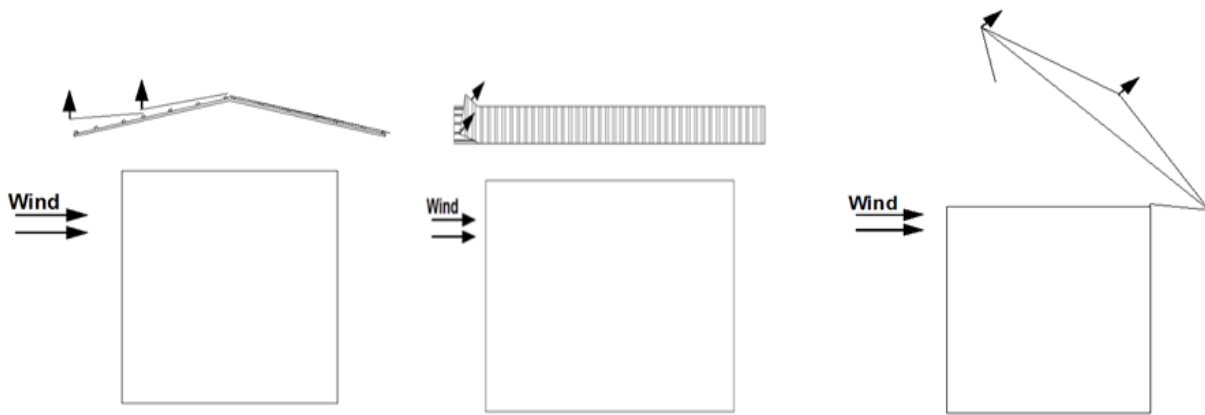
In the case of 2011 and 2013 windstorm, different mode failure of rural home roofs as shown in Figure 41 & Figure 42, it was observed that the common failure of the rural home roofs in Bhutan was due to the poor connections, lack of anchorage system, roof-to-wall connection, large overhang and inadequate timber sections. The failure mostly occurred at the gable roof ends and roof ridge as you can see in the Figure 43.

Figure 41: Gable end and roof edge failure

As described in the Figure 41, one of the most common roof damages occurred at the gable ends during the windstorm. It was observed that most of the gable end roof has weak connection especially between the purlins and rafters. The large roof overhang creates the high uplift pressure at the gable end. Since most of the rural home roofs of Bhutan has the roof overhang between 950mm and 2500mm. As described in the Figure 37, the positive pressure and suction pressure at the roof overhang; if the roof overhang is large the pressure at that point will certainly increase and cause the damage at the roof end.

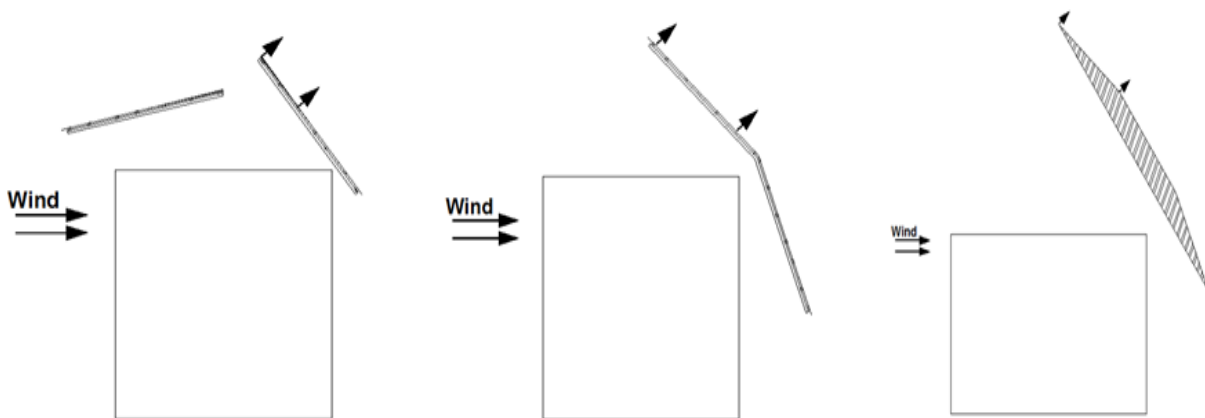
Figure 42: Roof failure at roof ridge and over turning failure mode

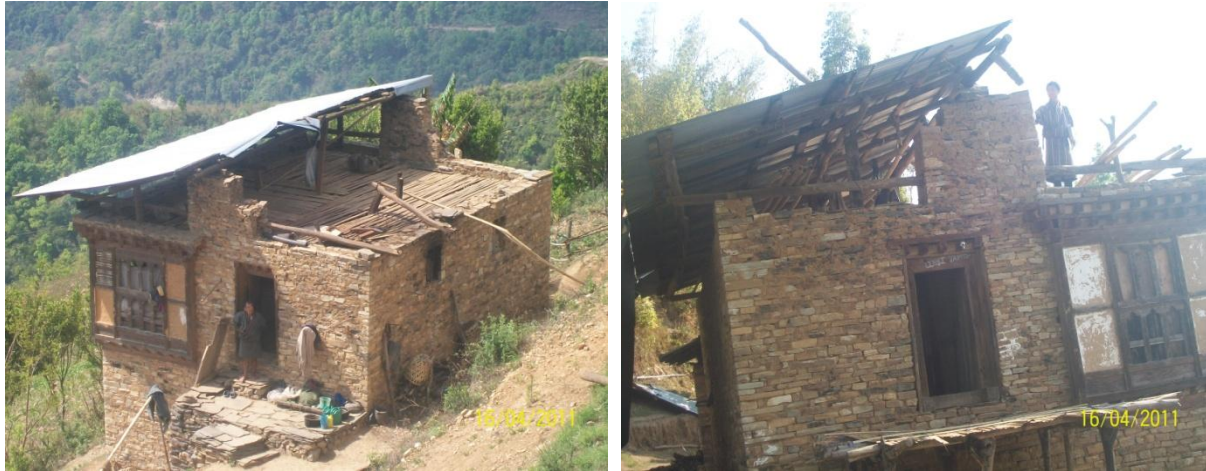
Figure 43: Roof ridge failure during 2011 windstorm

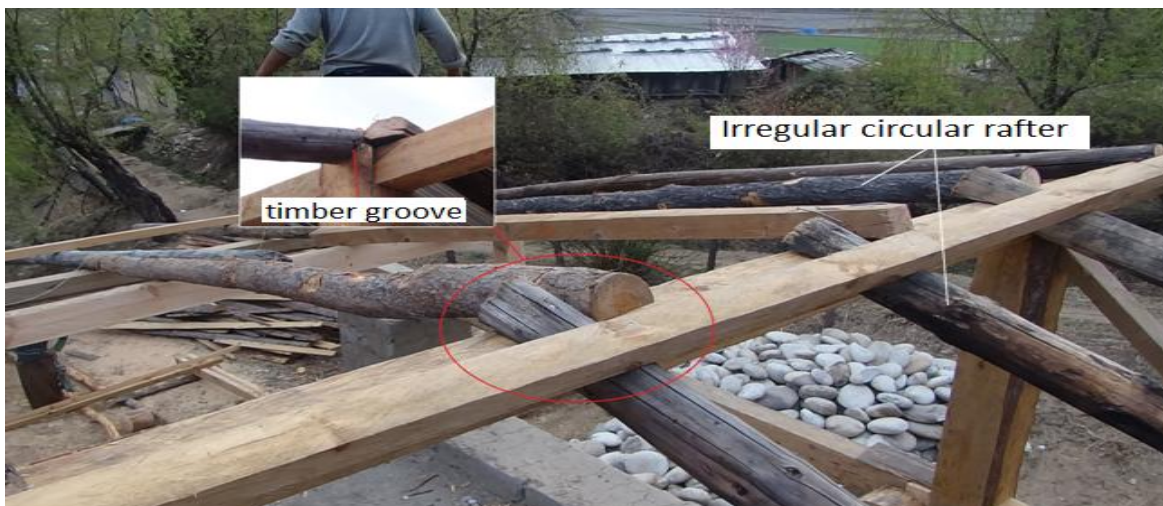
During the 2011 and 2013 windstorms, one of the common failures in the rural home roofs was observed at the roof ridge in the eastern part of Bhutan. It was observed that most of the purlins and rafter was irregular circular timber, whereby the connection at the roof ridge is not good. It was observed that the connection at the roof ridge is a simple lap joint with single toe-nail connection but generally the roof ridge connection is done by the bamboo strap or string. The irregular circular timber rafter makes difficult to secure tight connection at the roof ridge and also the groove made in the circular rafter makes the timber section weak during the strong wind to fail at the roof ridge as shown in Figure 44.

Figure 44: Roof ridge connection in rural home roof with deep groove and lap joint

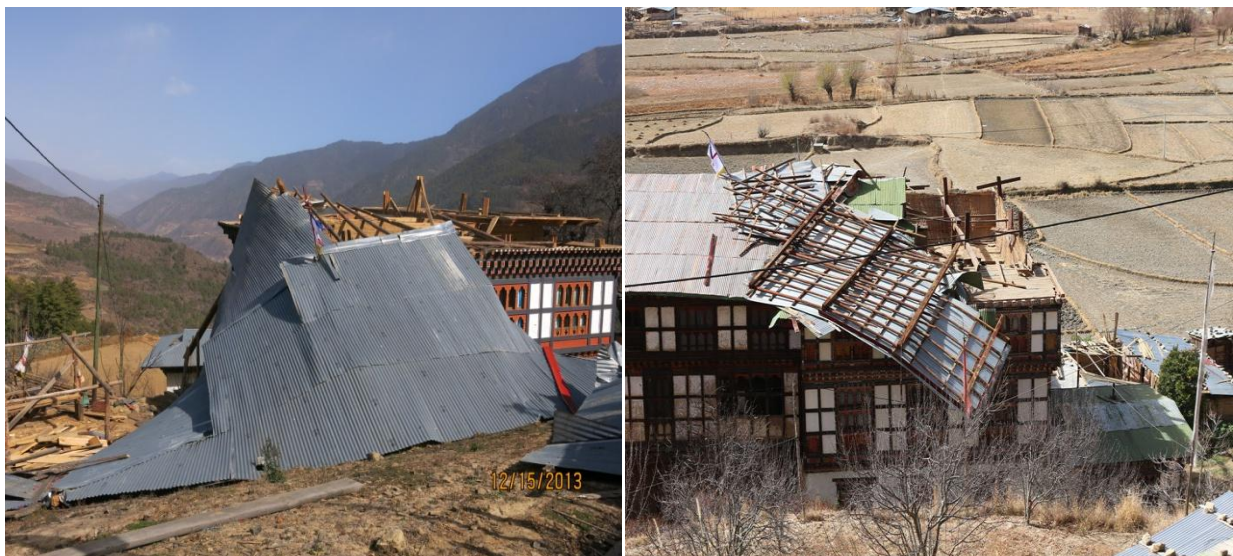
Figure 45: Failure due the poor connection between rafters and struts causing full-blown off

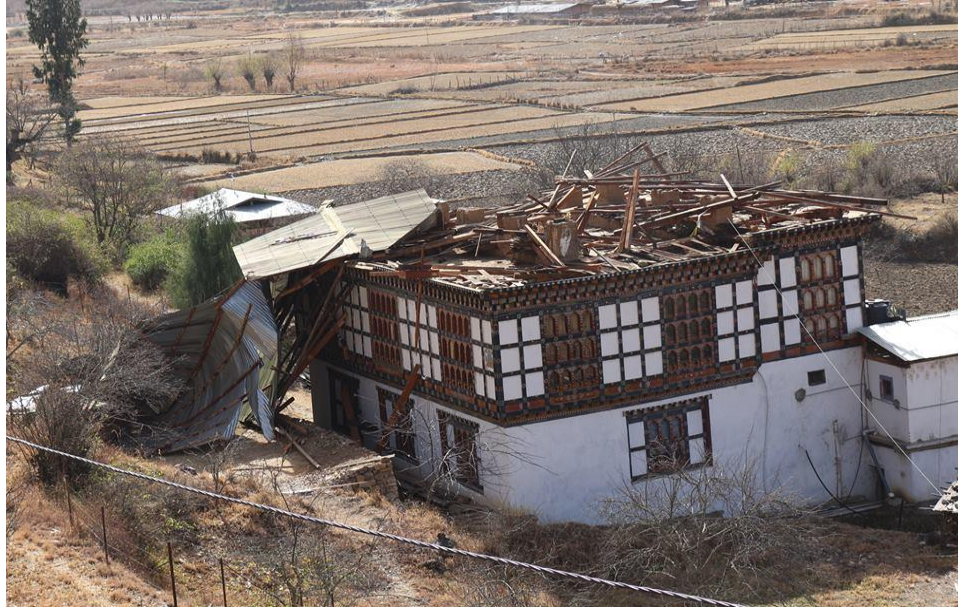
Figure 46, failure of roof was observed due to the connection failure between the rafters and struts causing the full-blown off. The rural home roof of Bhutan is simply support on the attic floor, whereby there is no connection between the support and floor or wall. Therefore, it was observed that most of the failures are due to lack of rigid connection between the strut/support and attic floor and roof-to-wall connection.

Figure 46: Full-blown of rural home roof due to failure in the connections

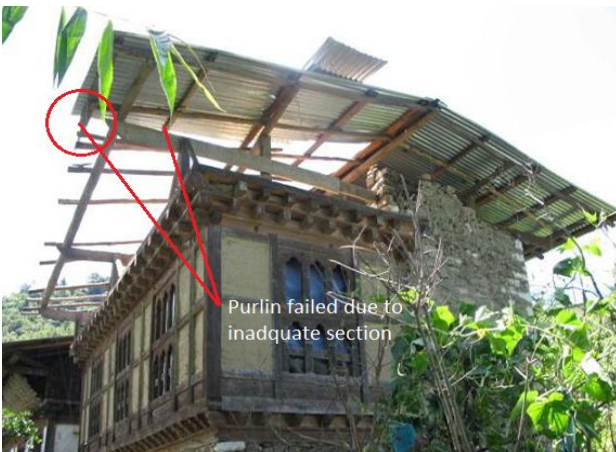
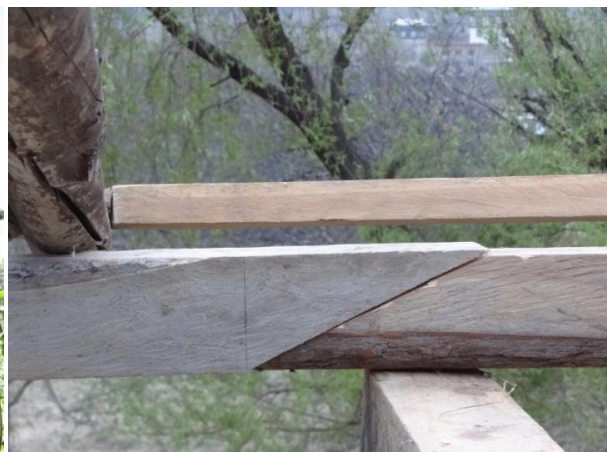
Figure 47) was used by the local carpenters, which is weak to resist the strong wind pressure.

Figure 47: Purlin section failure (L) and joint failure (R)

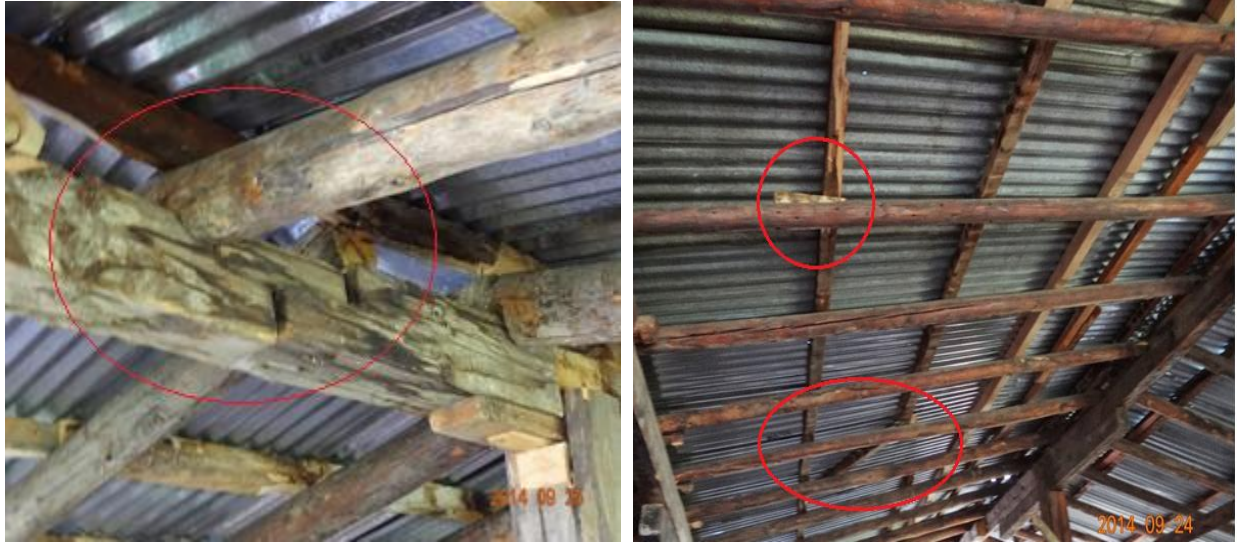
Figure 48: Weak lap joint at roof ridge (L) and purlin are not laid equally (R)

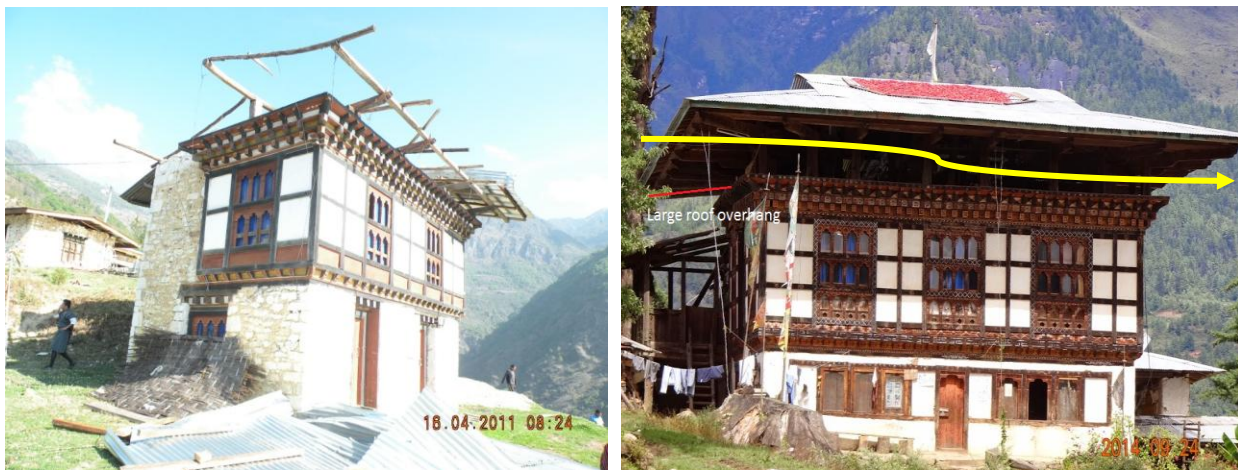
Figure 49: Gable roof end failure (L) and large roof overhang (R)

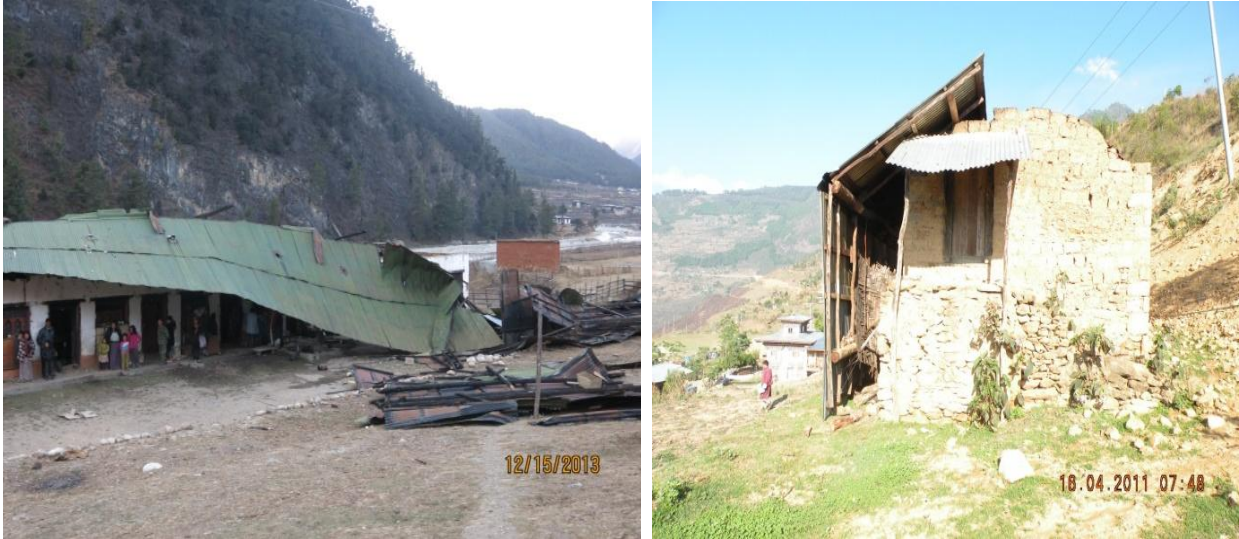
Figure 51: Sliding of roof (L) and over-turning of roof (R)

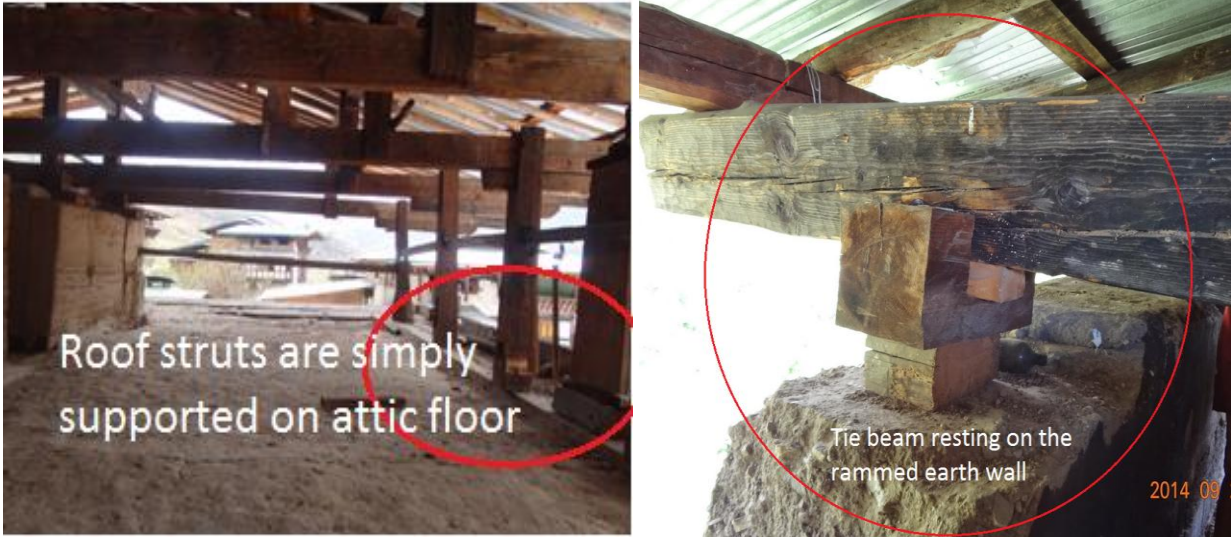
causing the roof damage. As described in the graph (Figure 53), most of the rural home roofs in the western and central part of Bhutan are simply supported

Figure 52: Roof supports/struts are simply supported on the attic roof or wall

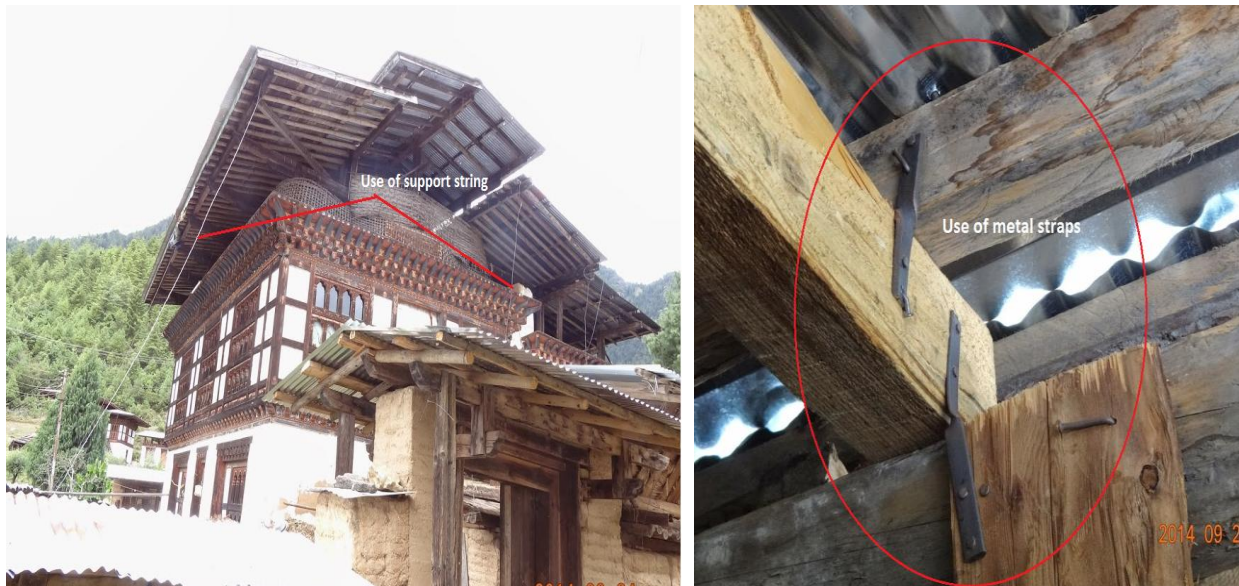
Figure 59: Use of support string (L) and metal straps (R) during the reconstruction in Paro

The use of support string helps to hold down the roof structure to prevent from the uplift during the windstorm. The support string should be anchored to the ground to withstand the wind pressure. As shown the in figure 59, the use of metal straps to connect the purlin to rafter and then to struts to reduce the uplift of roof during windstorm.

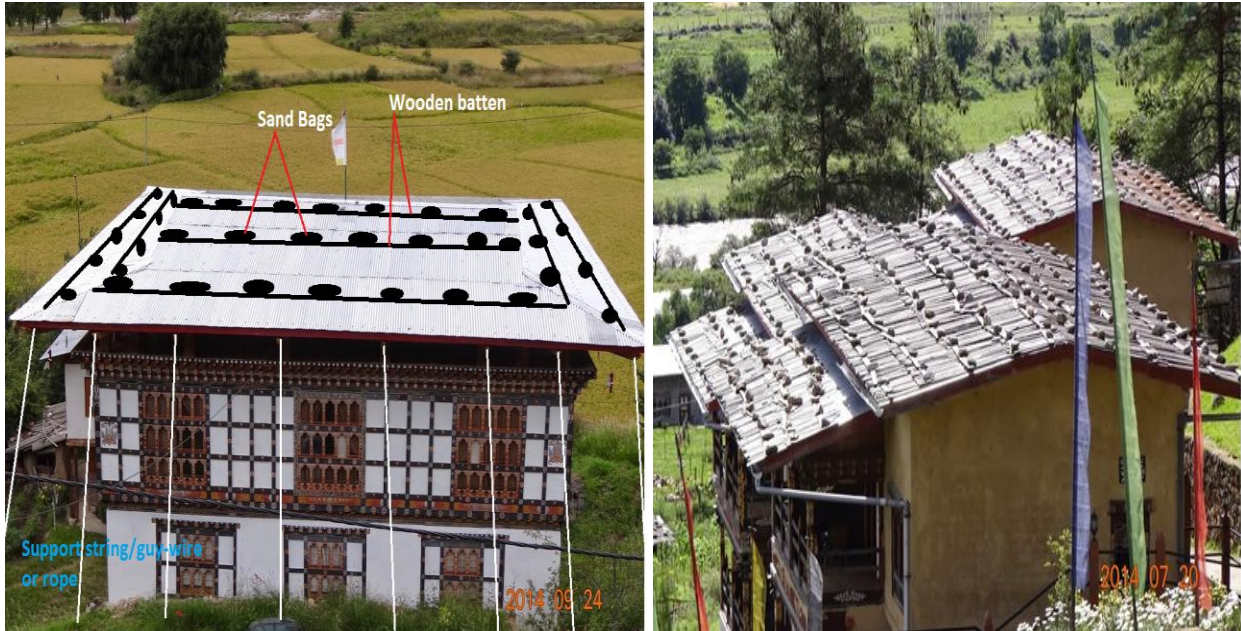
Figure 61: Support string or guy-wire or rope and sand bags (L) and wooden shingle over CGI sheet metal with stone (R)

4. Use of 10-20kg sand bags as shown in
5. Figure 61
6. Use of support string or guy-wire or ropes (Figure 59 & figure 61)
7. Use of G.I hook, G.I coach screw square head and G.I crank bolt (figure 63)
8. Use of metal straps Figure 59
9. Use of sufficient side laps and end laps as shown in Figure 63
10. Use of rubber washer instead of bitumen washer

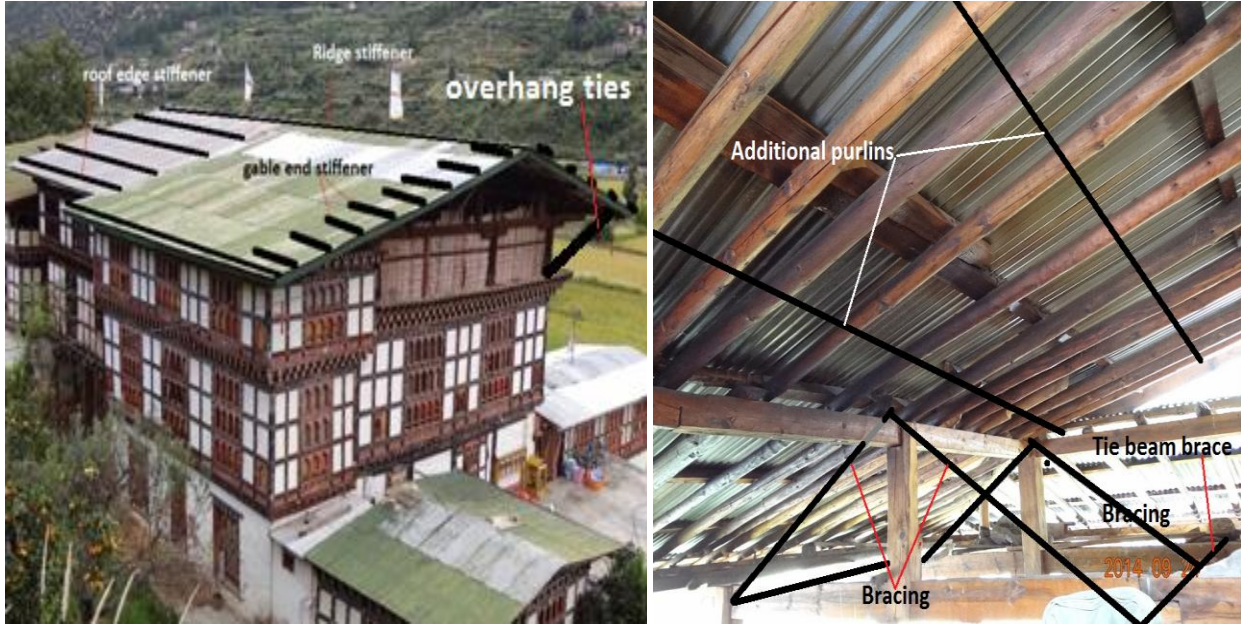
Figure 62: Gable end stiffener, roof ridge stiffener, corner stiffener and overhang ties (L) and additional purlins & bracing (R)
