An Overview of GLOF Hazards and Risk Reduction Initiatives in Bhutan

**Department of Disaster Management, Bhutan
“Reducing Disaster Risk for a Safe and Happy Bhutan”**

Asian Conference on Disaster Reduction 2016

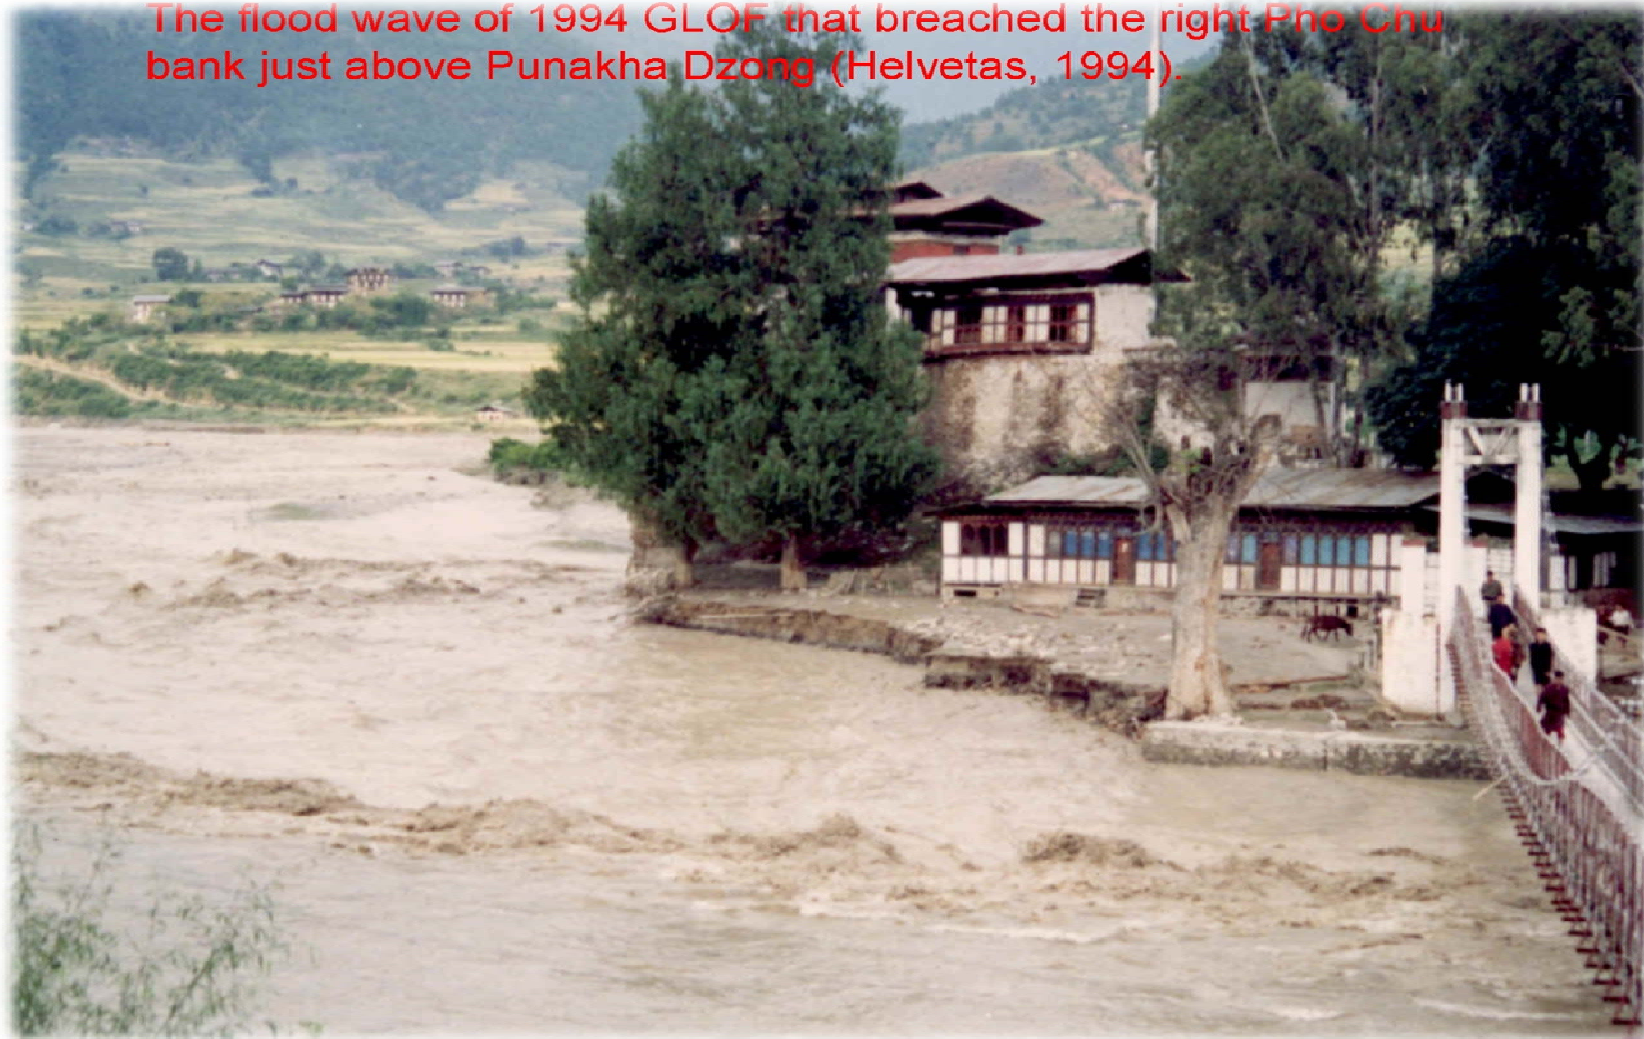
The flood wave of 1994 GLOF that breached the right Pho Chu bank just above Punakha Dzong (Helvetas, 1994).

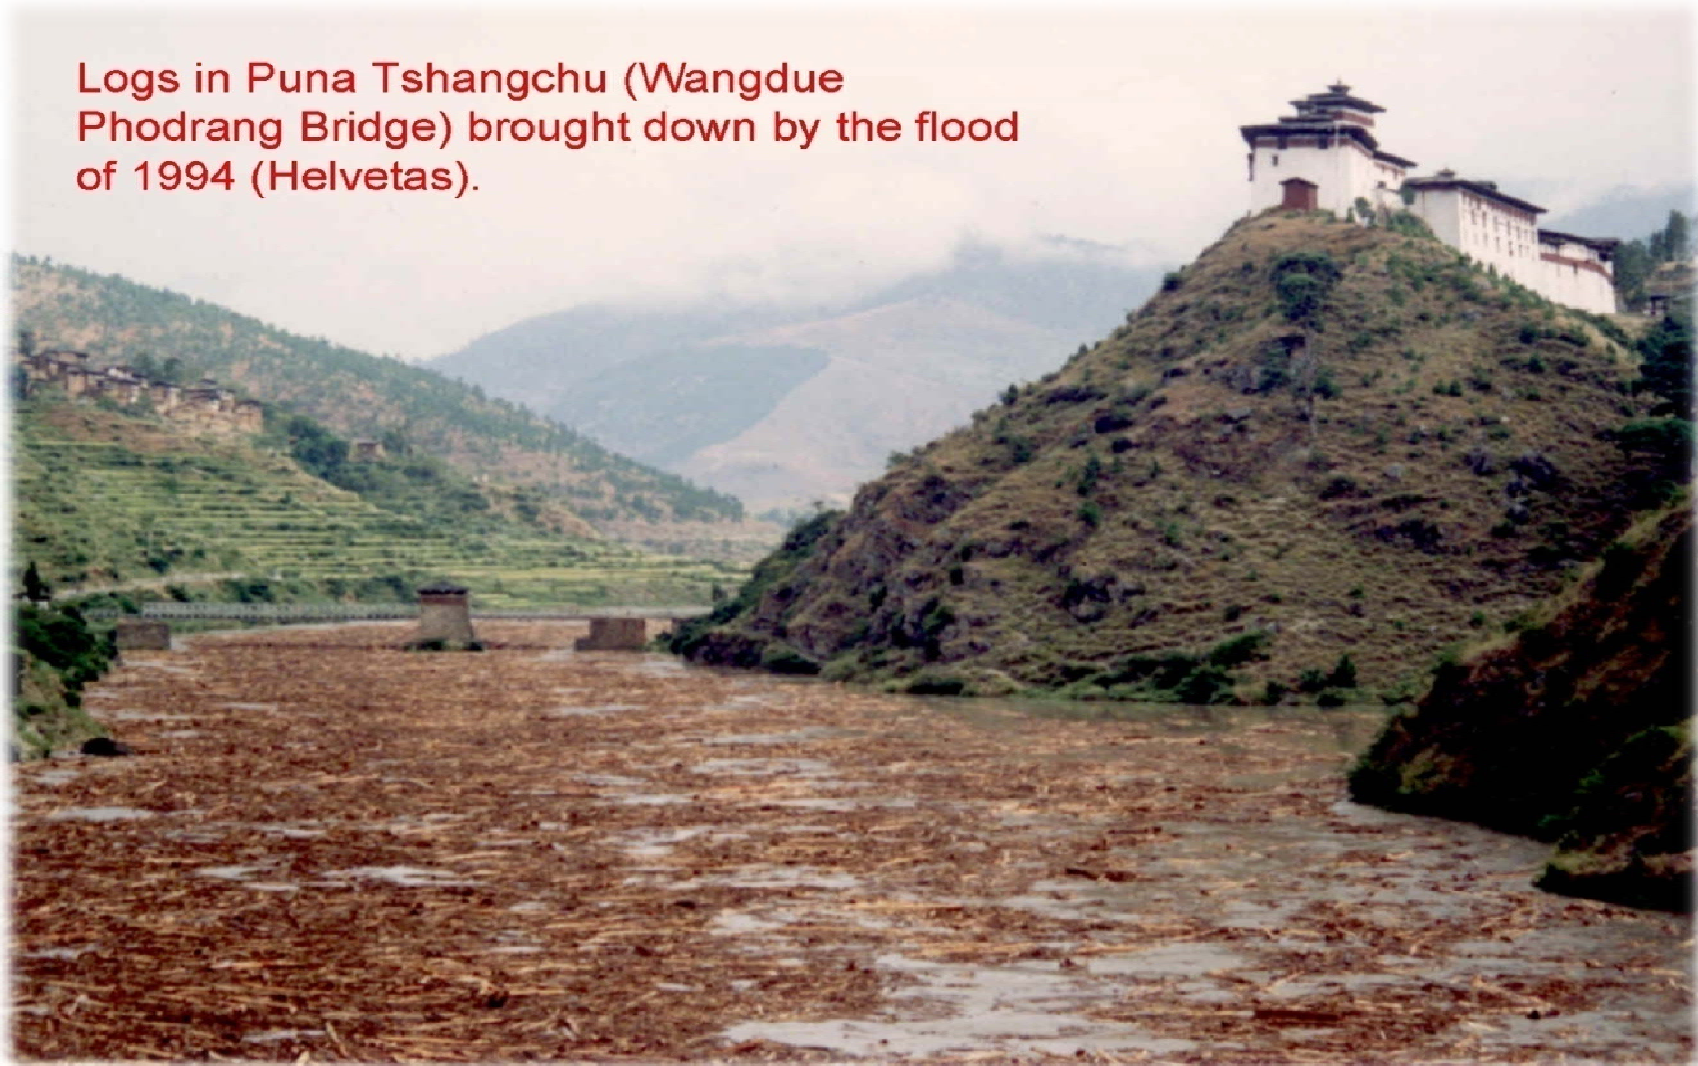
Logs in Puna Tshangchu (Wangdue Phodrang Bridge) brought down by the flood of 1994 (Helvetas).

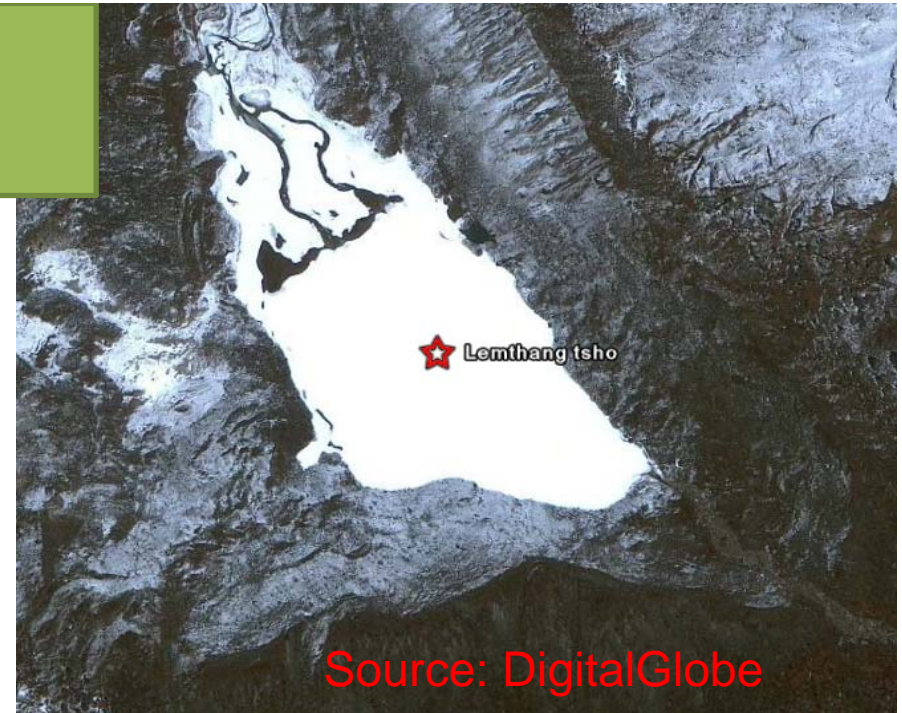
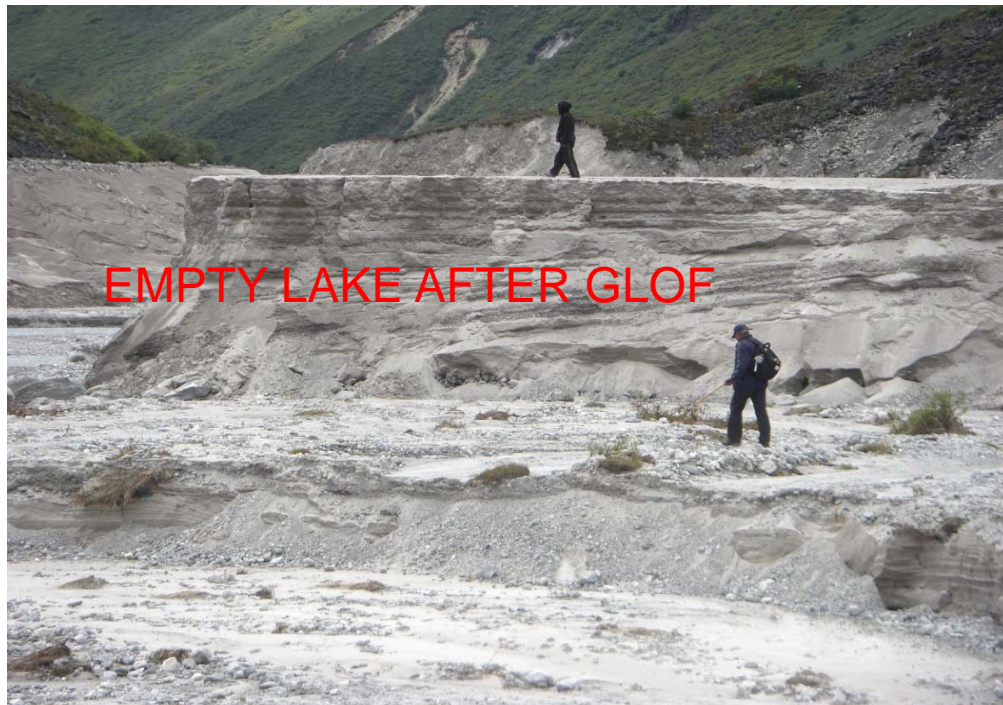
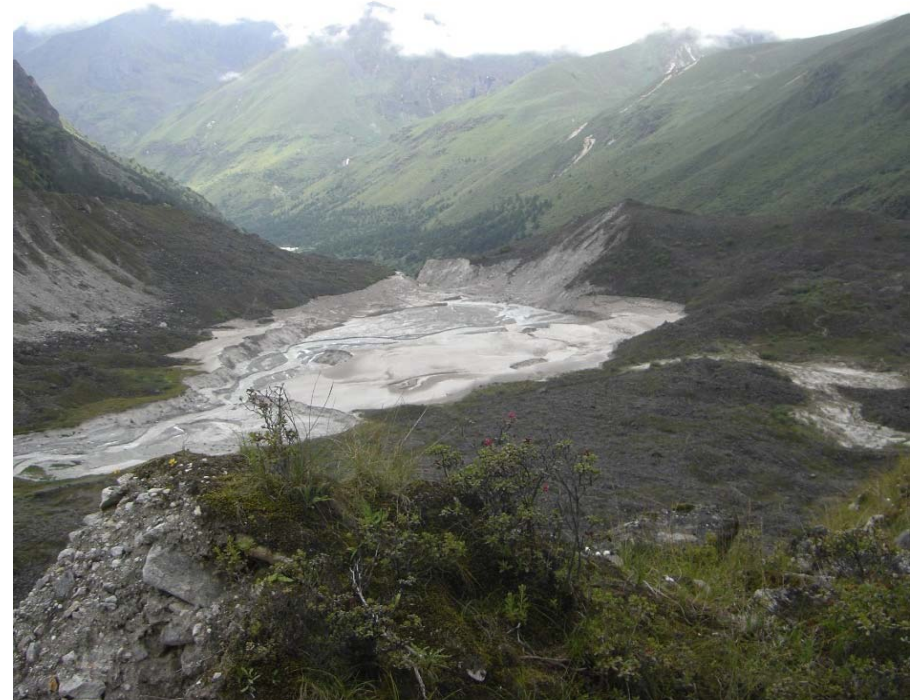
Lemthang Lake Outburst on 28 June 2015

Location: 28° 4' 1"N; 89° 34' 52"E

Elevation: 4290 msl

Length: 445m

Area: 0.076 sq km

Avg. depth: 6.29m

Deepest point: 14.42m

Volume: 0.37 million m³

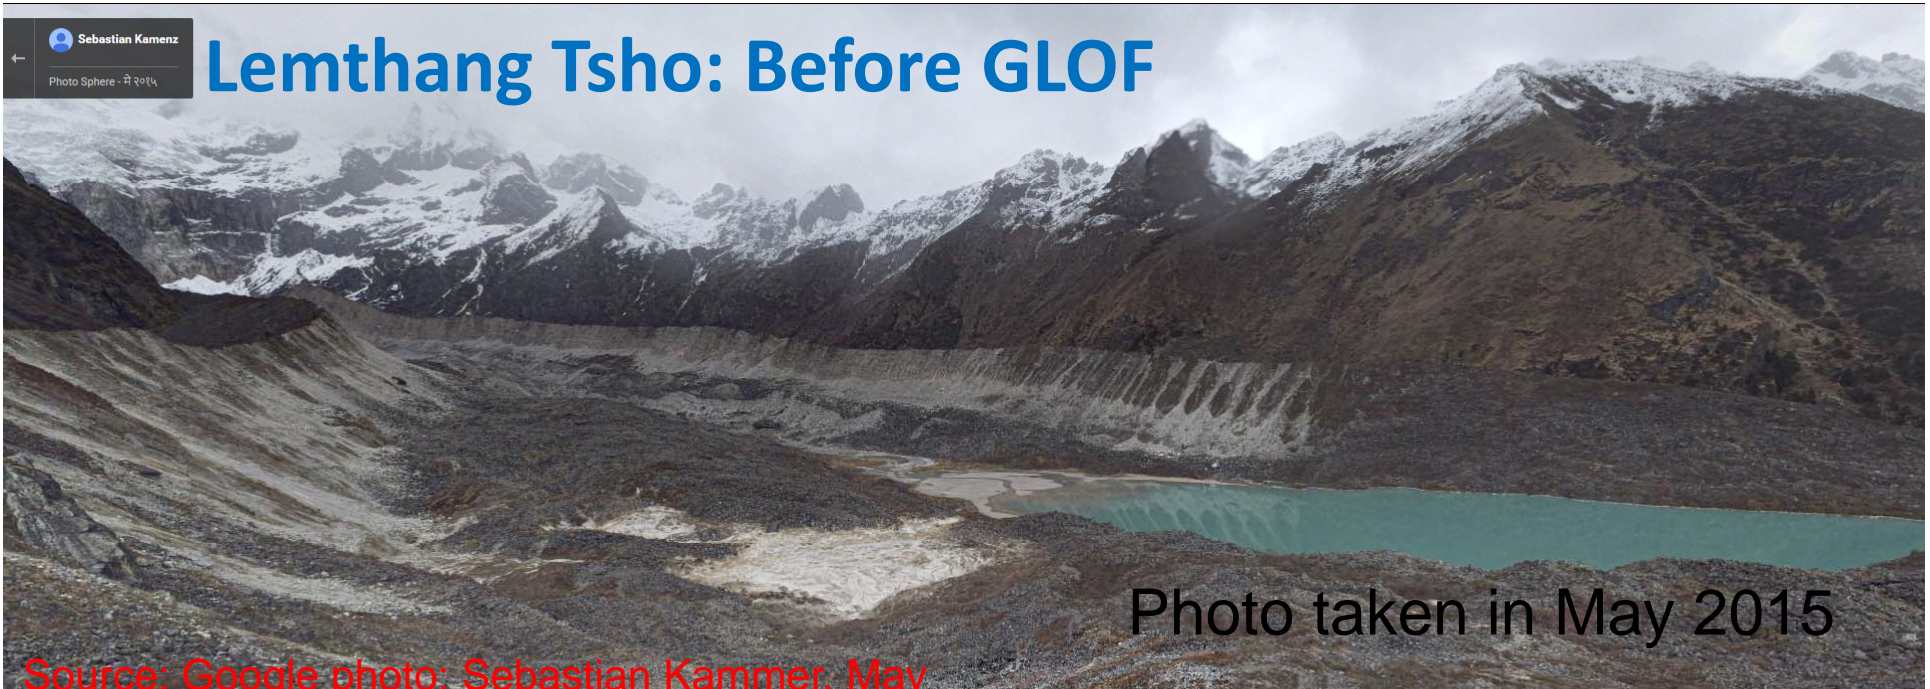
Lemthang Tsho: Before GLOF

Photo taken in May 2015

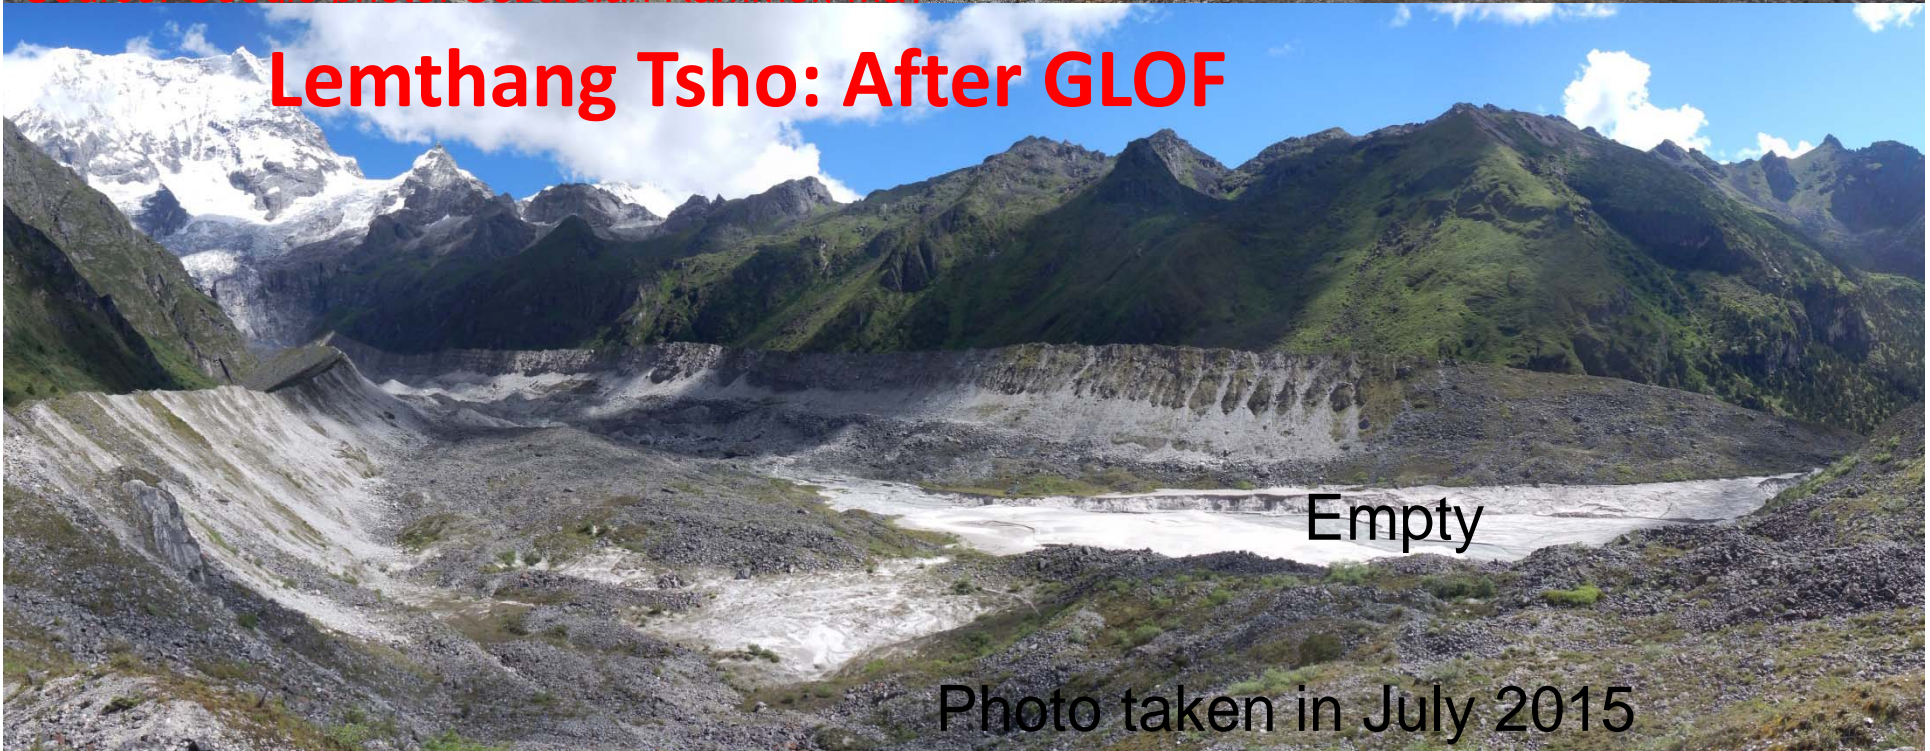
Lemthang Tsho: After GLOF

Empty

Photo taken in July 2015

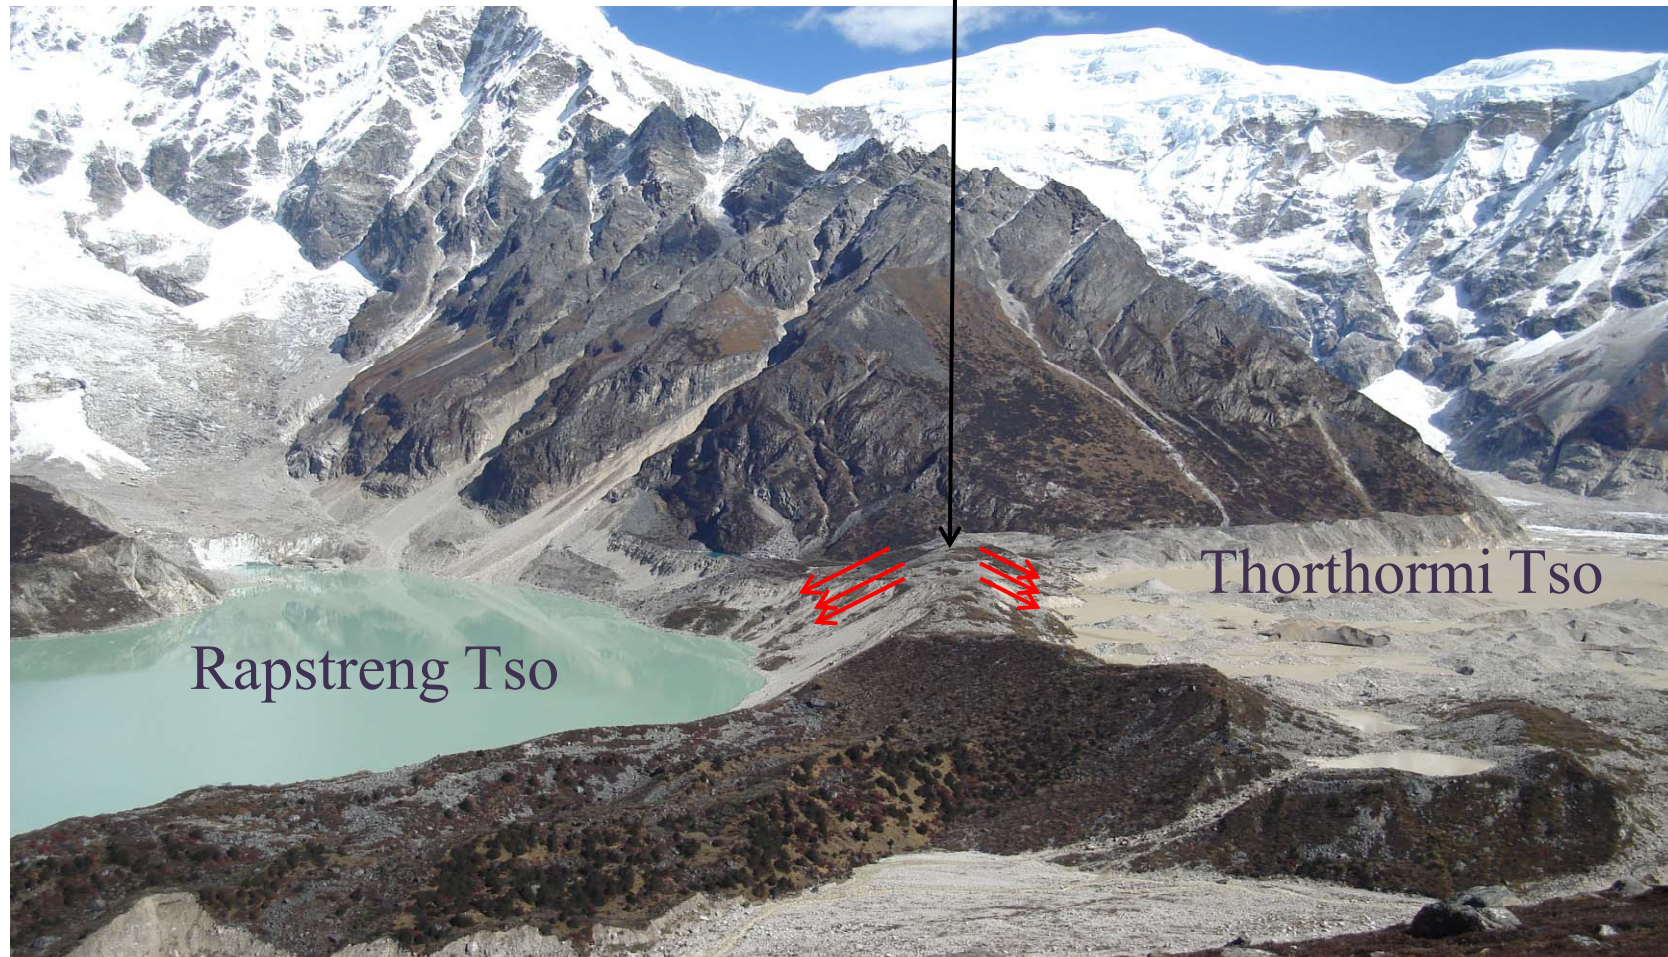
Moraine Barrier

Results in the thinning of the moraine barrier between Rapstreng and Thorthormi Tso

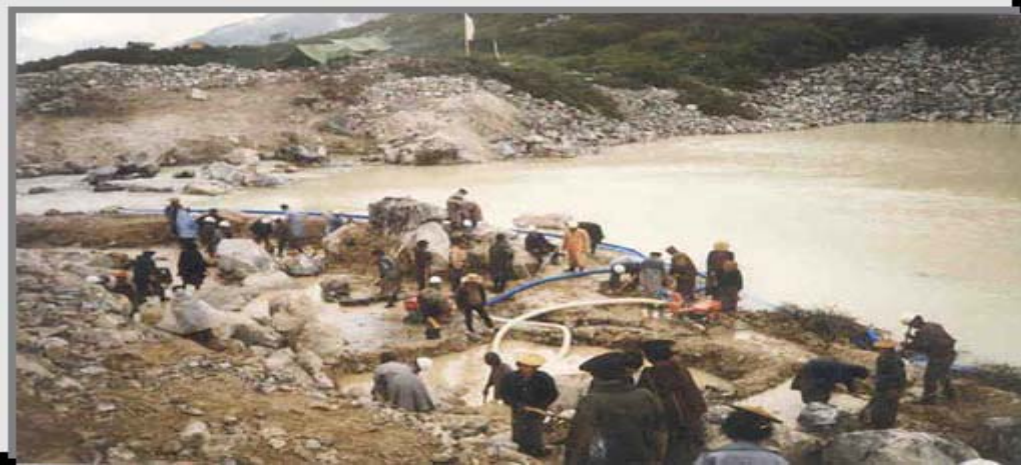
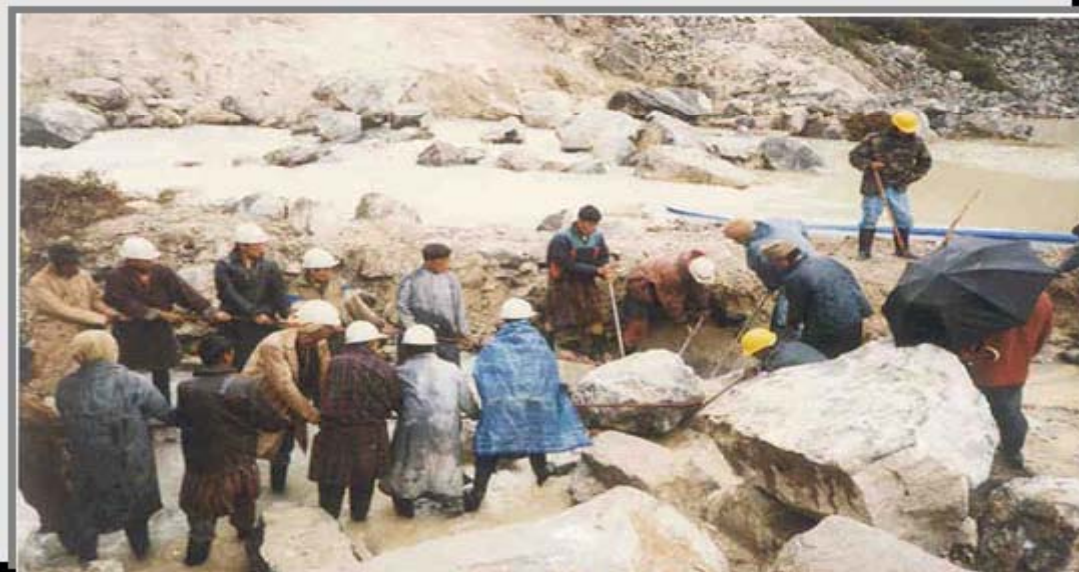
Raphstreng Tsho (Lake) Mitigation (1996-1998)

- Based on assessment after 1994 Lugge Tso outburst, Raphstreng Tso found to be critically dangerous
- Work started in 1996 to lower the water level by 4m
- Funded by the Royal Government of Bhutan & Government of India
- Coordinated by the Ministry of Home & Cultural Affairs

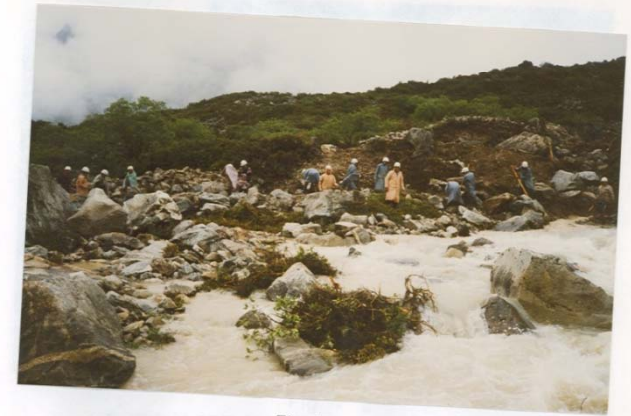
Fig. 4. 1 (a)
DISAPATED BY
OFF BY CANY BASKETS

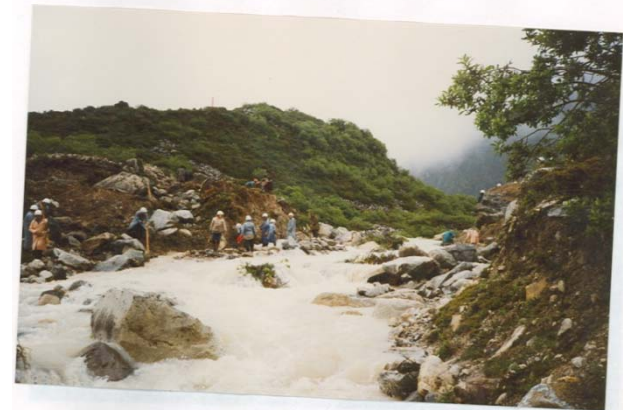
Fig. 4. 1 (b)
WIDENING BETWEEN SUBSIDIARY LAKE I & II
(WORK IN PROGRESS)

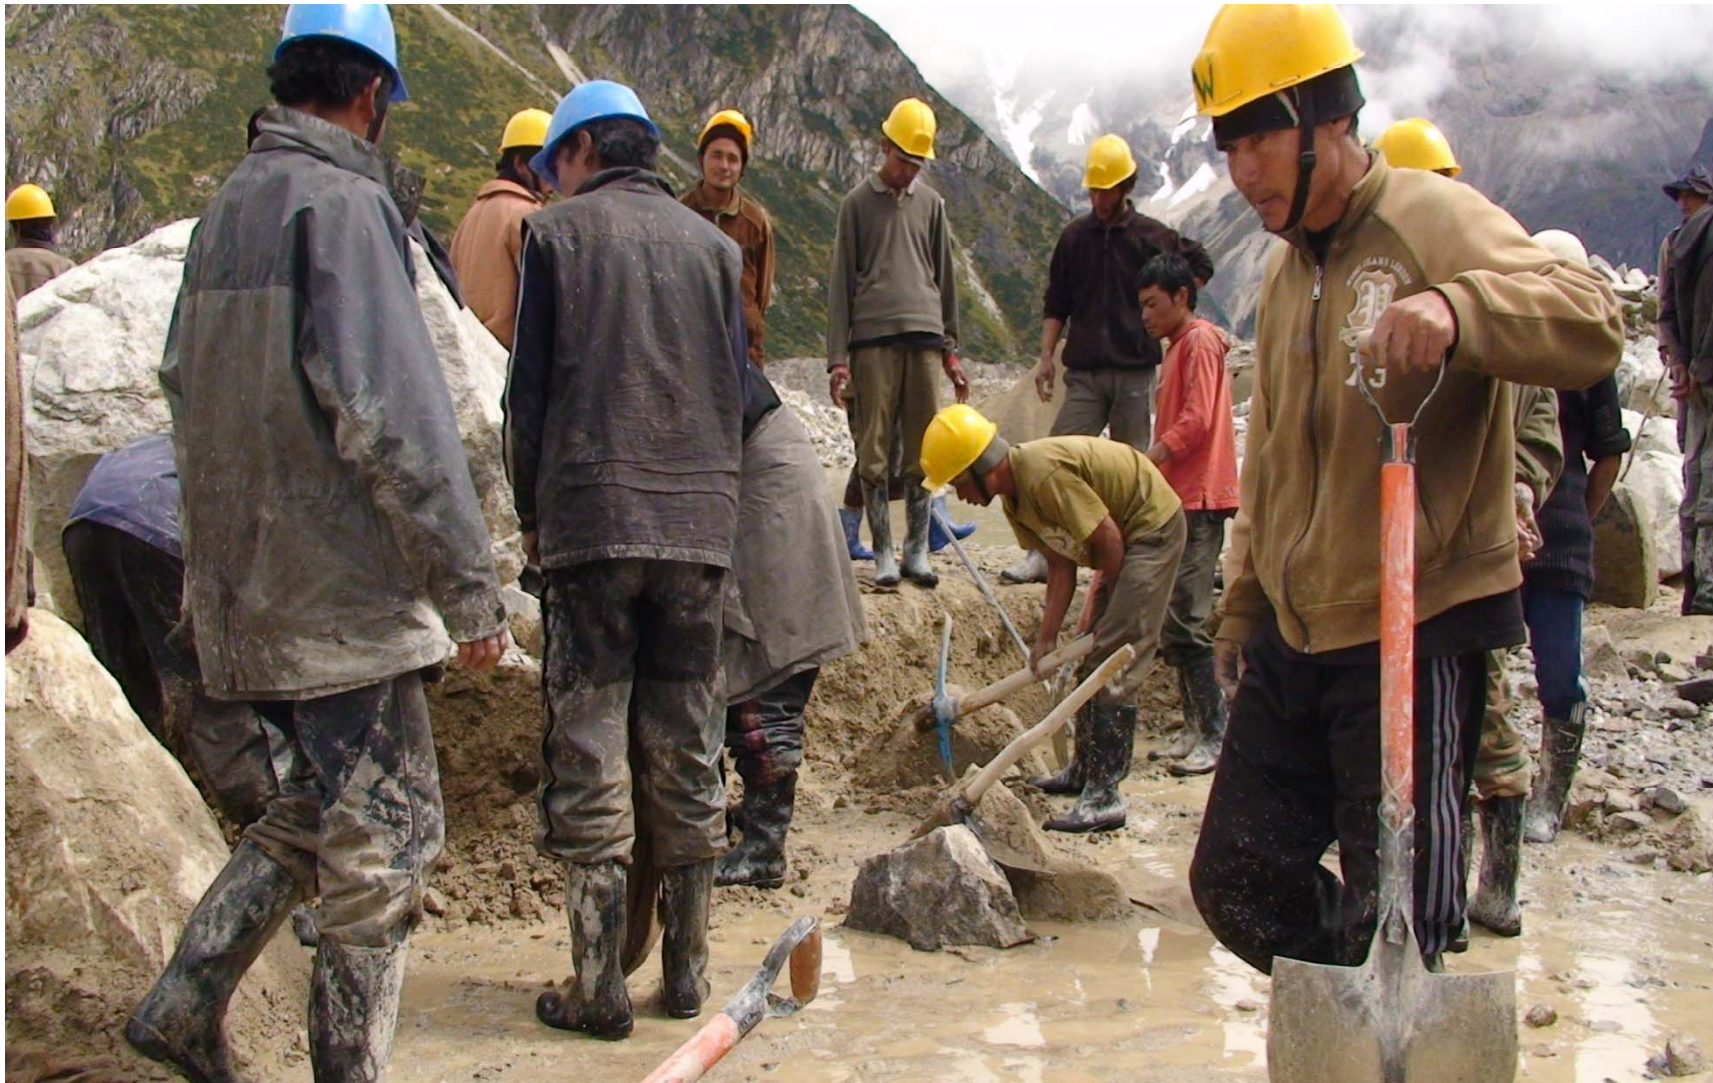
Thorthormi Tsho (Lake) risk mitigation (2008-2012)

- Design for 4 years with 4 months of working duration each year
- 360 workers
- USD 4.23 million +RGOB Co-financing
- Objective : lowering lake level by 5m in Thorthormi Tso (Approx. to 17 million cubic meters)
- Successfully lowered the lake level by 5m
- Reduced GLOF risk from the lake
- Minimal impact to the environment
- Benefits in terms of income generation to the communities

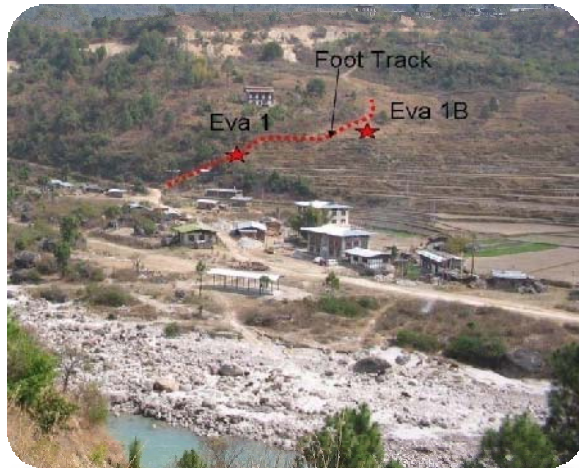
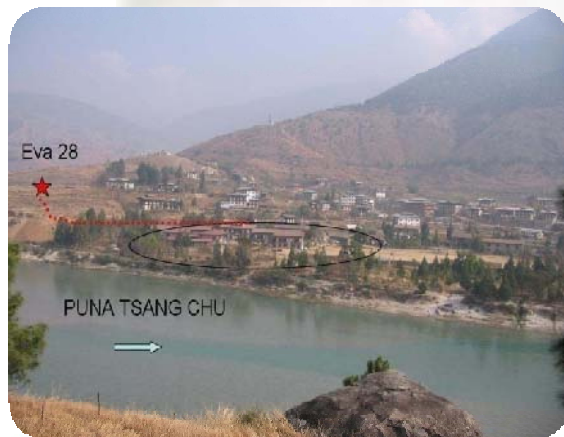
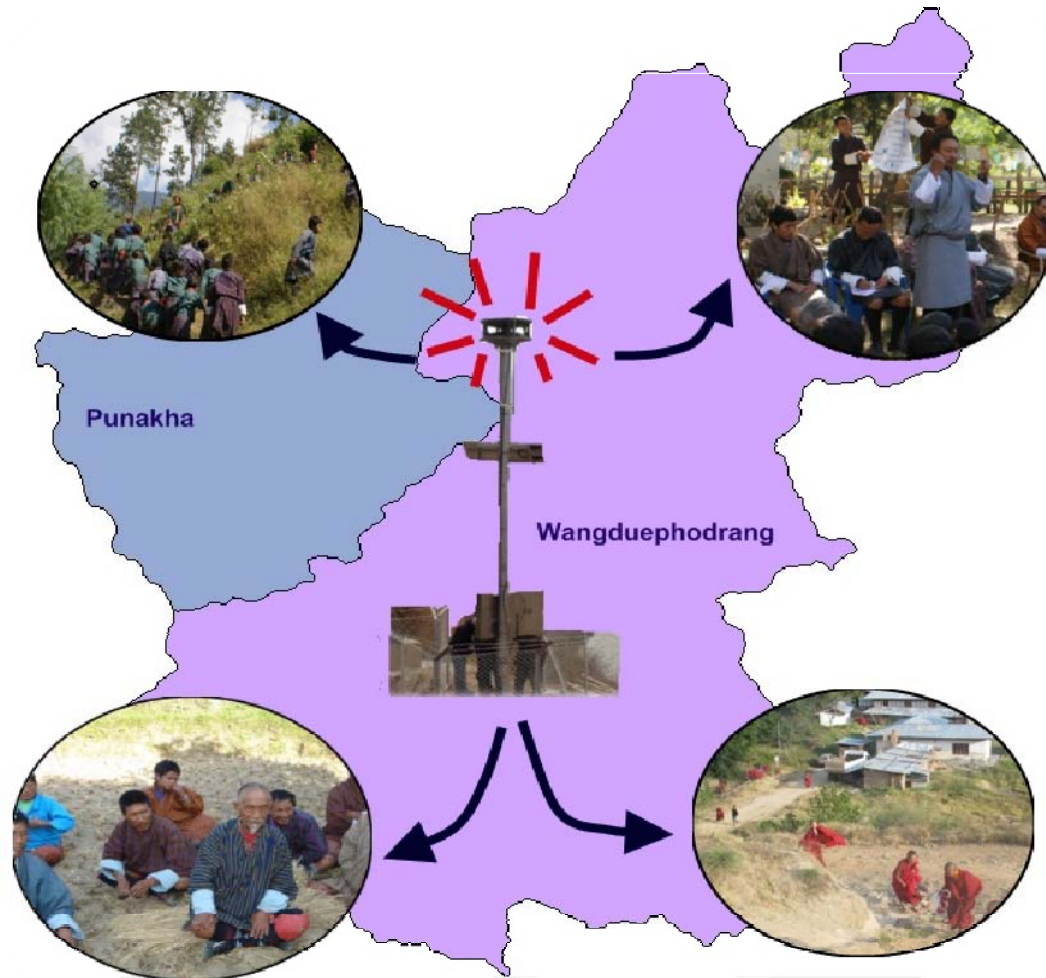
Early Warning System for GLOF

- Under the GLOF project a comprehensive EWS installed in the Pho Chhu and Punatsang Chhu valleys to provide sufficient lead time for evacuation
- 31 Vulnerable communities identified
- Public consultation meeting for Information sharing on GLoF event
- Community Focal Points for Early Warning in each vulnerable area
- Community Focal Points issued with Mobile phones/sim card /monthly vouchers
- ToR developed for Community Focal Points
- Information Flow mechanisms arranged
