# Damage to and Restoration of Kumamoto Castle

Kumamoto City Tourism Exchange Division

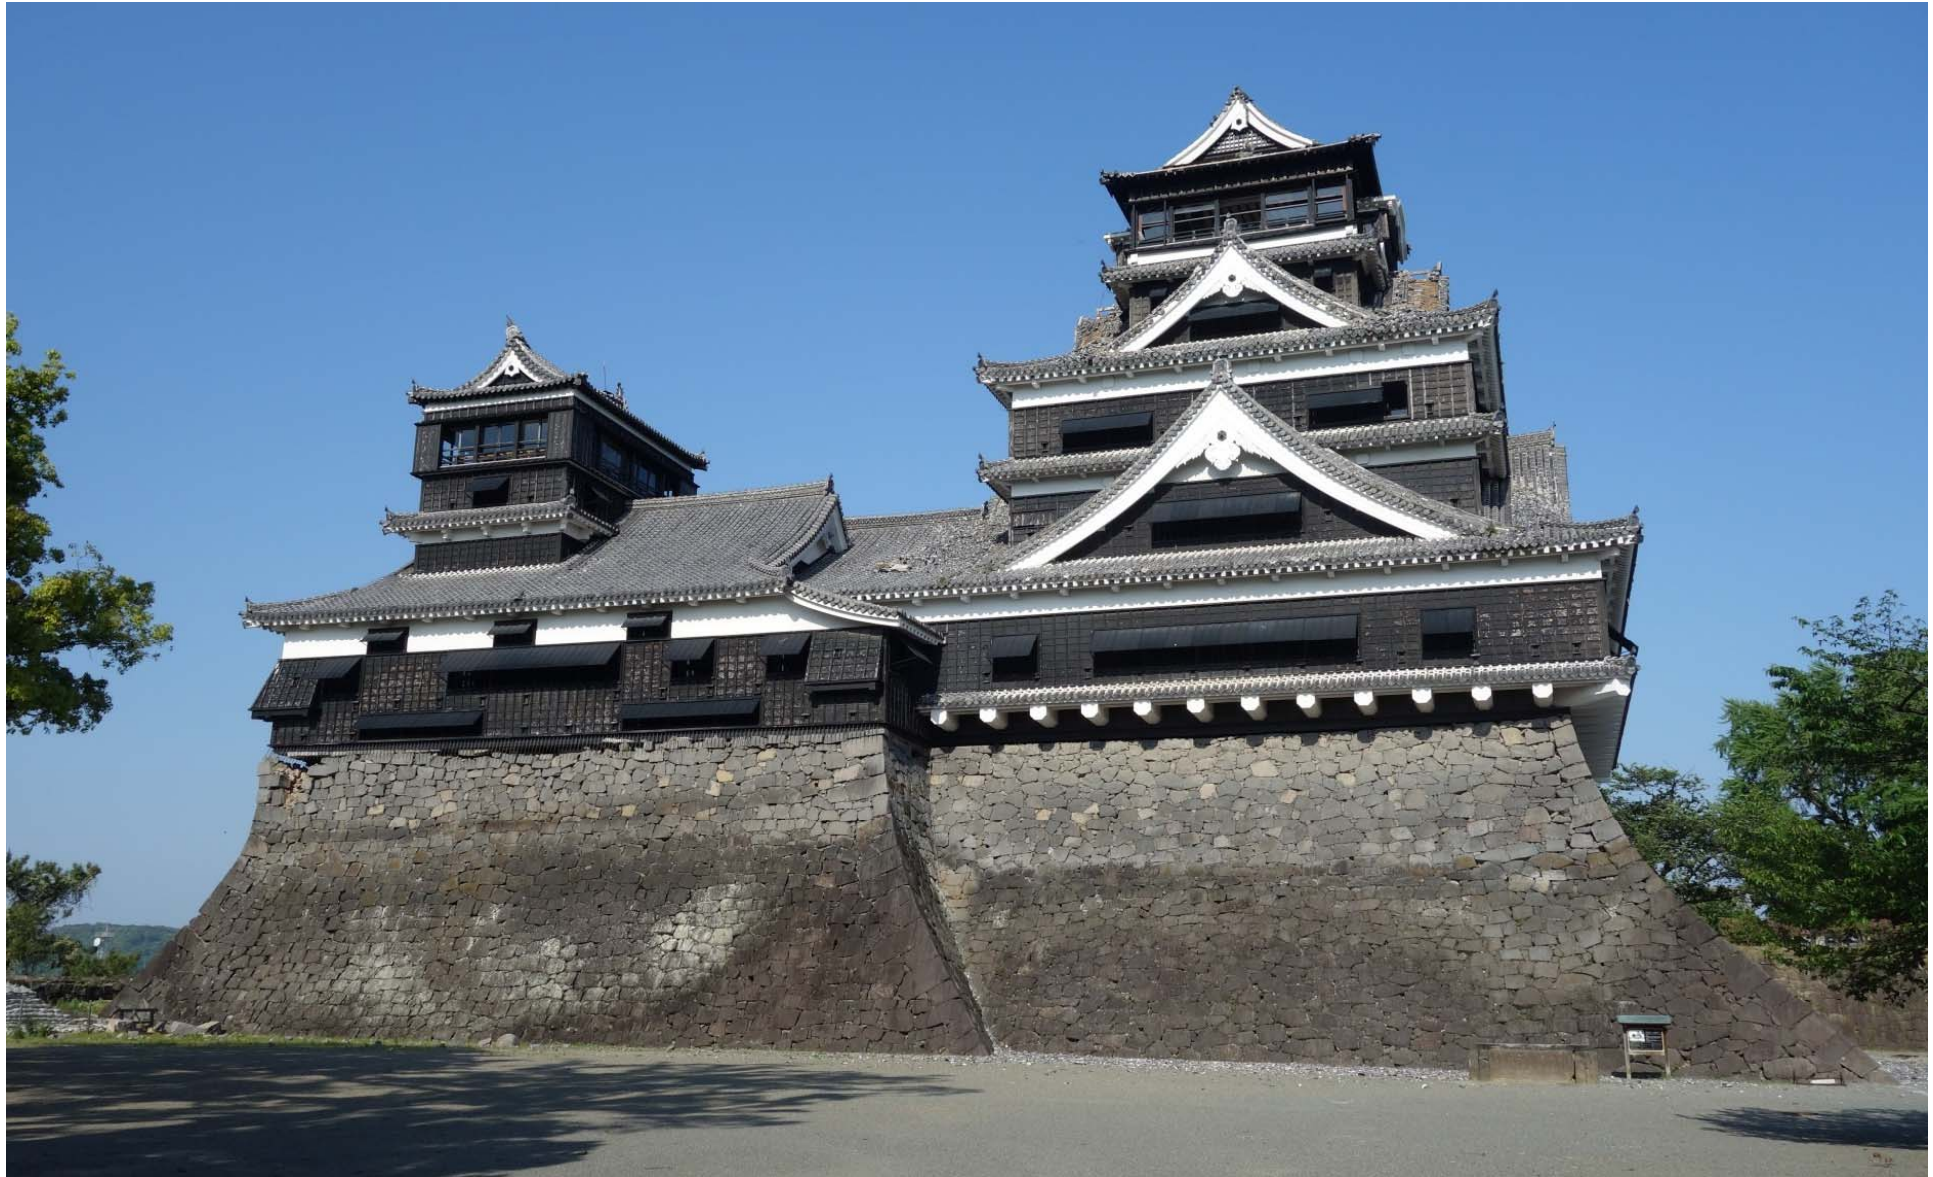
No significant change is seen from the west, but notice the damage to the main keep's roofs and to the top left corner of the small keep's stonewall.

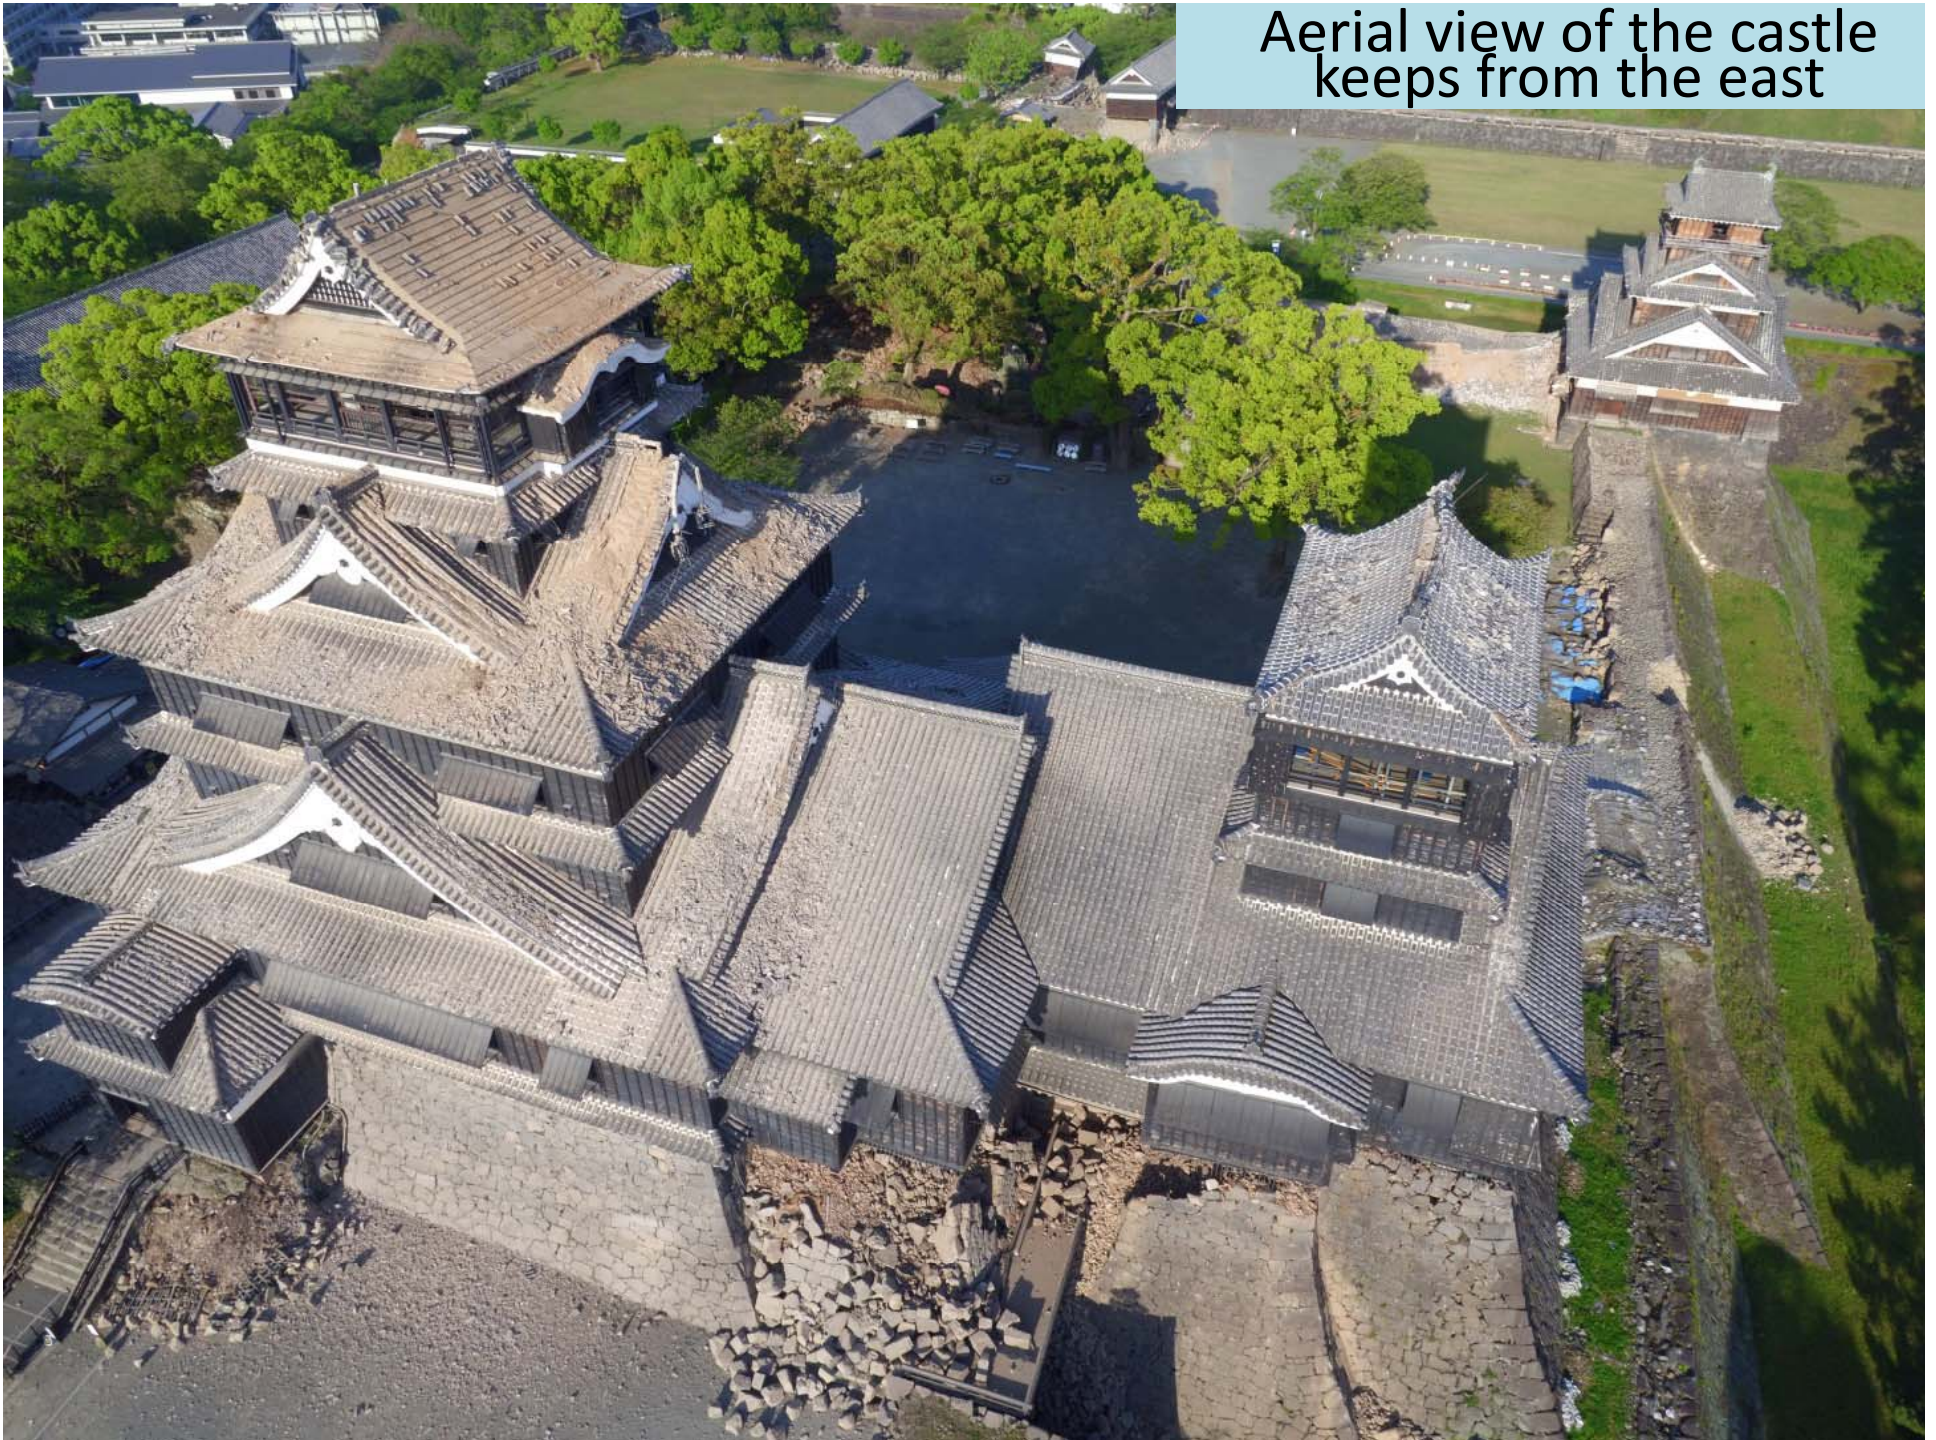
Aerial view of the castle  
keeps from the east

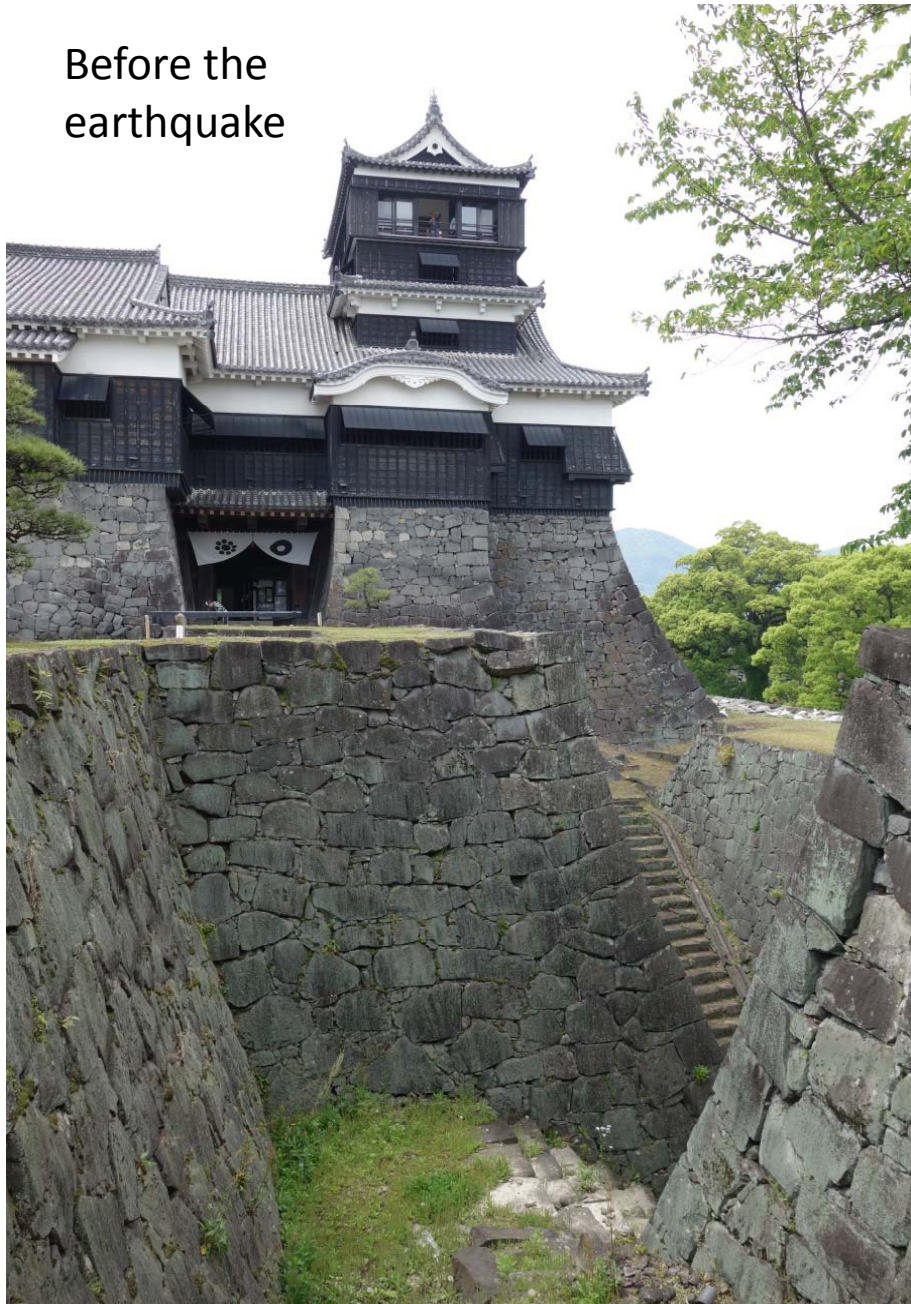
Before the earthquake

# Collapsed Stonewalls of the Small Castle Keep

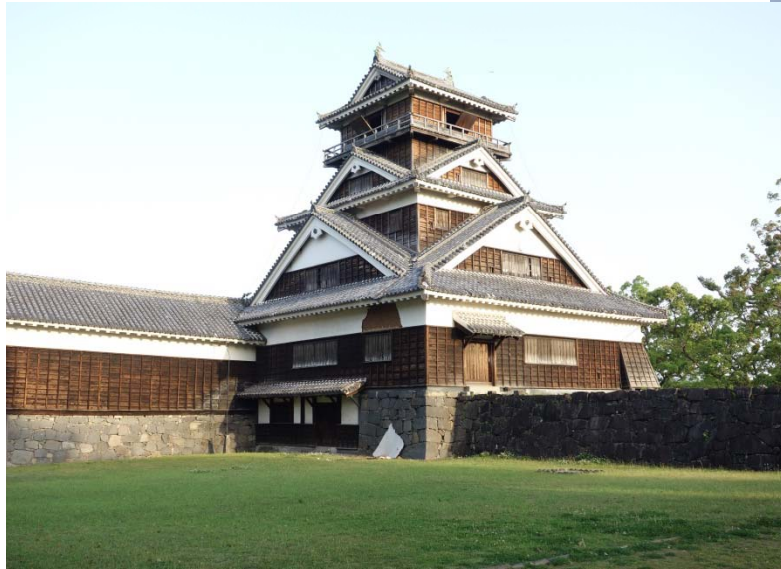
**The morning of April 15**

# Important Cultural Properties – Uto Turret and Tsuzuki Turret

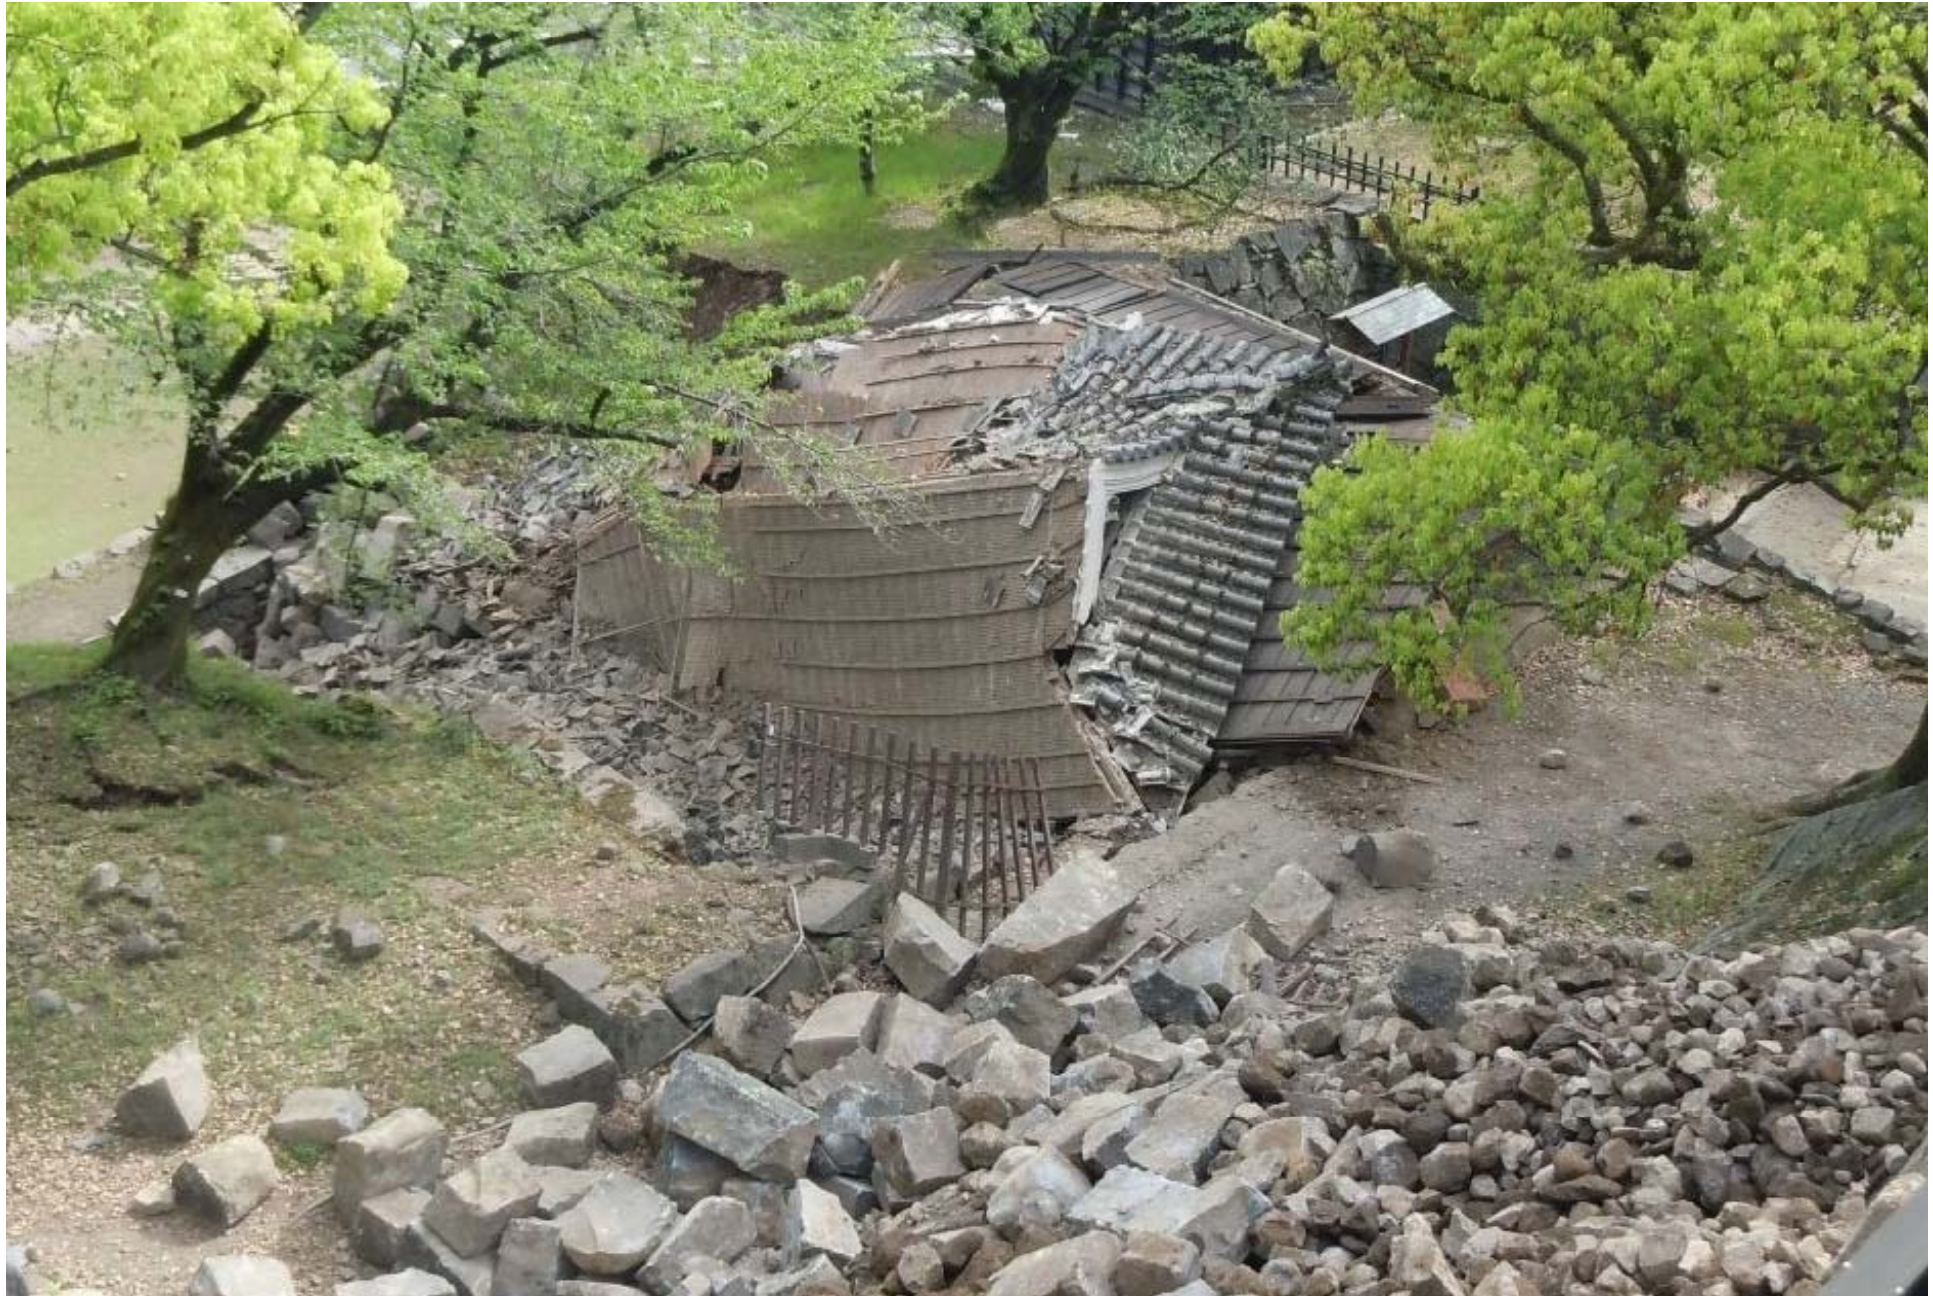
# Important Cultural Property – Akazumon Gate

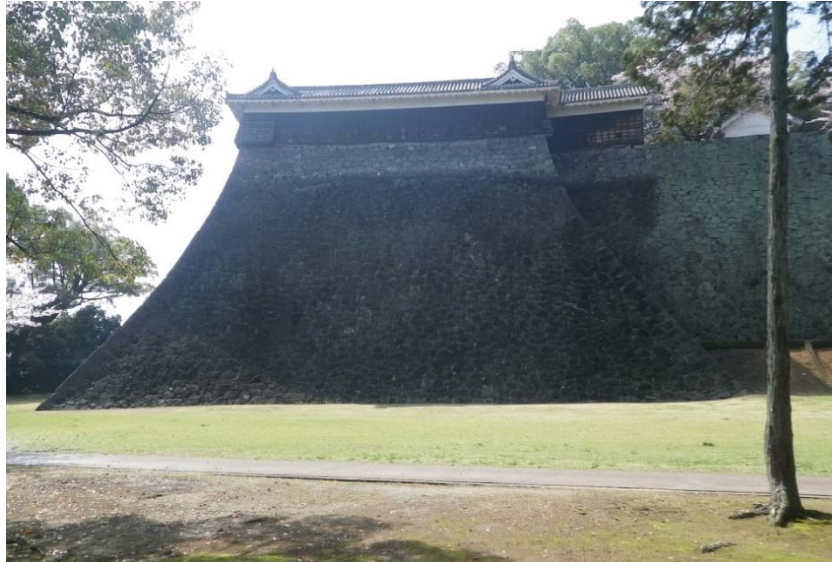
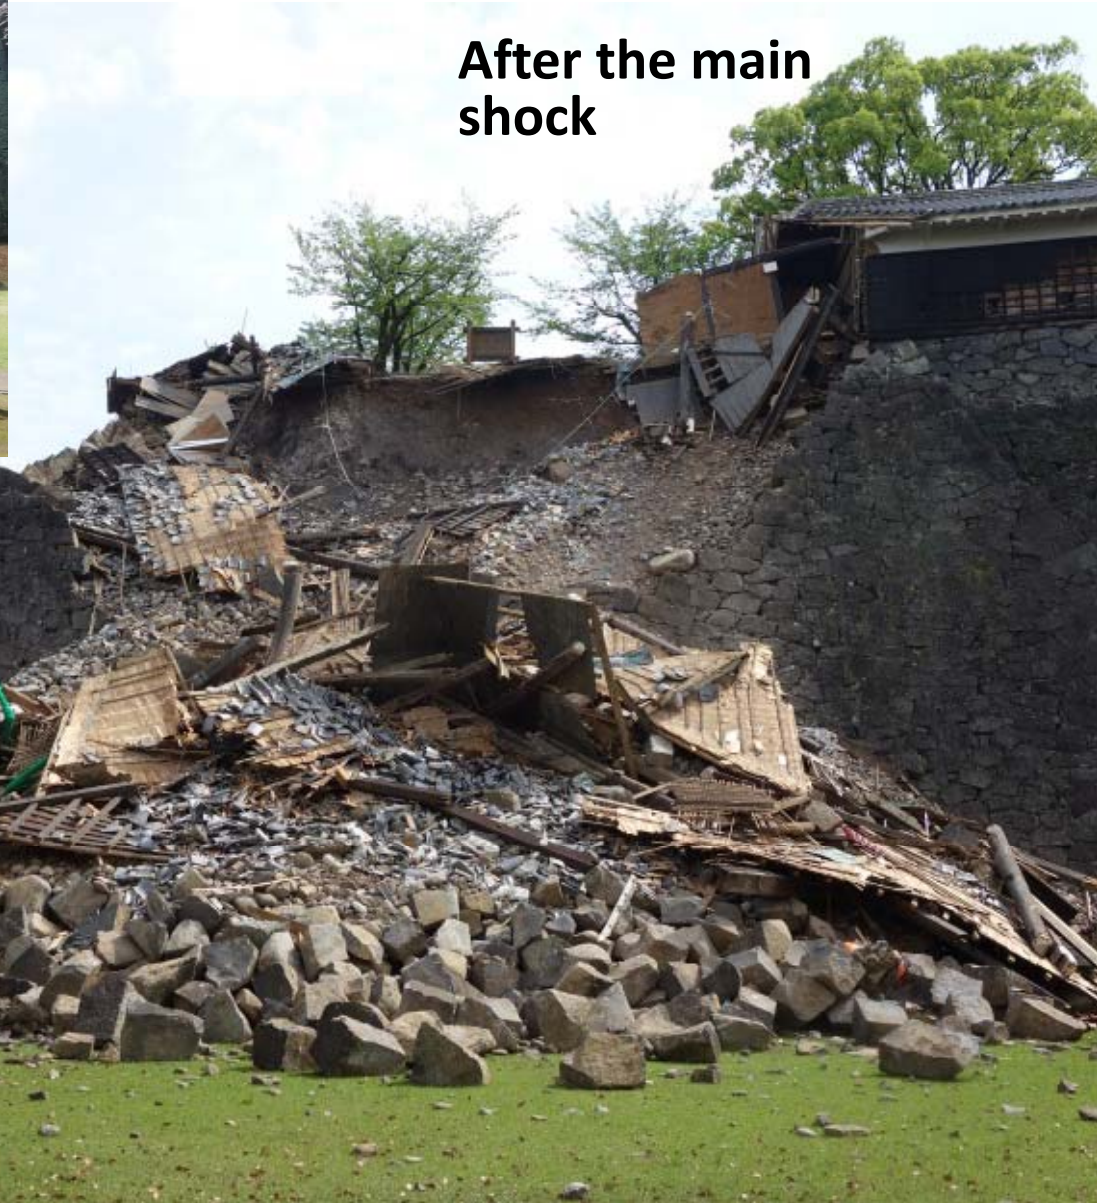
# Important Cultural Property – Kita Juhachiken Turret

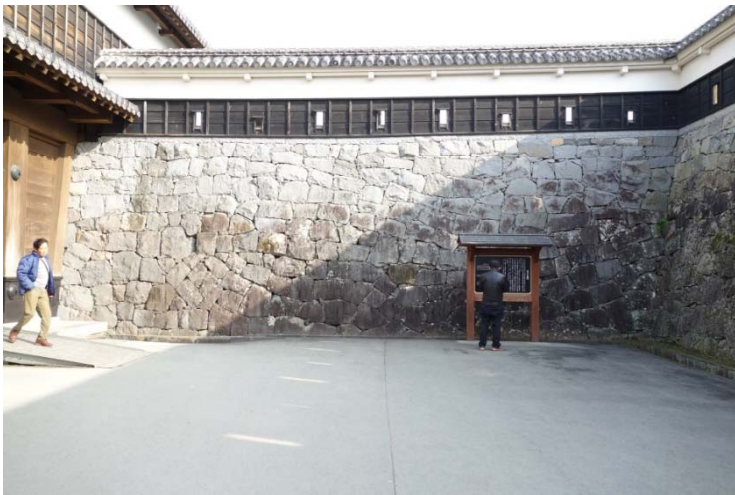
**Before the earthquake**

# Square Entrance to Nishi Otemon Gate

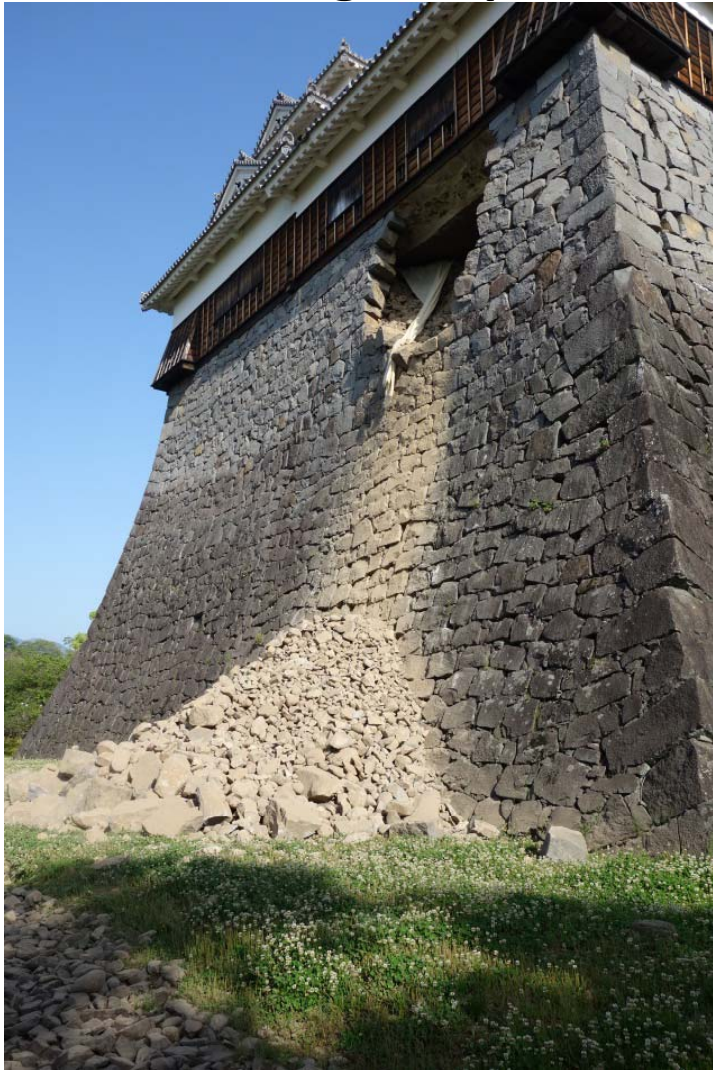
The morning of April 15

# South Eastern Corner of Iidamaru Gokai Turret

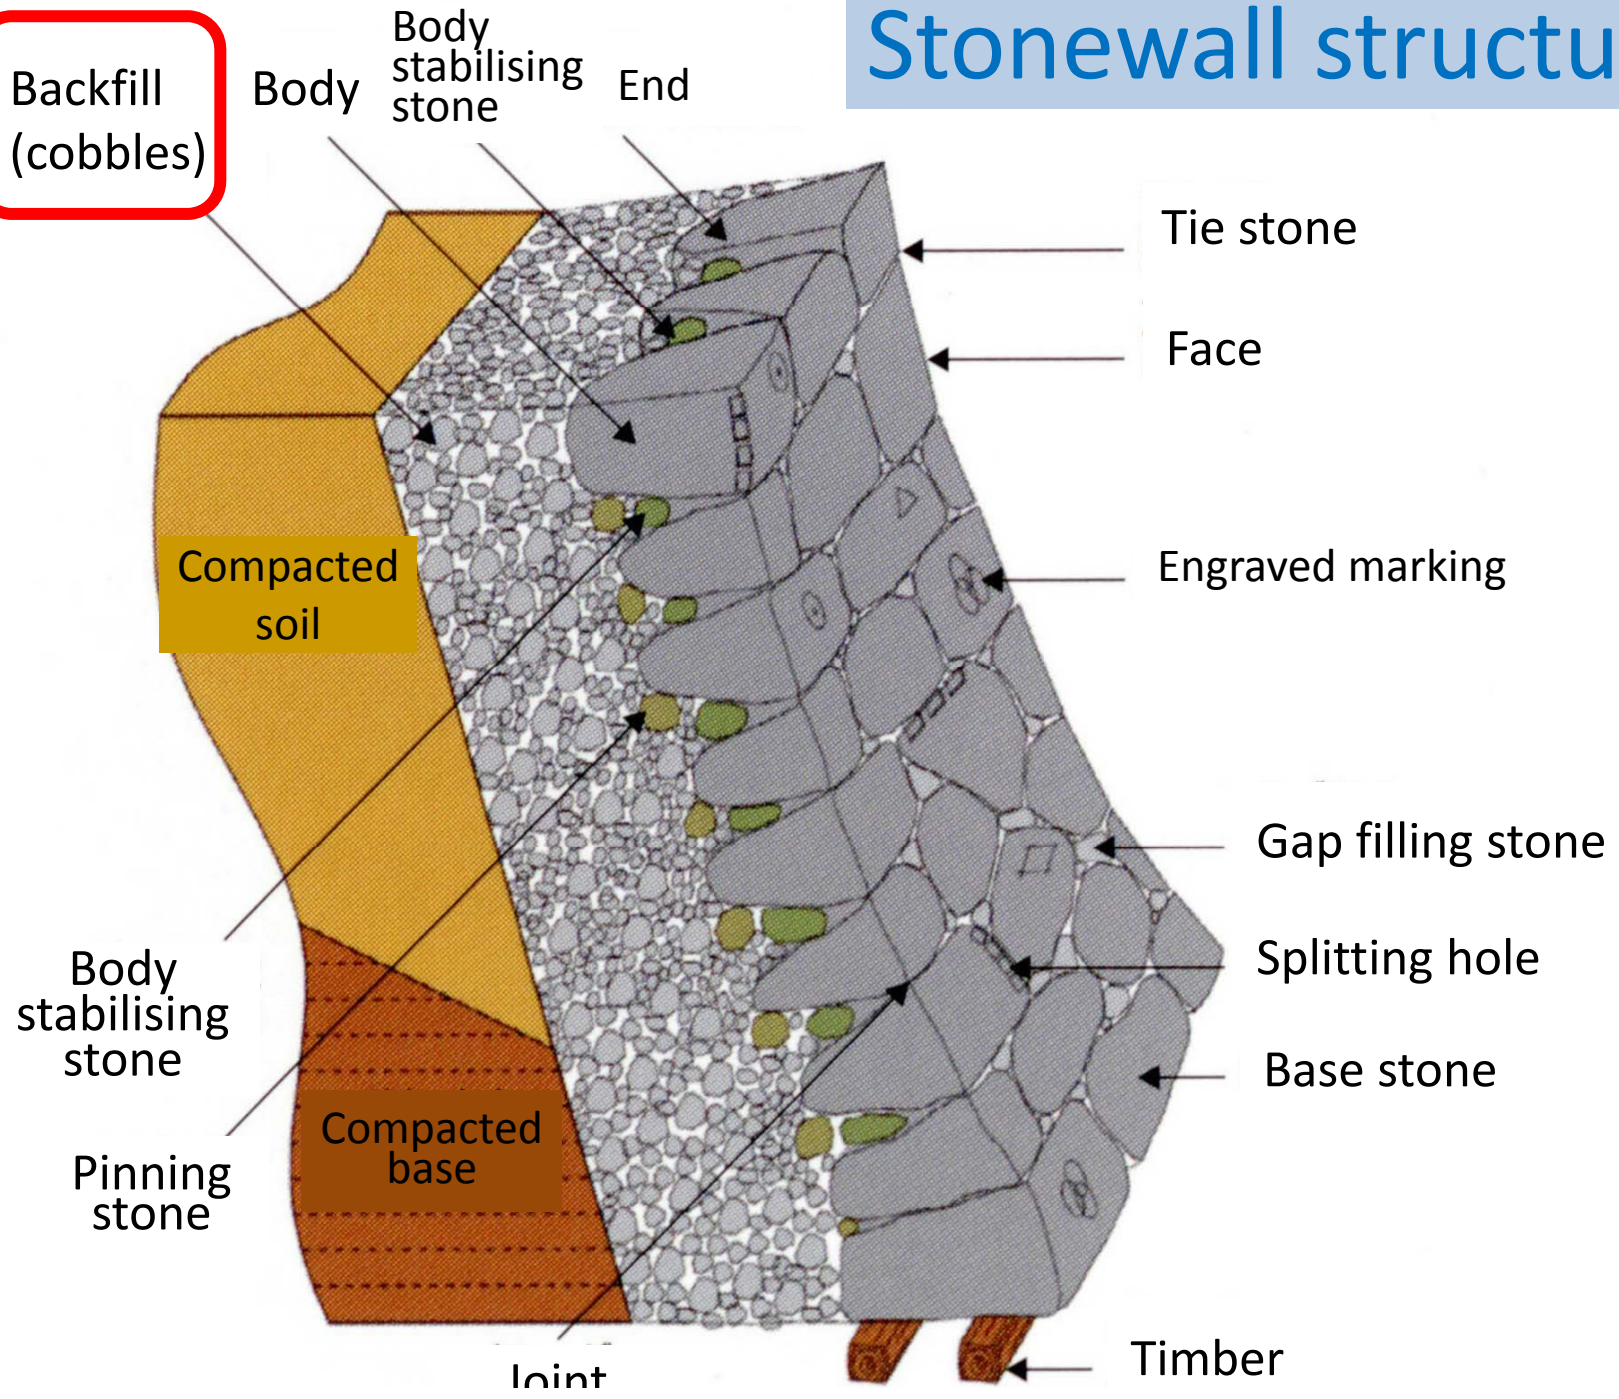
# Stonewall structure

Backfill (cobbles)

Body Body stabilising stone End

Tie stone

Face

Compacted soil

Body stabilising stone

Gap filling stone

Pinning stone

Compacted base

Base stone

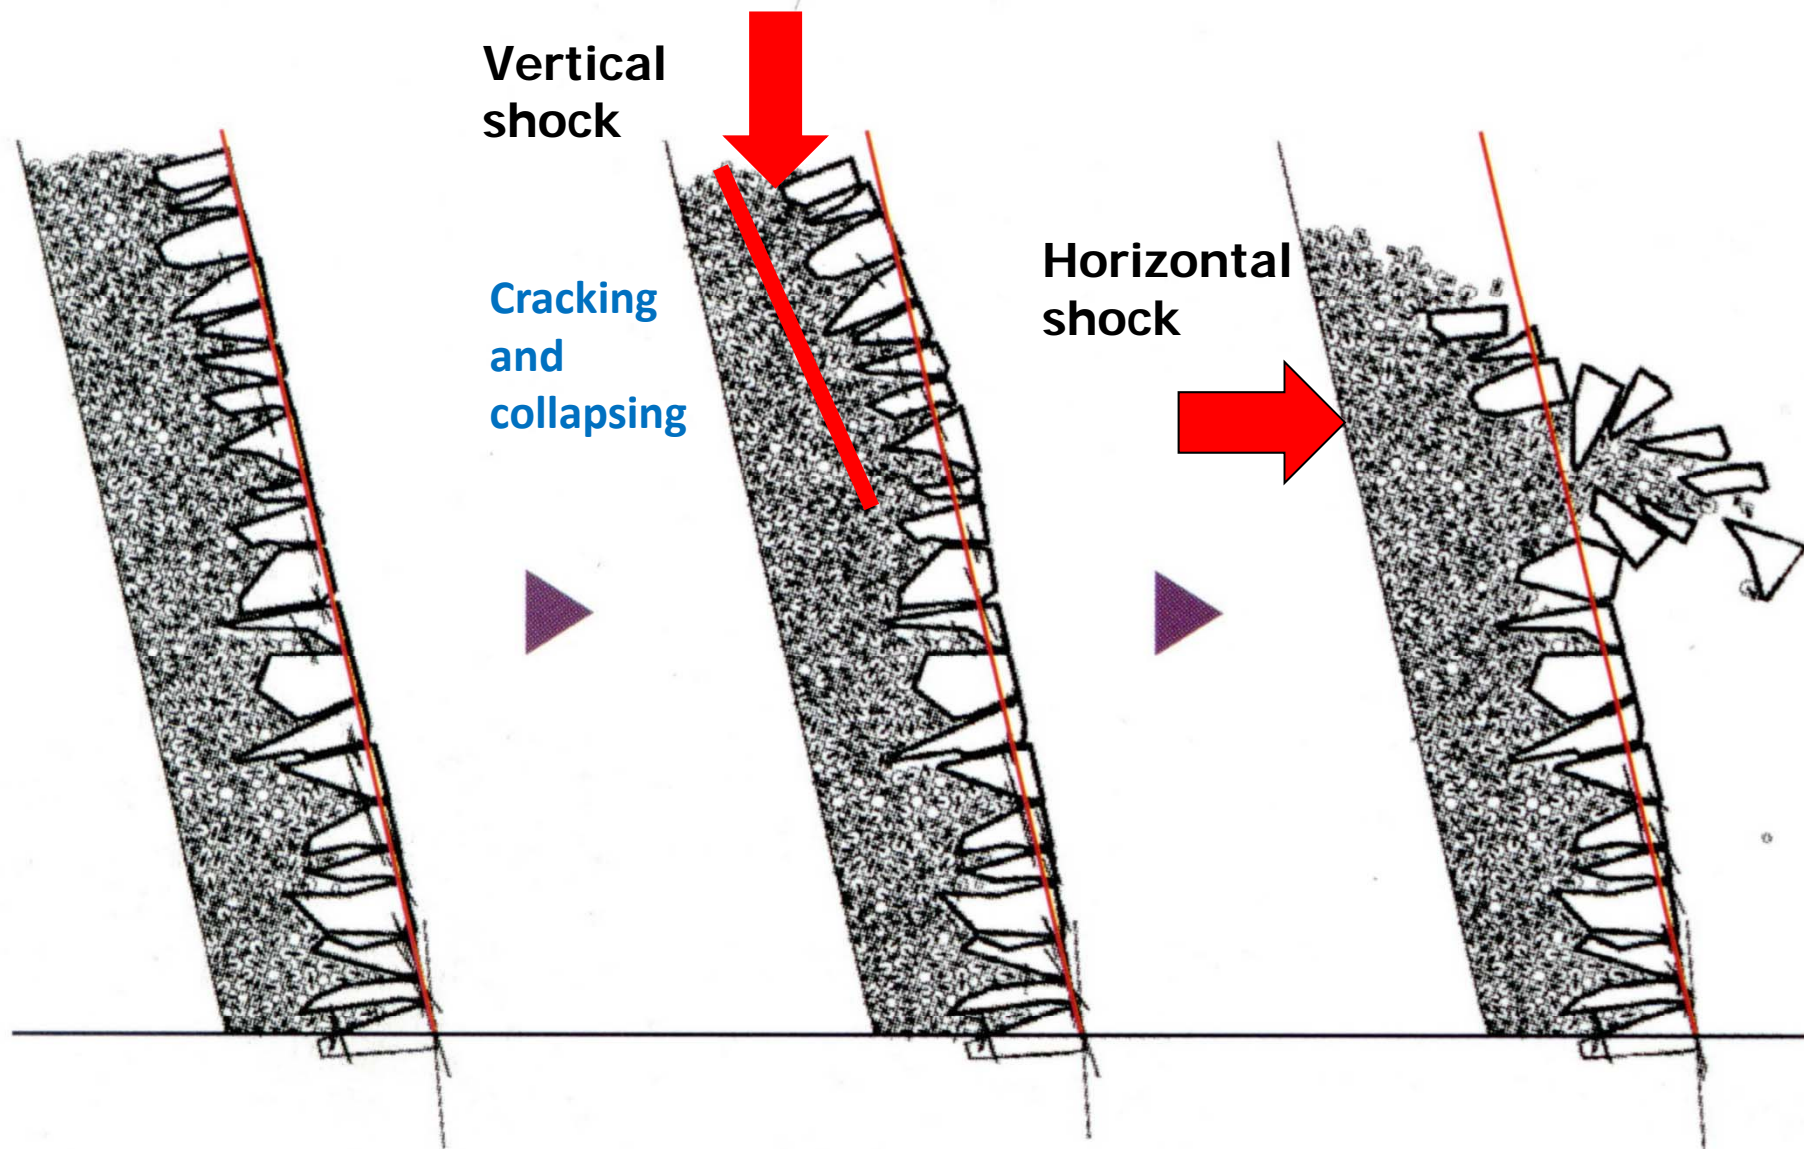
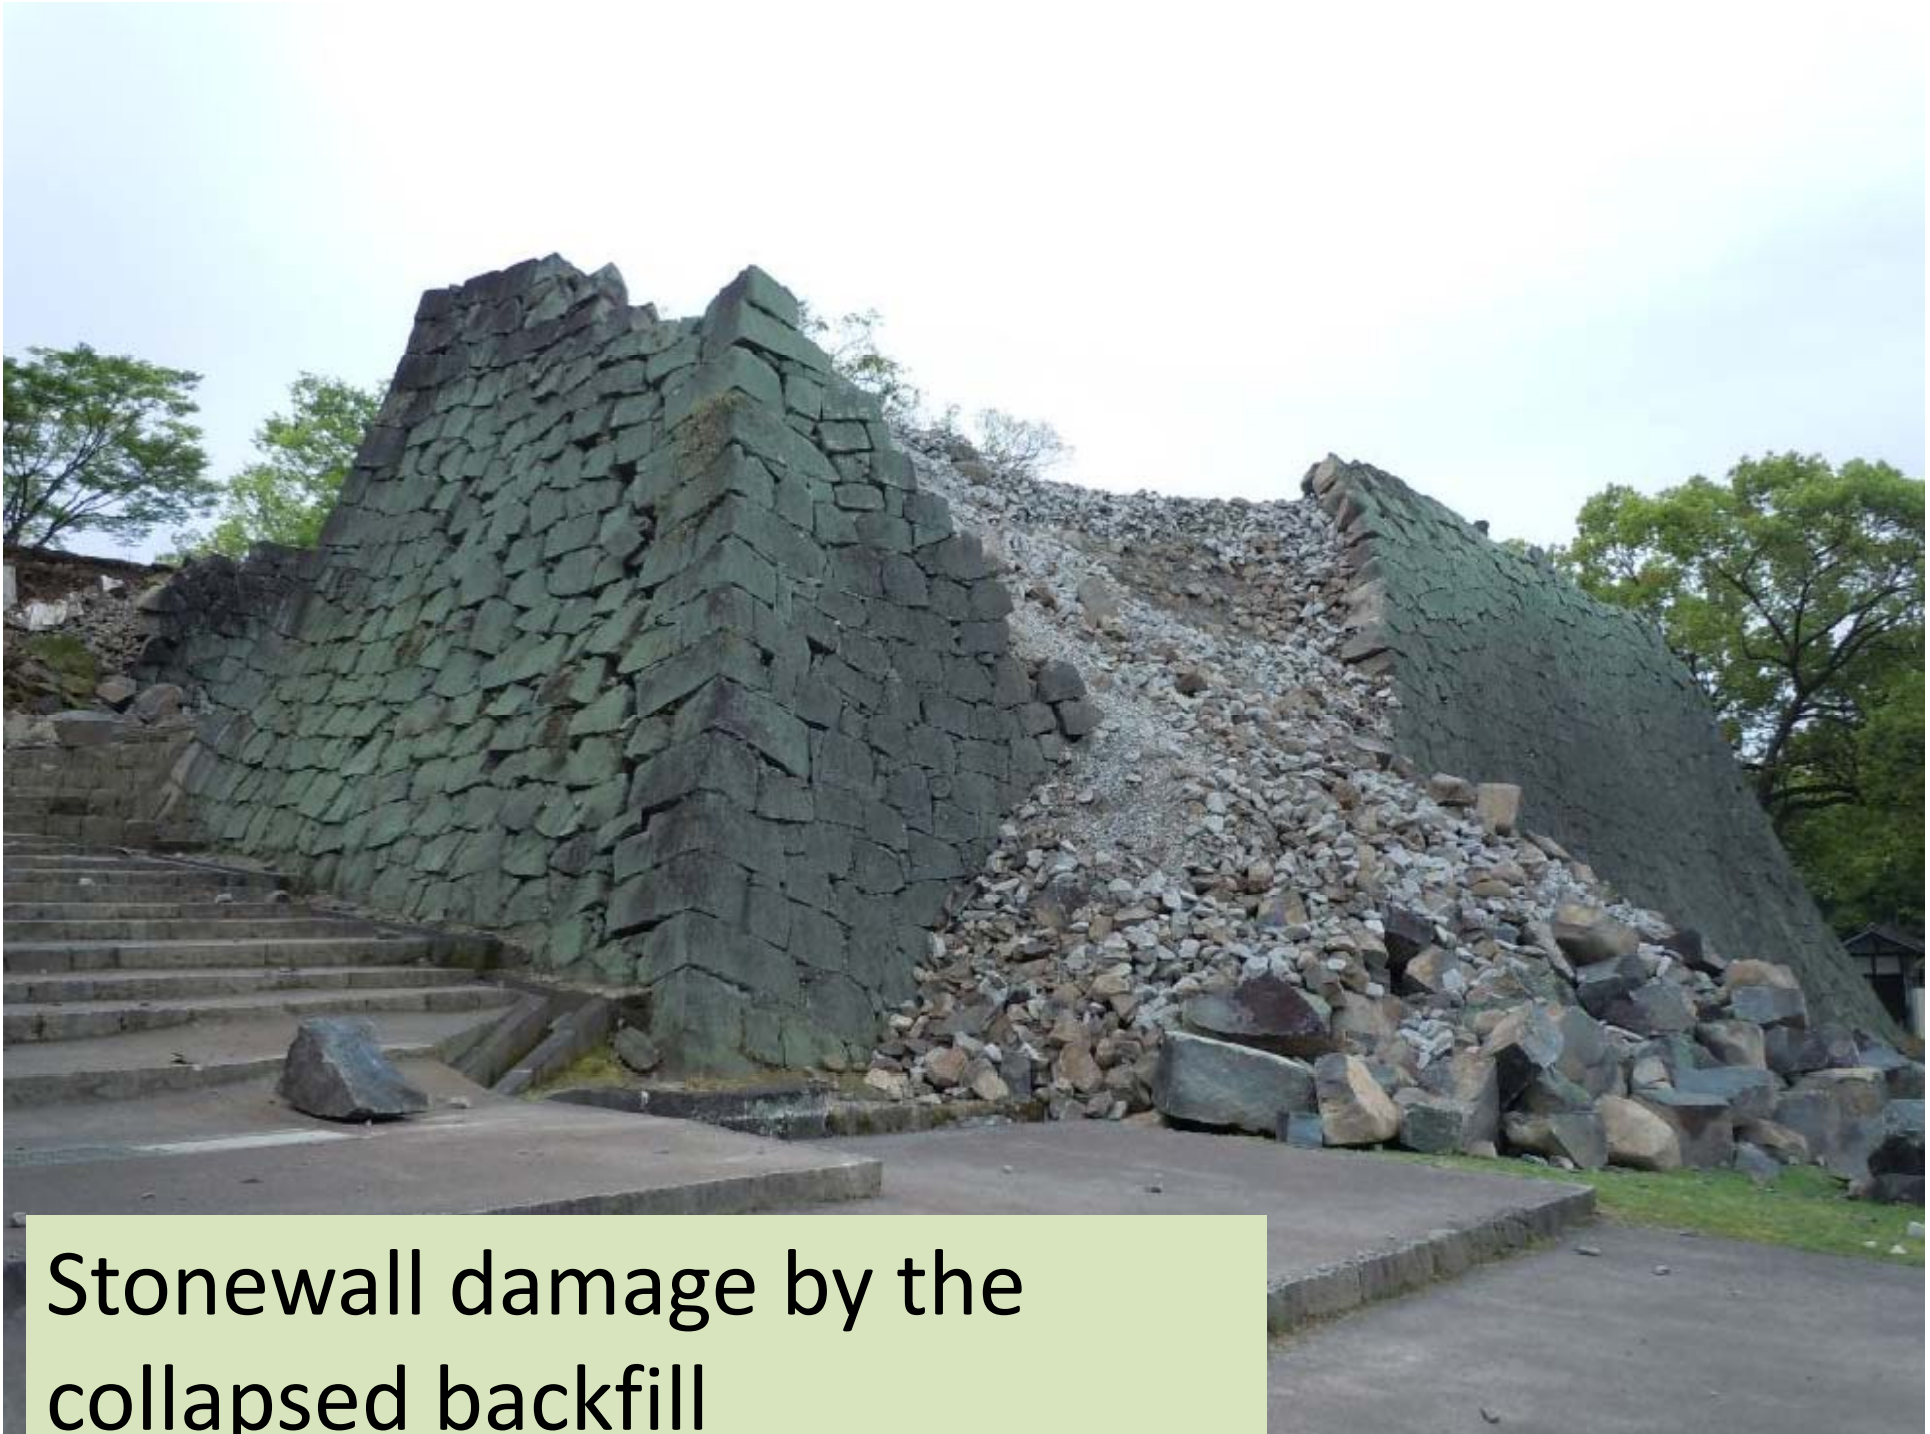
# Stonewall Damage – Model 1

Stonewall damage by the collapsed backfill

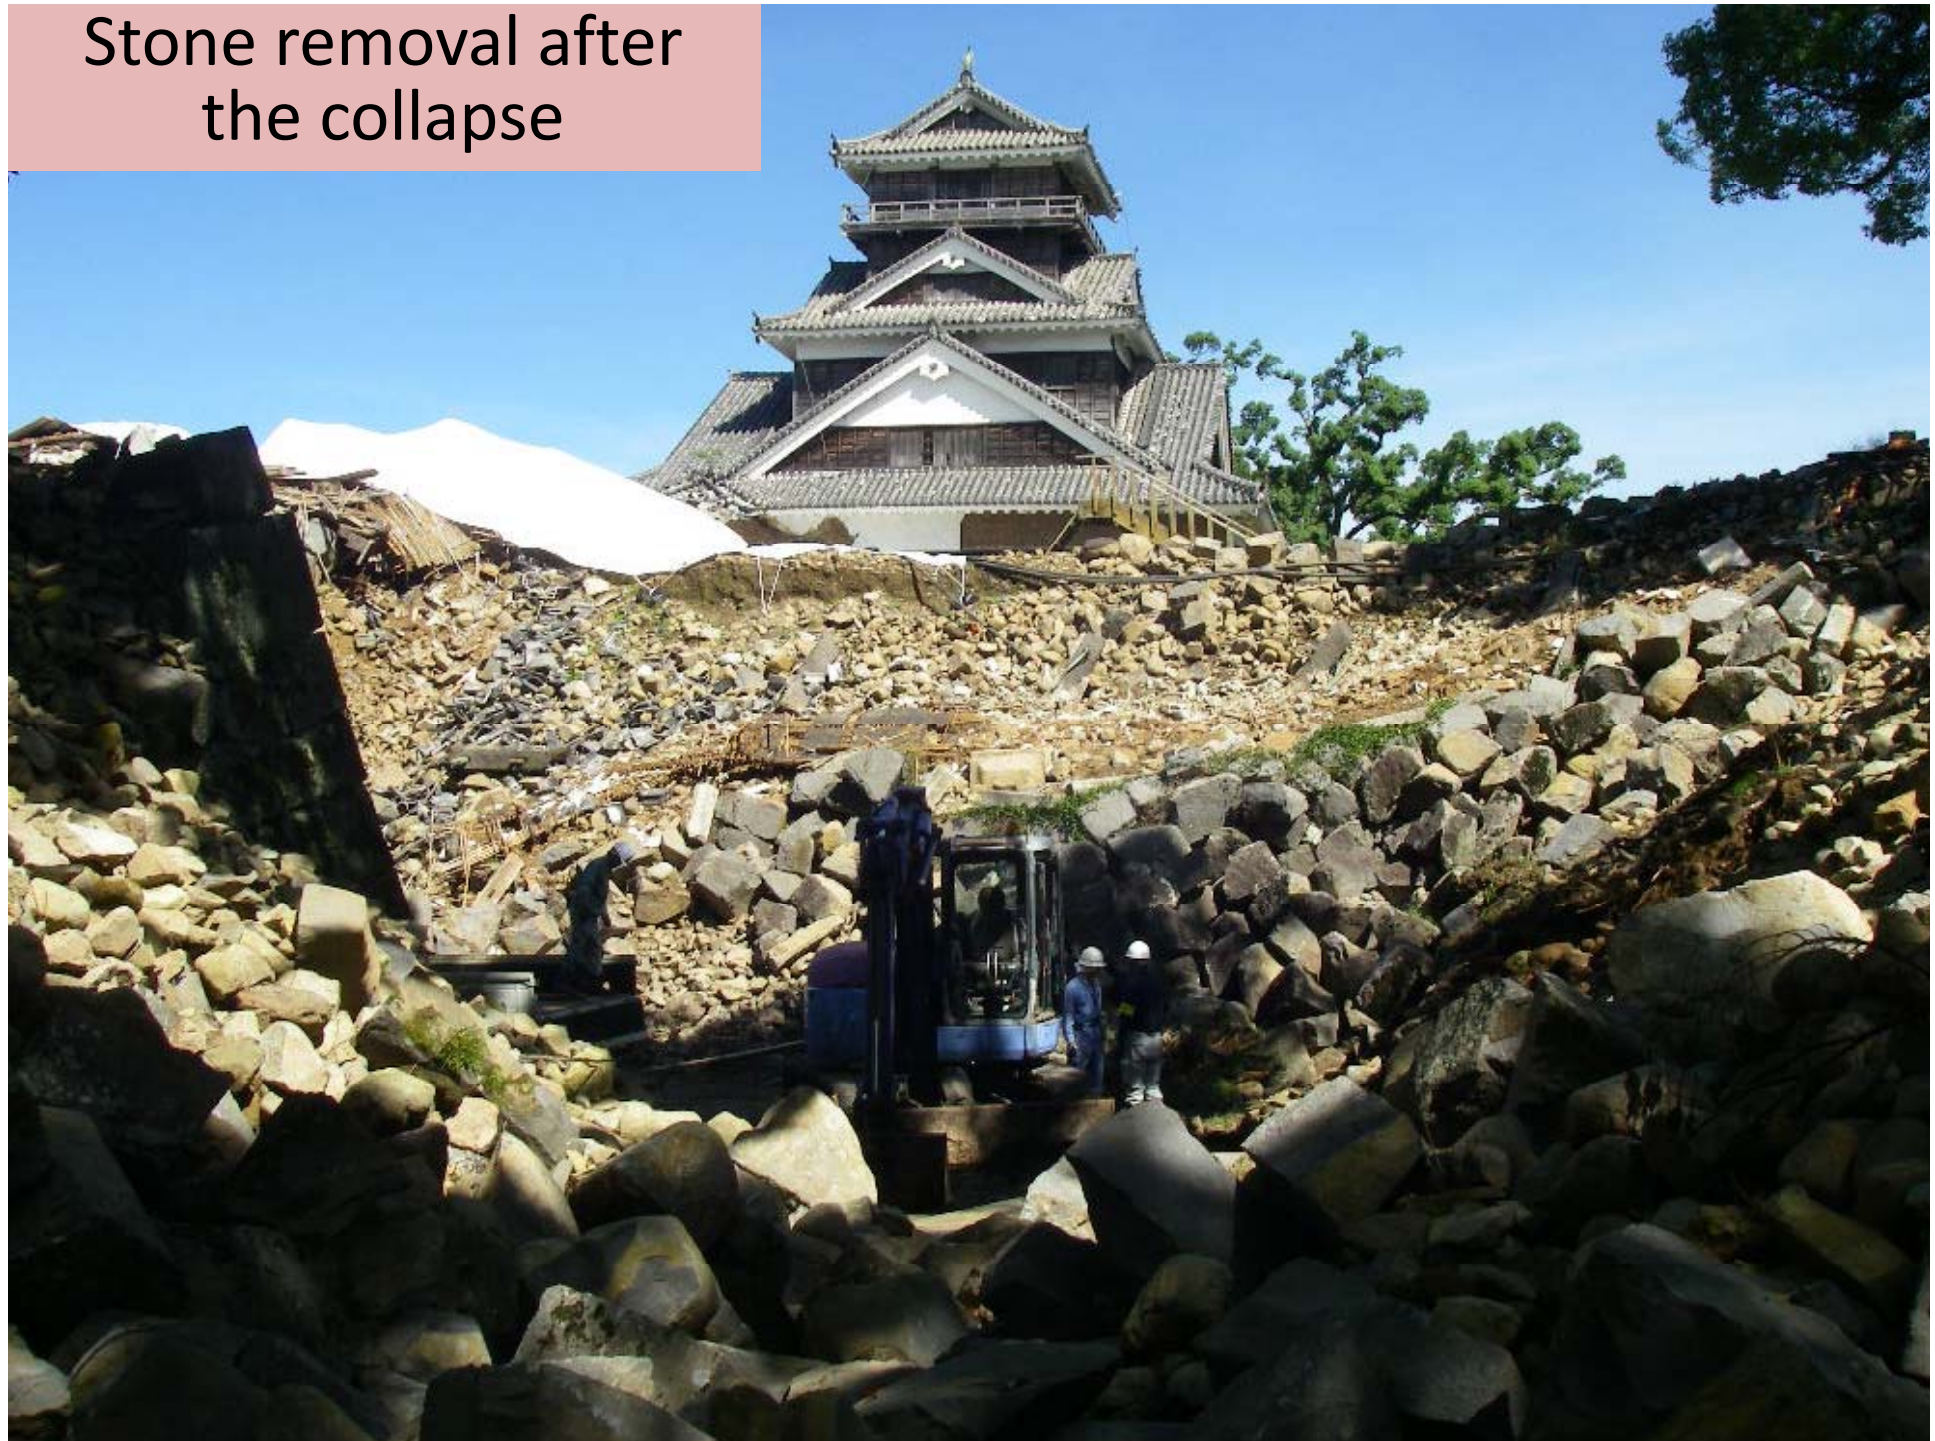
# Stone removal after the collapse
