# Damage to and Restoration of Kumamoto Castle

Kumamoto City Tourism Exchange Division

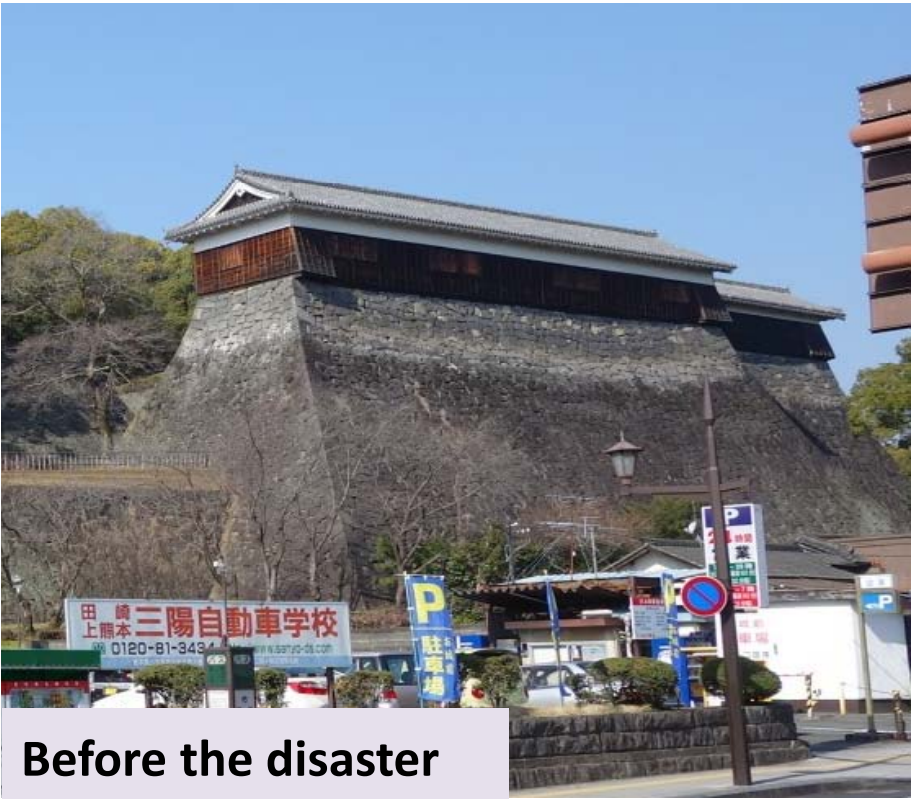
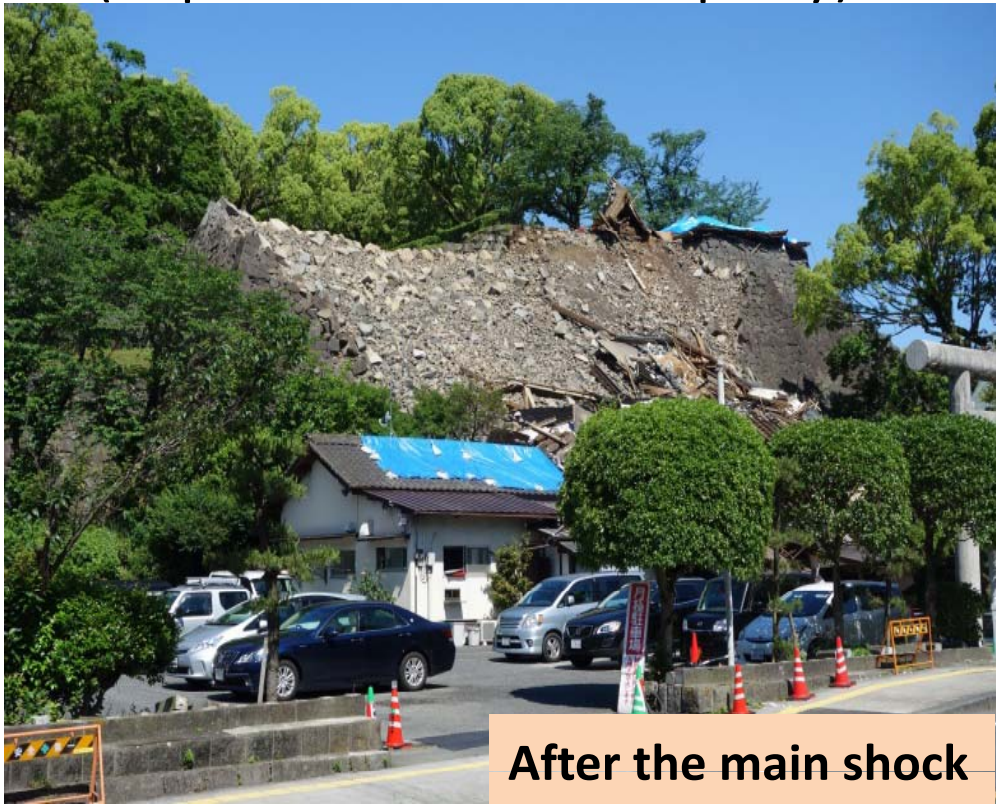
# Higashi Juhachiken Turret (Important Cultural Property)
