# WIND INDUCED DAMAGE TO ROOFS

## A Comparative Study on Roofs in Bhutan and Japan

Yeshey Lotay  
Visiting Researcher  
Asian Disaster Reduction Center (ADRC)

April 22, 2015

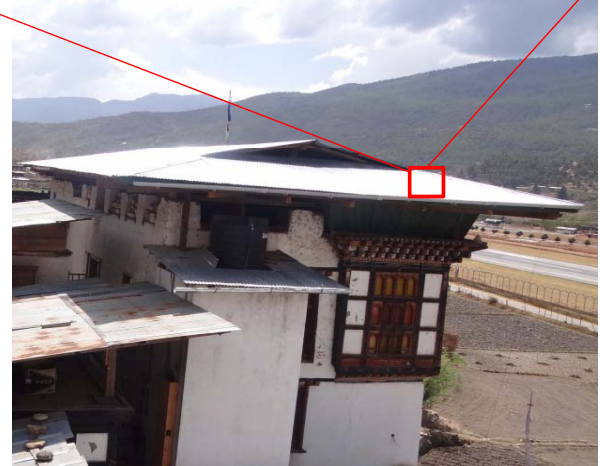
Hip-and-gable roof with CGI sheets

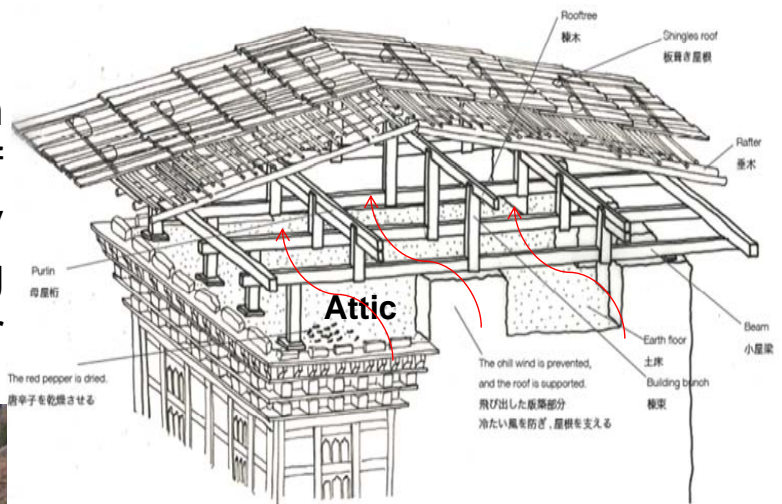
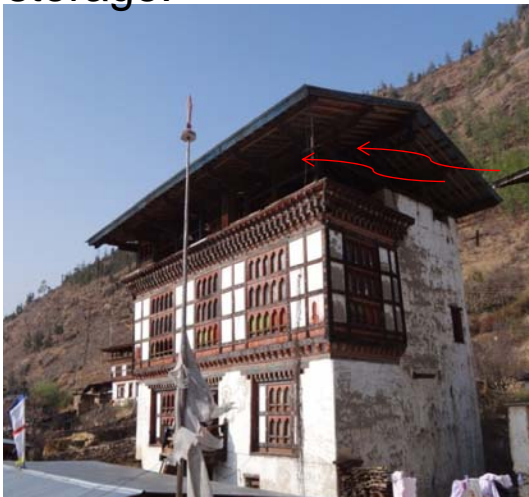
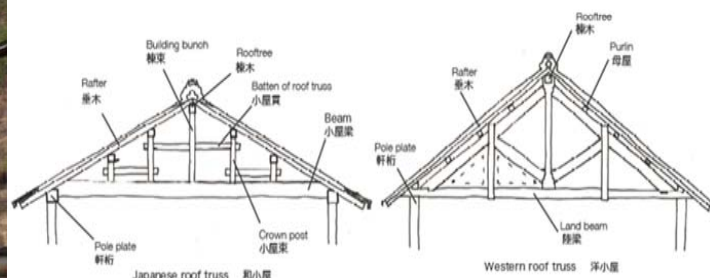
- Roof slope  $12^{\circ} - 15^{\circ}$
- Space (attic) between roof floor and roof covering is use for hay and red pepper drying and use as open-air storage.

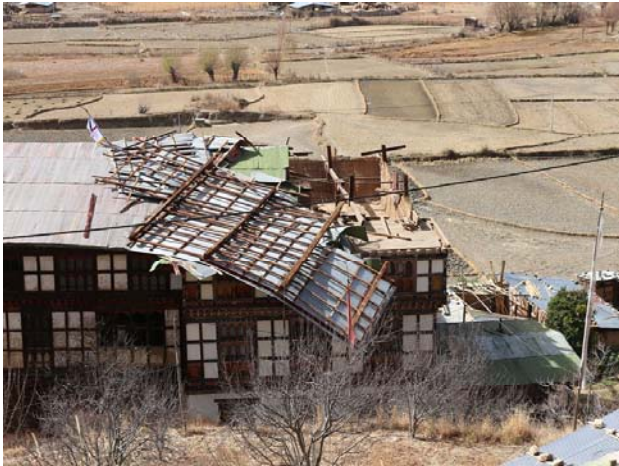
2013 Windstorm damage

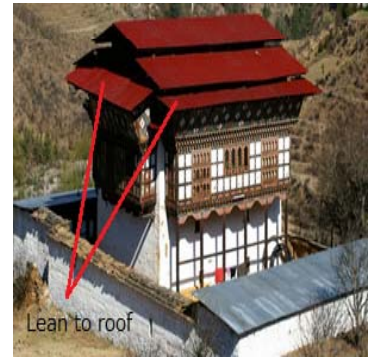
Lean-to and drangrim roof

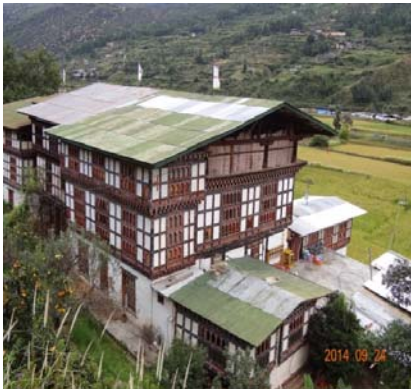
Gable roof

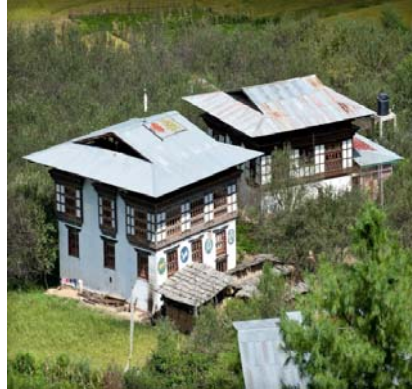
Hip-and-gable combined

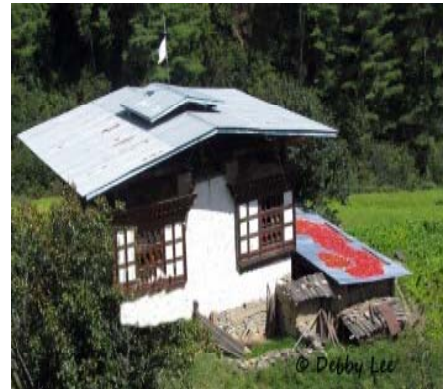
Jamthok roof

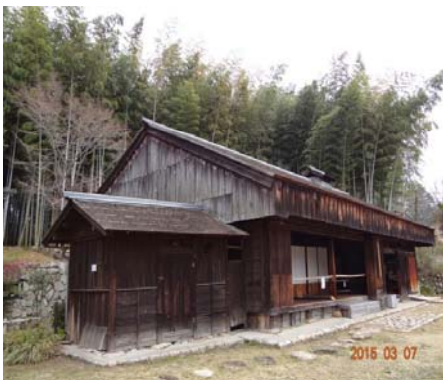
Gable roof

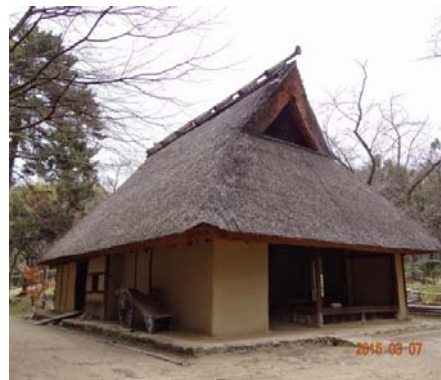
Hip-and-gable roof

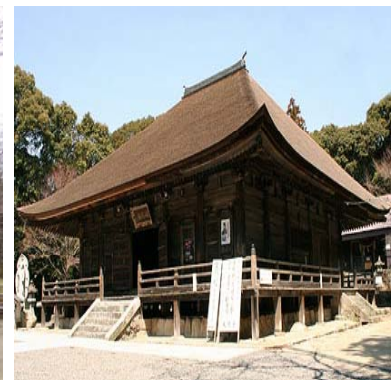
Hip roof

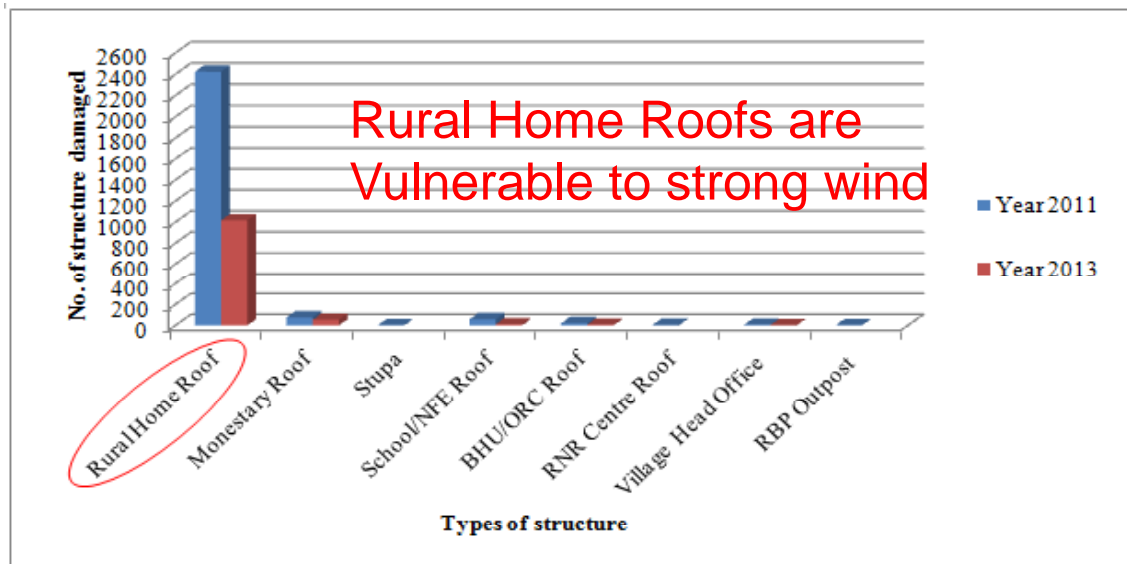
- In 2011 windstorm damage, 2424 rural home roofs damaged out of 2598 total damaged structures (93.30%)
- In 2013 windstorm damage, 1017 rural home roofs damaged out of 1093 total damaged structures (93.05%)

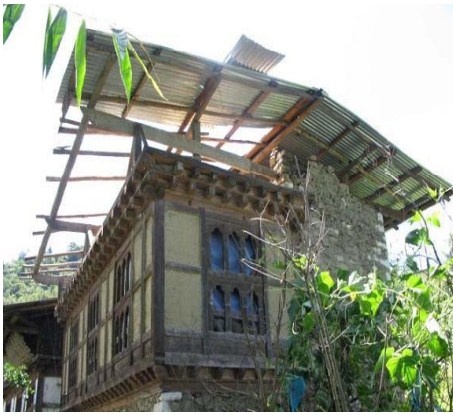
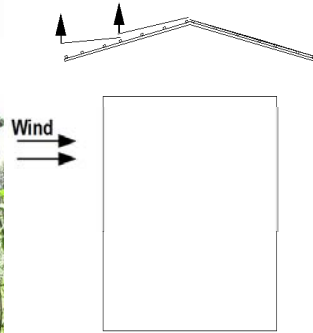
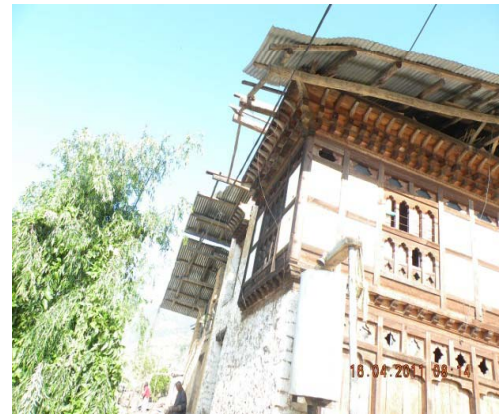
CGI sheet lift/loss at roof edges and gable roof end

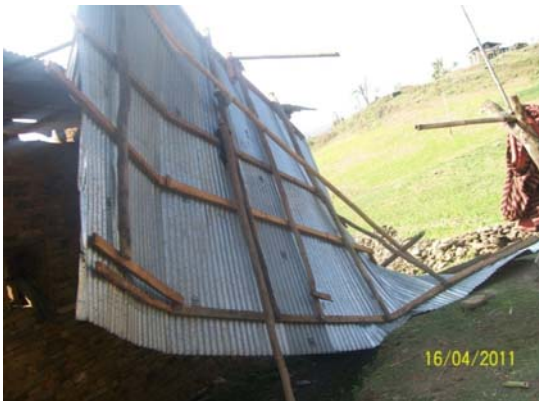
- Failure in timber section
- CGI sheets are intact on batten
- Timber batten section are not adequate to withstand wind pressure

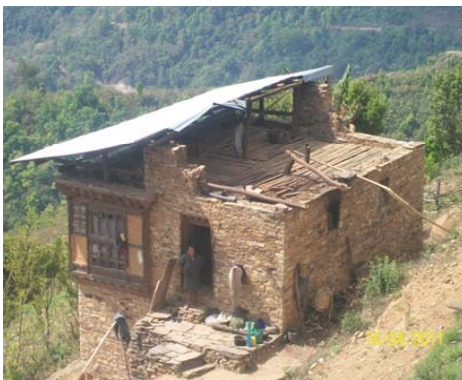
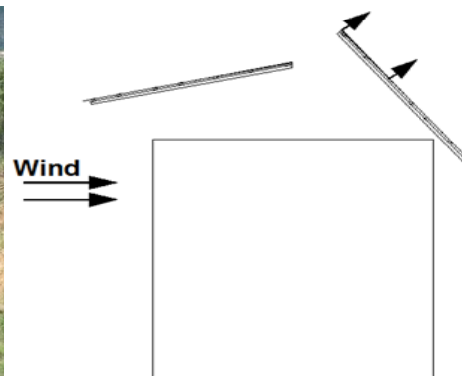
Failure at roof ridge connections

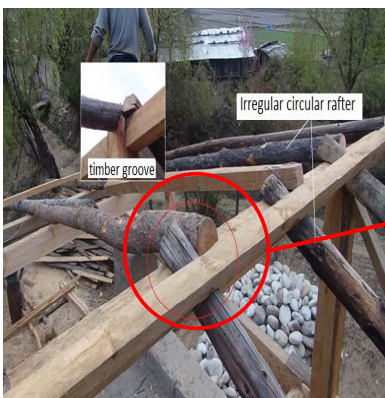
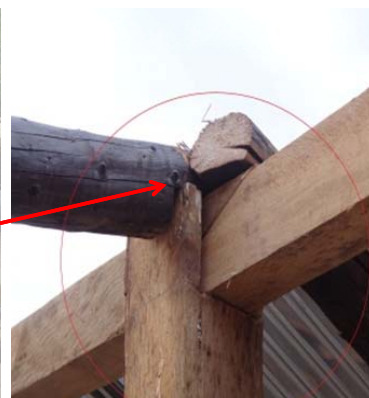
Toe-nails

- Timber lap joint with single 4-5inch toe-nail connection at roof ridge
- Poor connection

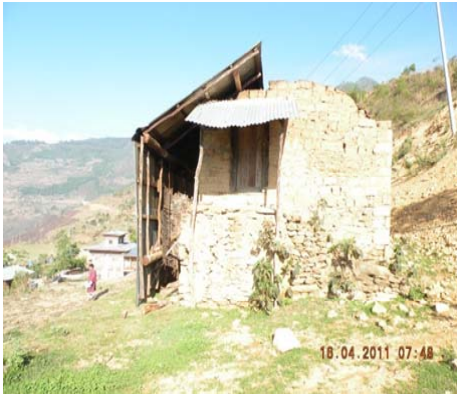
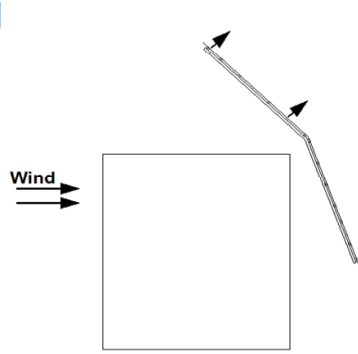
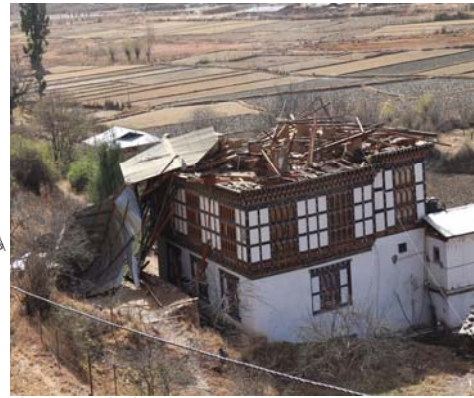
Full blown-off or overturning of roof failure

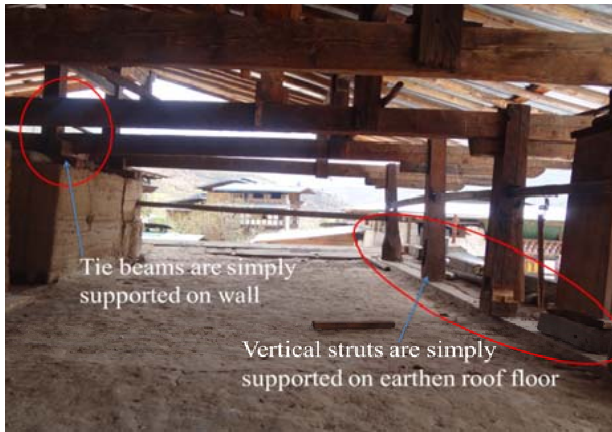
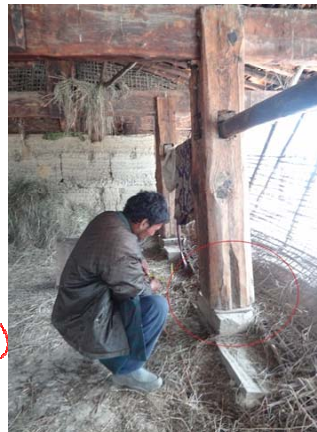
- No connection roof-to-wall connection
- No connection between struts and attic floor

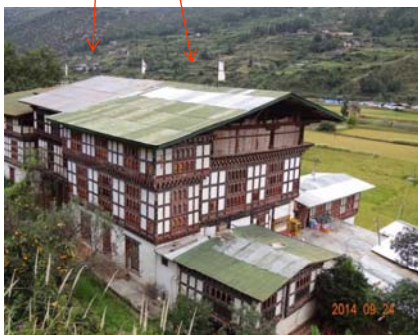
Gable Roof

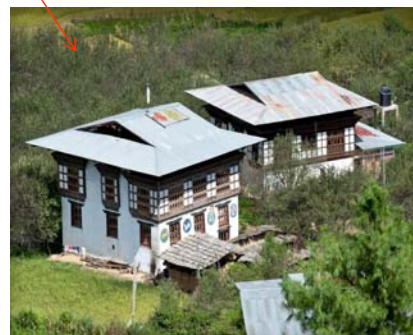
Hip-and-gable Roof

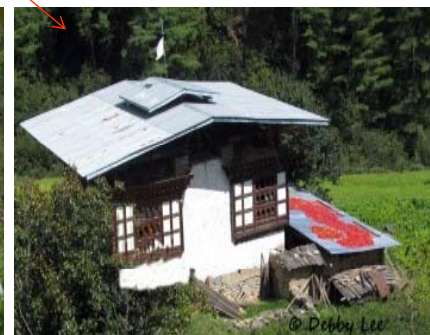
Jamthok Roof

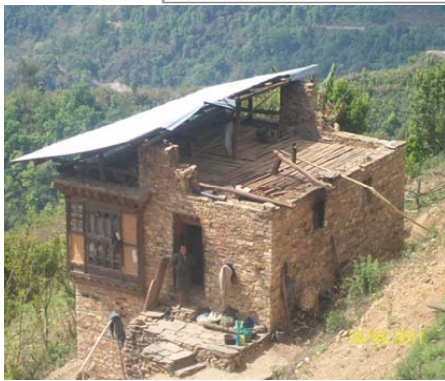
**SIMPLY SUPPORTED ROOF SUFFERED MAXIMUM FULL/HALF DAMAGE**

Half blown-off

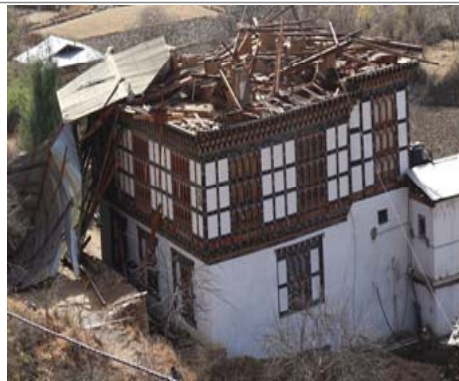
Fully blown-off

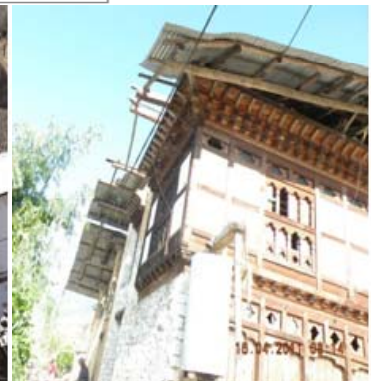
Partly blown-off

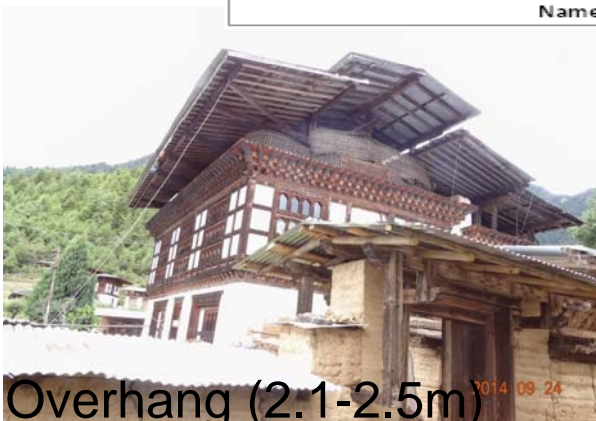
**LARGER THE ROOF OVERHANG MORE VULNERABLE DURING WINDSTROM**

Overhang (2.1-2.5m) 2014 09 24

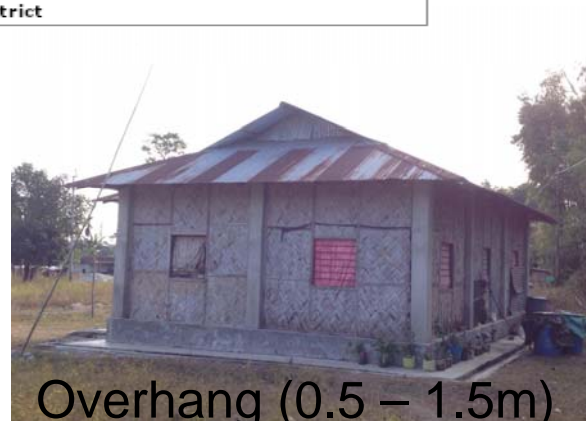
Overhang (0.5 - 1.5m)

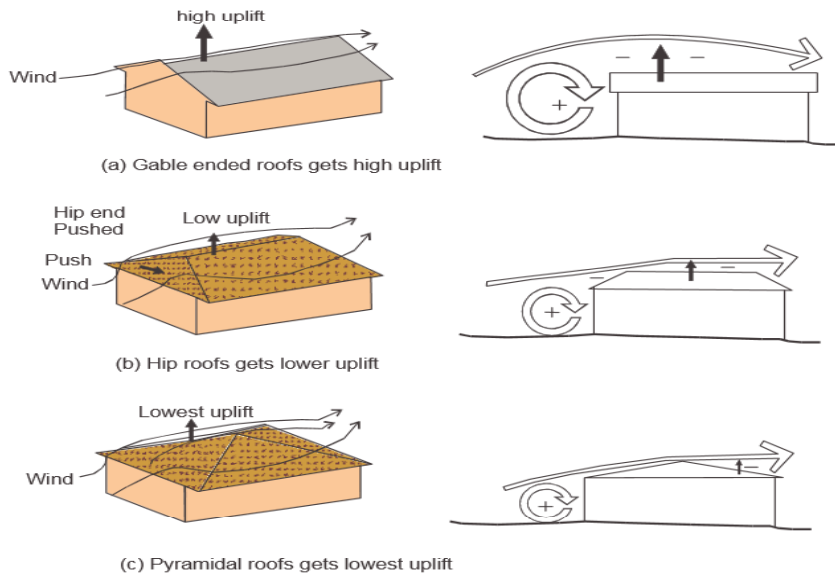
(Source: Roof type effect on uplift pressure (Bhandari et al., 2005))

**HIP ROOF PERFORM BETTER THAN OTHER ROOF**
