2-2 Report on the Great East Japan Earthquake

(1) Profile of the Earthquake

(3) Disaster-Affected Areas

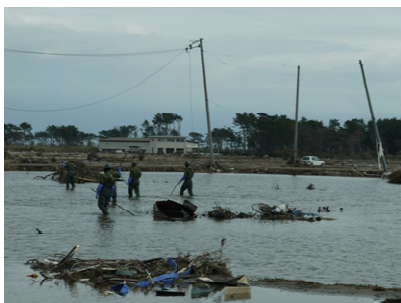
Wakabayashi ward is located in the coastal area of Sendai city, and was one of the areas more severely hit by this earthquake. This area has no historical record of any large tsunamis, and local hazard maps were designed around a maximum tsunami wave height of 3m. In reality, however, a much larger tsunami hit the area. A belt of windbreak forests had been built along the seacoast as a preparedness measure, and the elementary schools had been designated as evacuation sites since there are no hills in the area.

Search activities in Arahama district, Wakabayashi ward (22 March 2011)

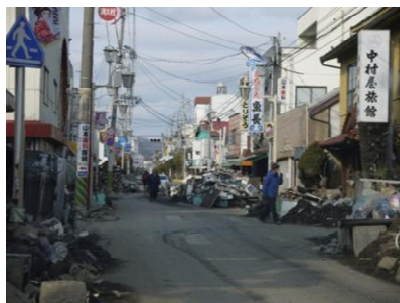
Ishinomaki city, the second largest city in Miyagi prefecture (population: 170,000), has a port, a fishing port, and factories owned by such companies as Nippon Paper Industries Co., Ltd. The city's downtown area sustained massive damage as a result of the tsunami and resulting fires, which caused many casualties. The coastal residential areas of Higashi-Matsushima city, which is located next to Ishinomaki, also sustained massive damage.

The downtown area of Ishinomaki city (22 March 2011)

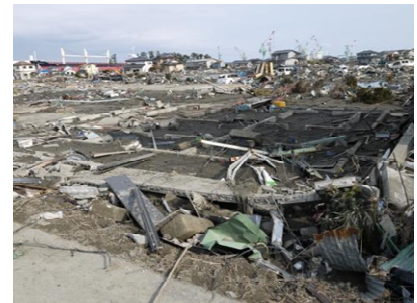
The coastal residential area of HigashiMatsushima city (22 March 2011)

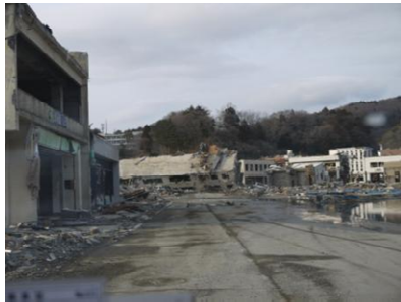
prefecture. Onagawa's downtown area was totally destroyed by the tsunami. Along the coast, wooden houses were carried away, leaving only their foundations, and even reinforced concrete buildings collapsed. The Onagawa town office is reported to have been inundated to the roof. A hill just behind the fishing port was designated as an evacuation area. Traces of water were found inside a hospital located on top of this hill,

The coastal area of downtown Onagawa (2011.3.22)

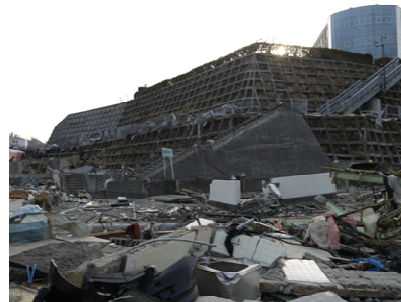
indicating that even that area, which is nearly 16 meters high, was not out of reach of this tsunami.

The evacuation route to Onagawa Municipal Hospital (2011.3.22)

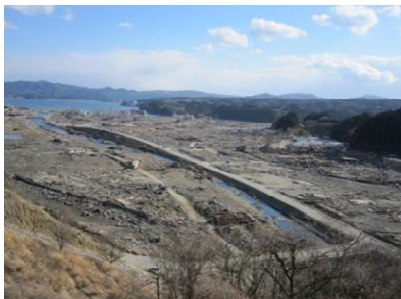
Minami-Sanriku town is located in northeastern Miyagi prefecture facing the Pacific Ocean. The tsunami washed away most of the buildings in the downtown area, completely devastating the town. At Shizugawa Hospital located near the coast (some 200 meters inland), there were indications that the tsunami had reached the 5th floor. In an apartment building near the seashore, which had been designated as a tsunami evacuation building, there were traces of water indicating that the tsunami had reached the 4th floor.

Panoramic view of Minami-Sanriku (2011.3.23)

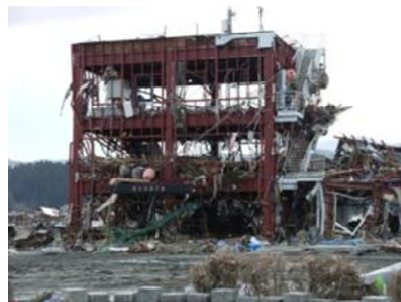
The disaster management center of Minami-Sanriku, a threestory building, was designed to function as a tsunami evacuation building. When the tsunami struck, about 30 municipal officials evacuated to the rooftop, but only 10 survived. A young official who kept delivering evacuation notices to the villagers until the very last moment has yet to be found. It was generally believed that three-story reinforced concrete buildings could be designated as evacuation buildings, but such structures provided insufficient protection during this disaster.

Disaster management center of Minami-Sanriku (2011.3.23)
