Research on disaster damages of Sumatra Earthquake in Indonesia

October 2009

**Asian Disaster
Reduction Center**

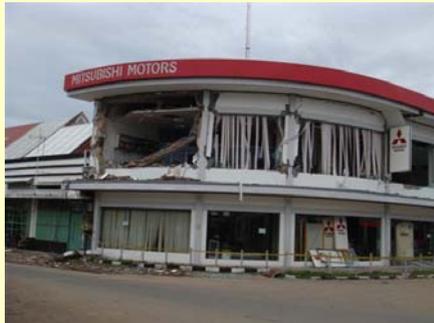
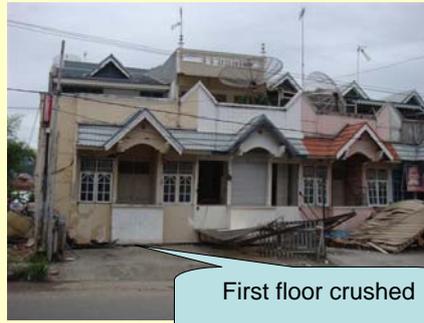
- ① First earthquake in Indonesia which caused damages to modern buildings
 - In the centre of Padang city, damages are not ubiquitous but sporadic phenomenon concentrating on three or more-story reinforced concrete buildings.
 - Most of the damaged buildings are public facilities or commercial facilities such as city buildings, schools, hospitals, mosques, hotels and shopping malls.
 - ✘ In the Java earthquake in May 2006, most of the deaths were caused by crushing by collapsed bricks.

First floor crushed

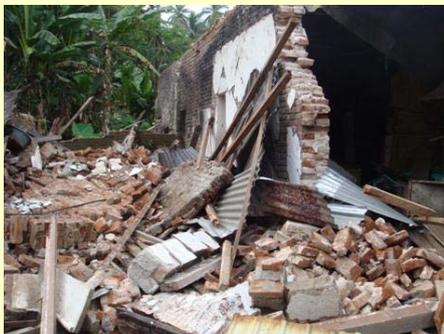
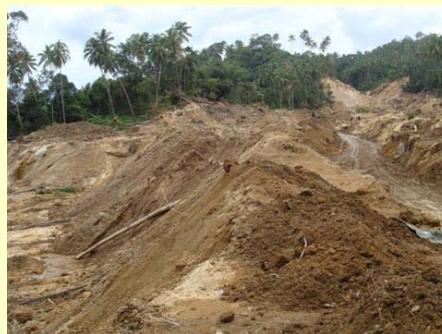
- ② In the large areas of Pariaman and its suburb or Padang Pariaman district, low rise residences and schools were found damaged.
 - Few middle or high rise buildings exist in Pariaman city.
 - Especially in mountainous areas of Padang Pariaman district, damages to villages caused by landslides are devastating.

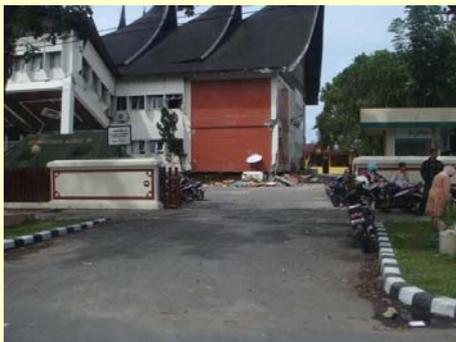
Public facility with the first floor destroyed
and unique big roofs
(Padang as of 5 October)

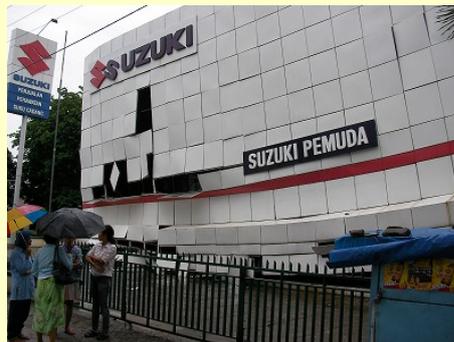
Showroom with the first floor crushed
(Padang as of 5 October)

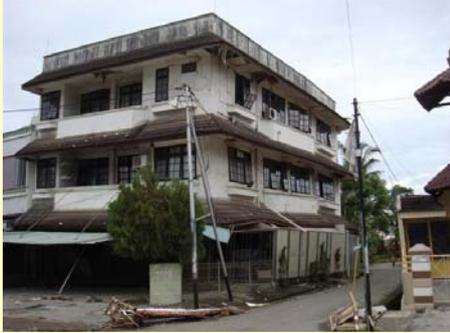
Leaning building with walls which cracked
(Padang as of 5 October)

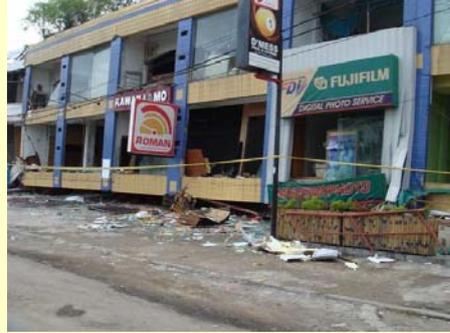
Commercial building with the first floor
parking lot crushed
(Padang as of 5 October)

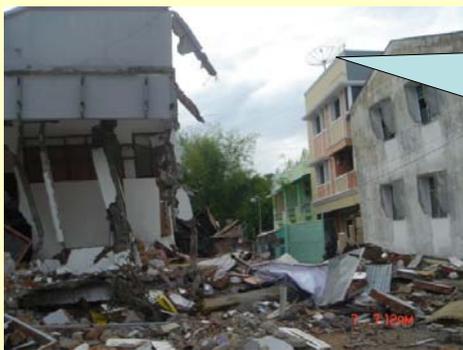
Commercial building with the first floor crushed
(Padang as of 5 October)

We stayed at this hotel.
According to its owner,
the hotel did not
collapse because the
design criteria for
earthquake-resistant
structure were
observed.

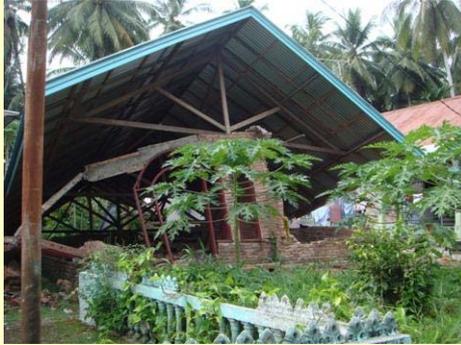
Destroyed building due to the collapses of brick walls
(Padang as of 6 October)

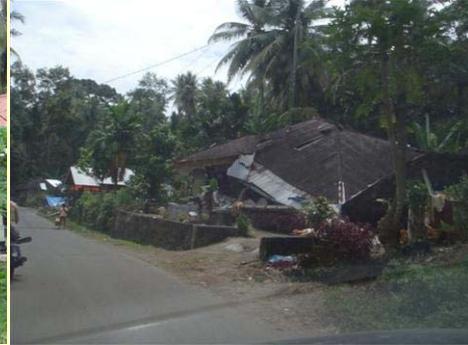
One-story residence totally destroyed
(Padang as of 6 October)

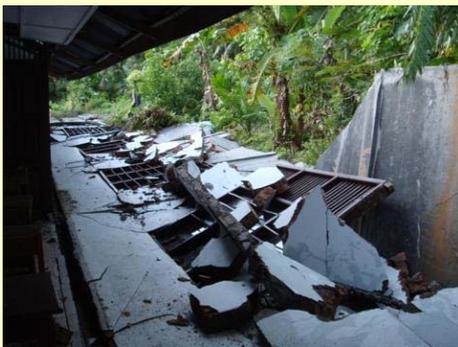
Collapsed junior high school' s wall with pillars and beams reinforced by steels but the steels are found not connected properly.
(Padang Pariaman district as of 6 October)

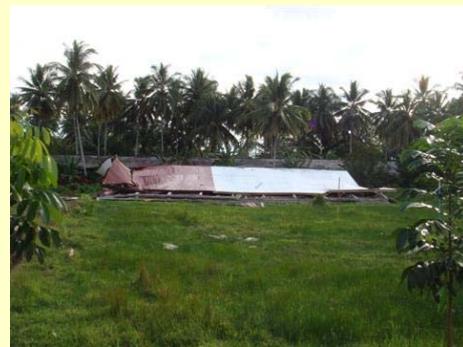
Totally destroyed junior high school building with roofs made of a light material- corrugated tinplate- and limited number of thin pillars
(Padang Pariaman district as of 6 October)

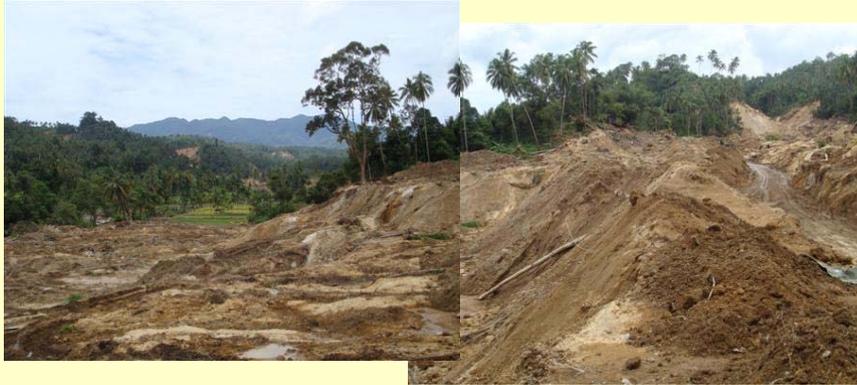
100 people were killed by a debris flow.
The school and residences were buried under debris.
(On 7 October in Padang Pariaman district)

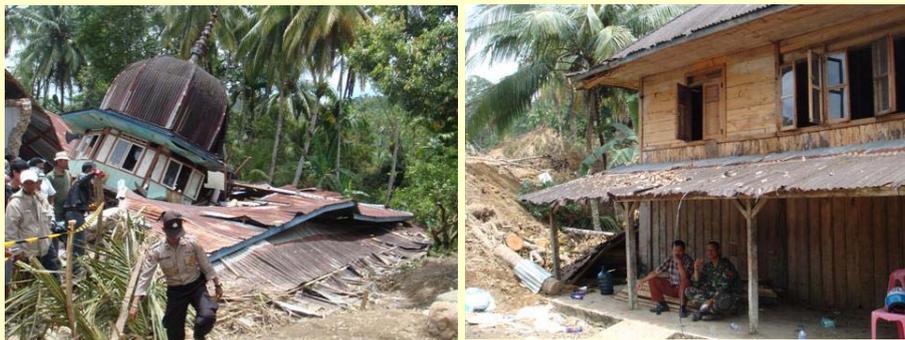
Mosque destroyed by the debris flow
(On 7 October in Padang Pariaman district)

A house which just had a narrow escape from
damage by the debris flow
(on 7 October in Padang Pariaman district)

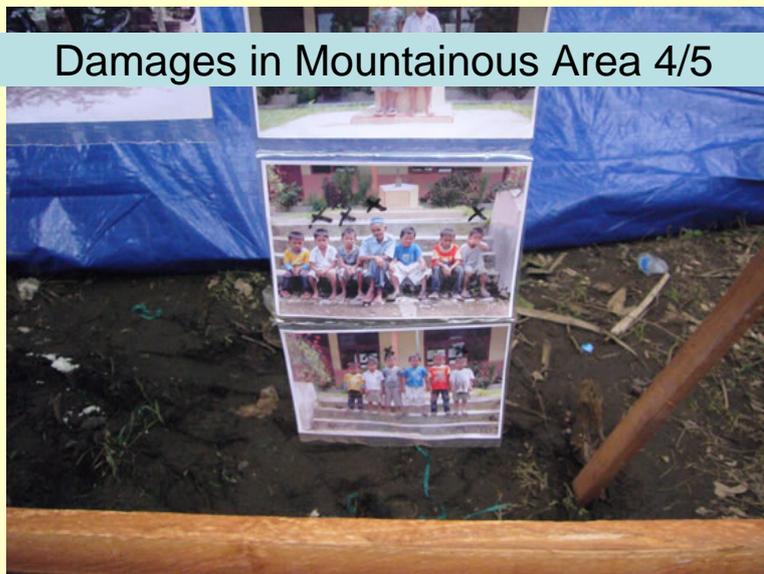
In Padang Pariaman district, debris flow crushed an elementary school resulting in as many as 100 deaths. Children with "X" on the pictures were ones killed. Those children were at homes which are close to the school.

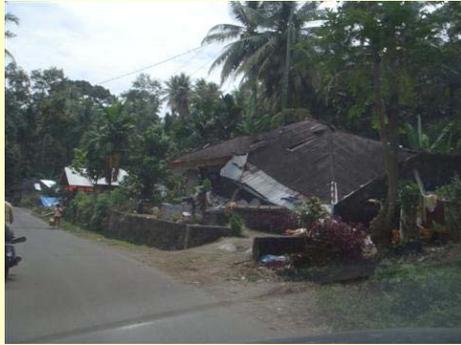
Collapsed residence close to the landslide area
(as of 7 October in Padang Pariaman district)

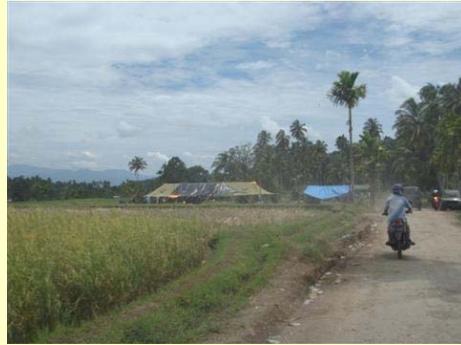
Scenery at the lower reach of the landslide
area
(as of 7 October in Padang Pariaman district)

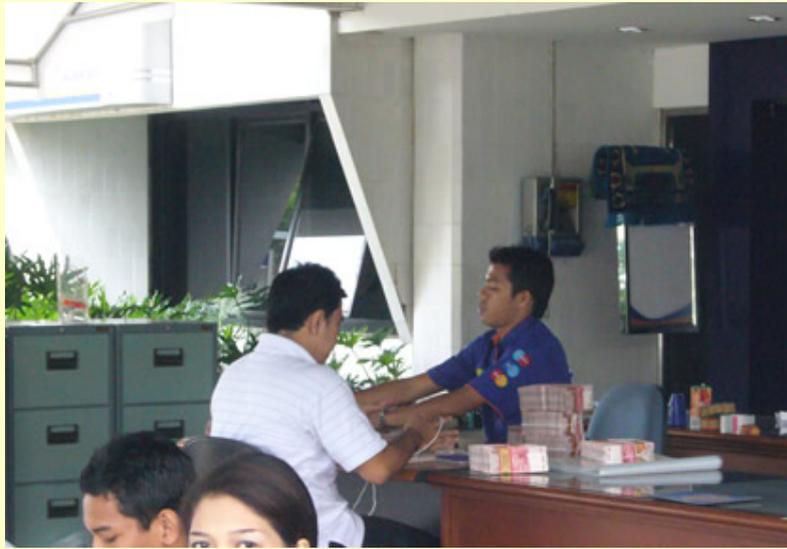
Damaged bank office

With the office, the inside of which is not available, employees are working in front of the office. Since the demands of withdrawing were increasing, they were working hard to provide cash for branch offices. (Padang city as of 6 October)
