2025 マンダレー地震 (ミャンマー)

(GLIDE No. EQ-2025-000043-MMR)

2025年3月28日12:50(MMT, UTC+6:30, 日本時間15:20)、ミャンマー中部ザガイン地区でマグニチュード7.7の地震が発生した(GLIDE No. EQ-2025-000043-MMR)。震源地は同国二番目の都市マンダレー近郊で、震源の深さは約10kmと推定されている。震源地付近の最大震度は9(修正メルカリ震度)を記録した。これは1912年5月23日に発生したメイミョー地震(マグニチュード7.9)以来最大の地震である。

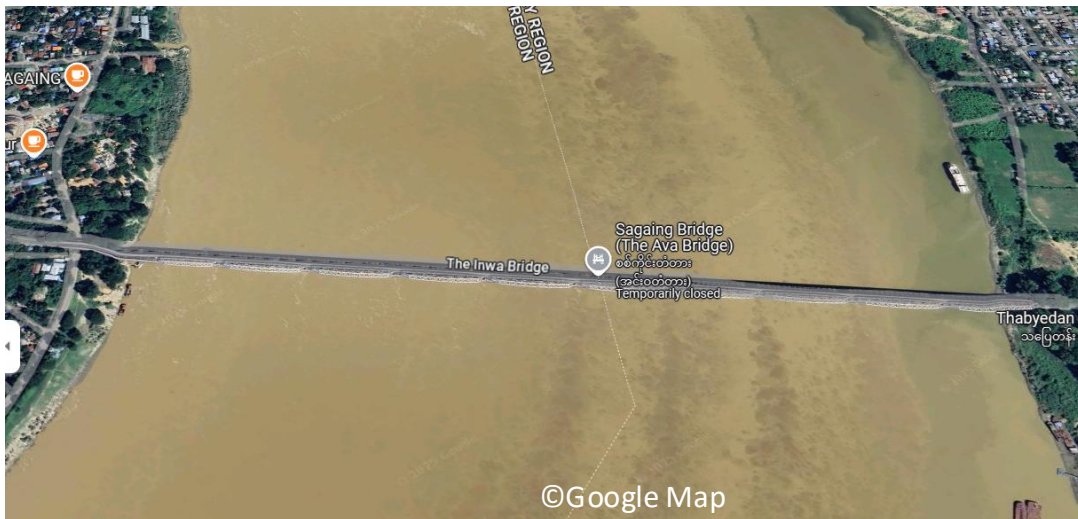
Comparison of the Inwa Bridge in Mandalay, before and after the disaster

Satellite imagery from Strix Satellite of Synspective, showed the collapsed Inwa (Ava) bridge in Mandalay.

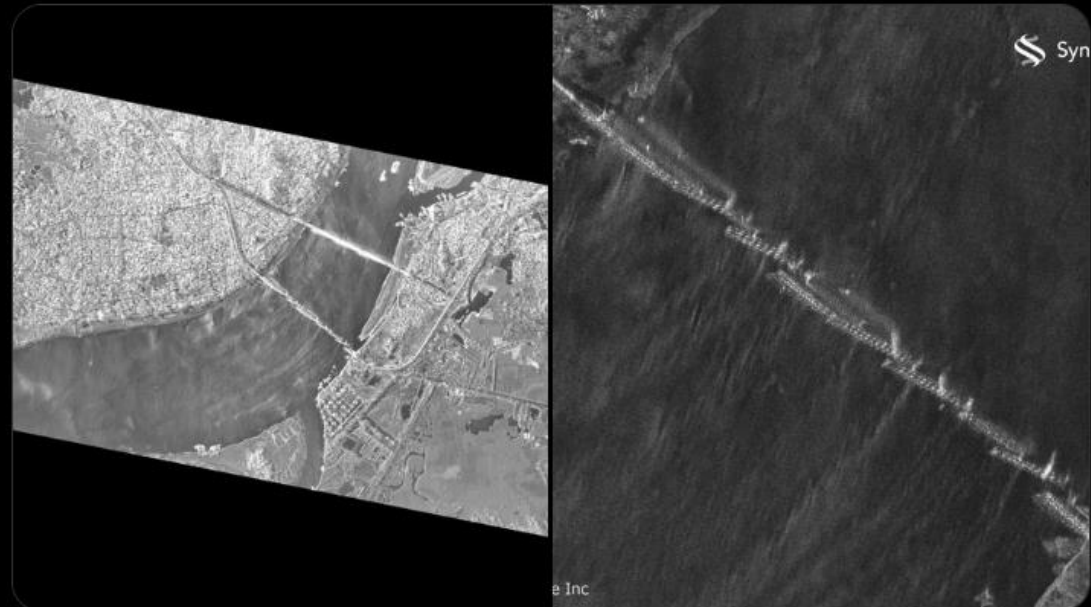
On March 28th, 2025, a 7.7-magnitude earthquake struck the Sagaing Region of Myanmar. Synspective StriX Satellite captured the Collapsed Ava Bridge in Mandalay.

Observation Date: 2025-03-28 21:15:55 UTC

Observation Mode: Staring Spotlight Mode (0.9m x 0.25m resolution)

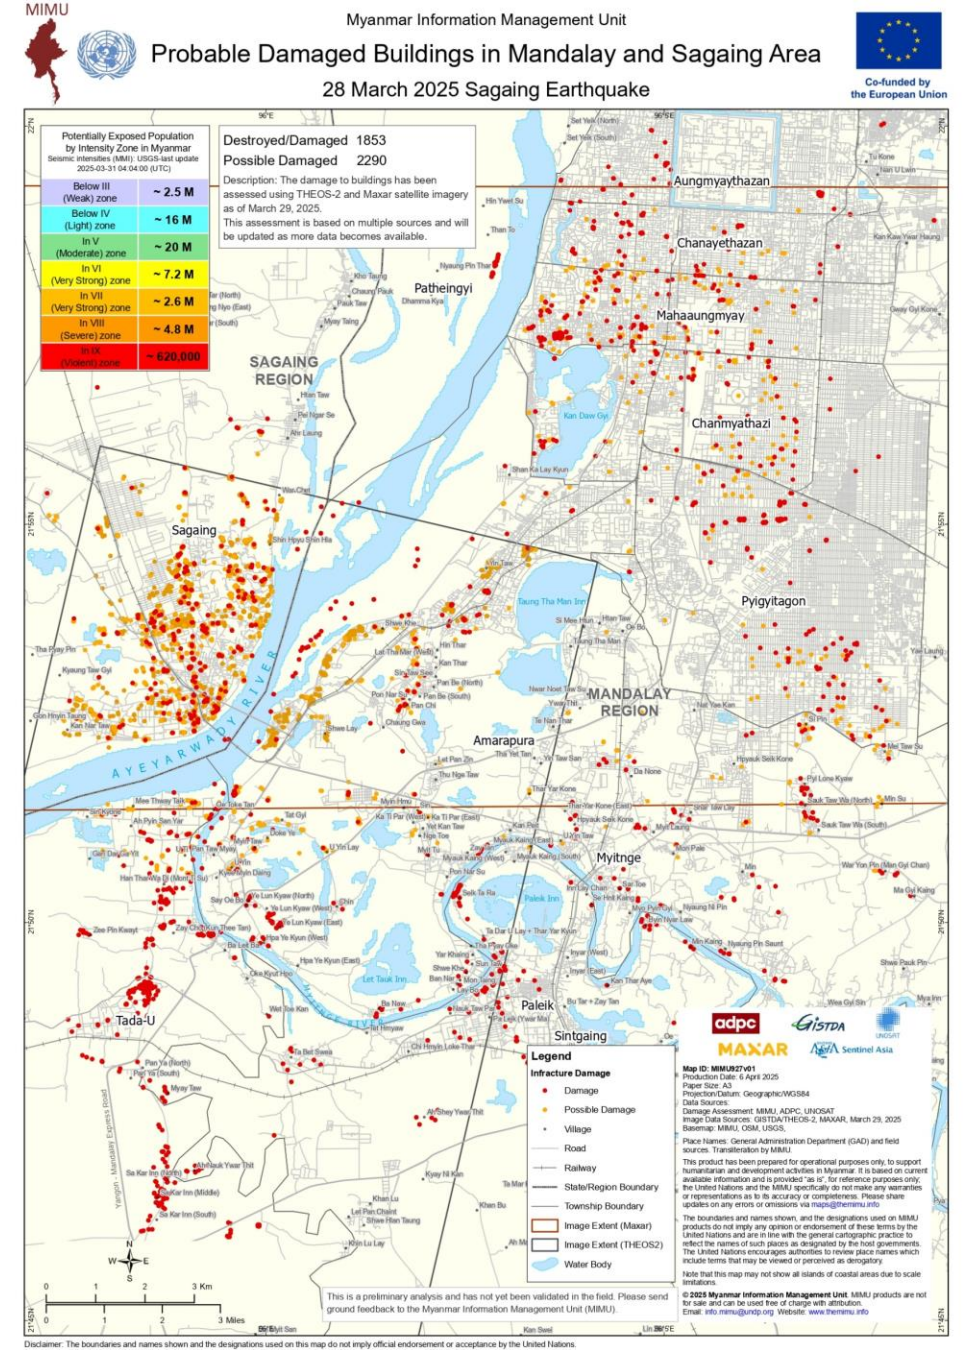
Probable Damaged Buildings in Mandalay and Sagaing Area is provided by MIMU. Destroyed/Damaged 1,853 Possible Damaged 2,290

The damage to buildings has been assessed using THEOS-2 and Maxar satellite imagery as of March 29, 2025.
