# Adaptive measures in responding to the Mw 6.9 Earthquake in Cebu, Philippines

Gerald Potutan<sup>1)</sup>  
 Koji Suzuki<sup>2)</sup>  
 Makoto Ikeda<sup>3)</sup>  
 Naoki Yamaguchi<sup>4)</sup>

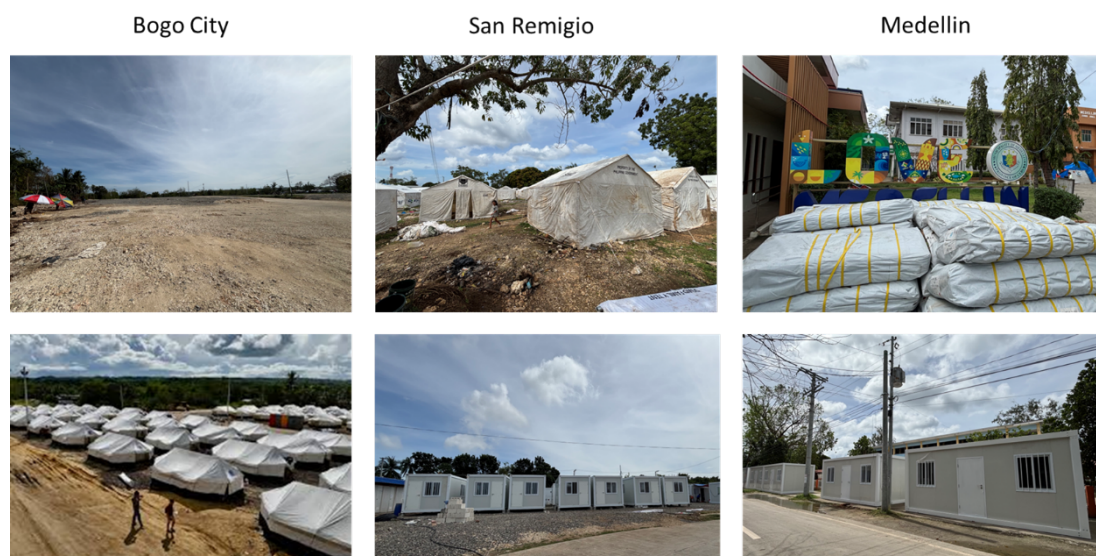
Figure 4 Tents and modular shelter units (MSUs) installed in the three impacted local governments of Cebu dismantled due to typhoon Tino. As shown in Figure 4 (lower right photo), the local government of Medellin also facilitated the installation of modular shelter units.

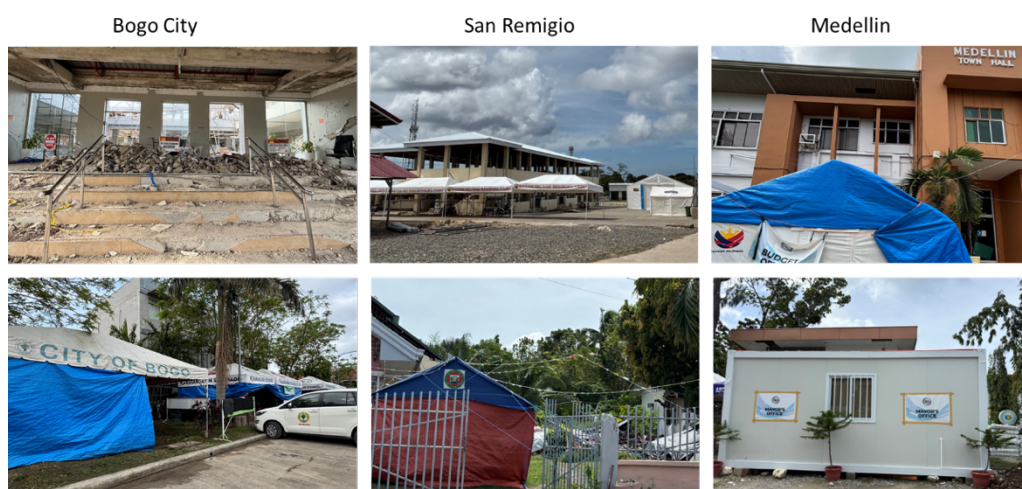
Figure 5 Damaged local government office buildings (above photos); tents and containers as temporary offices (below photos)

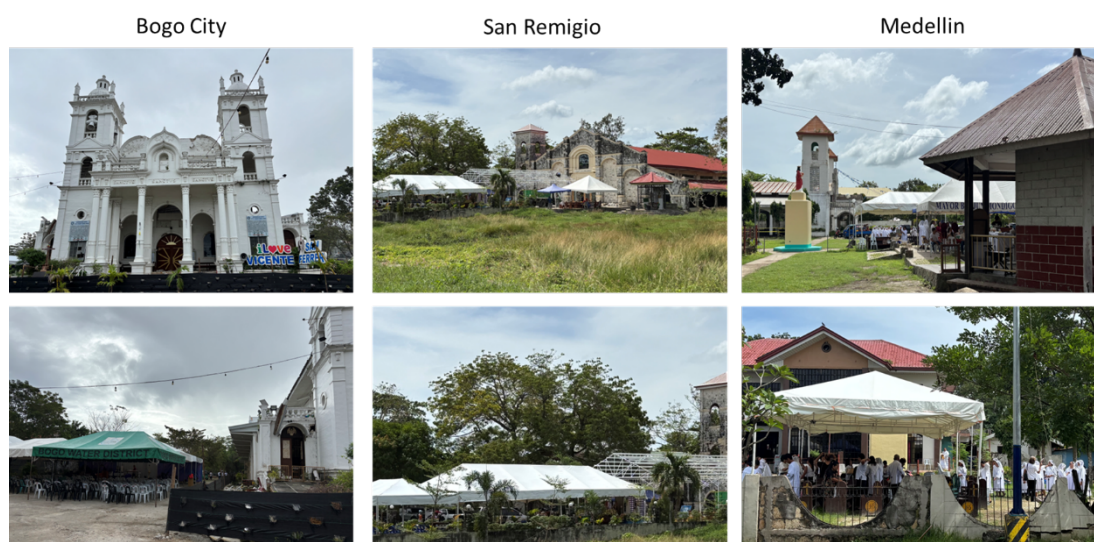
Figure 6 Damaged churches (above photos); Tents for church services (below photos)

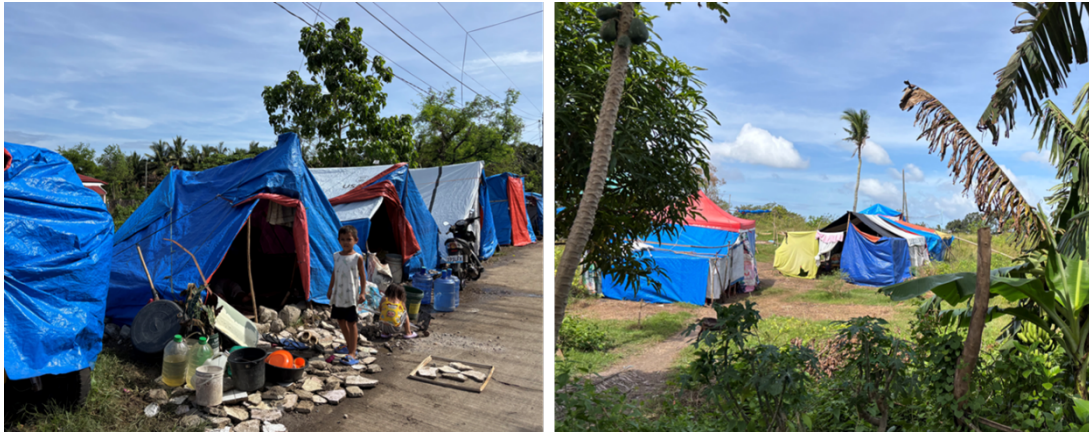
Figure 7 Makeshift tents serving as night sleeping lodges by some residents

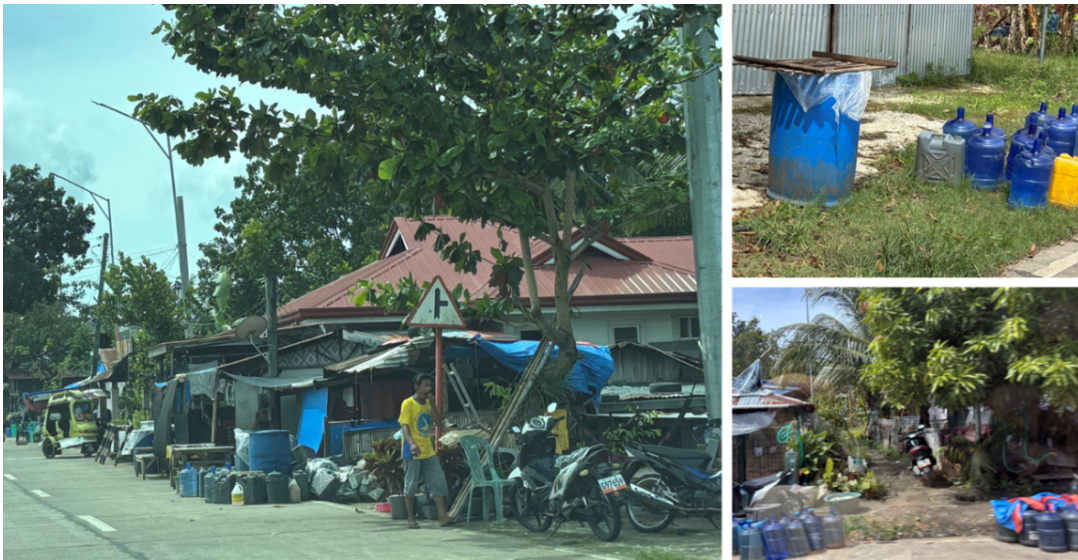
Figure 8 Water containers along the roadside of Barangay Dakit, Bogo City

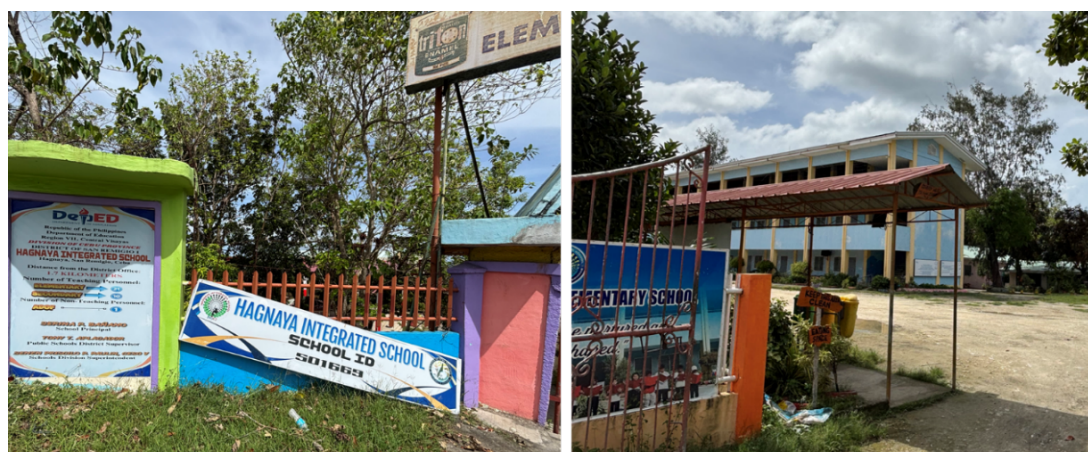
Figure 9 Left photo: Hagnaya Integrated School in San Remigio. Right photo: Medellin Central Elementary School in Medellin

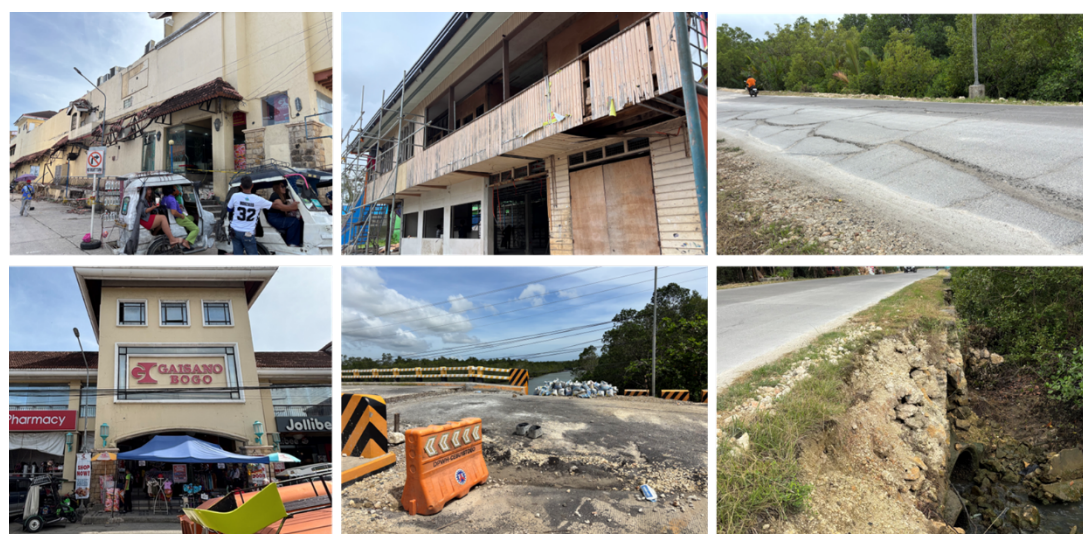
Figure 10 Reoccupied buildings and reusage roads prior to thorough inspection by local government

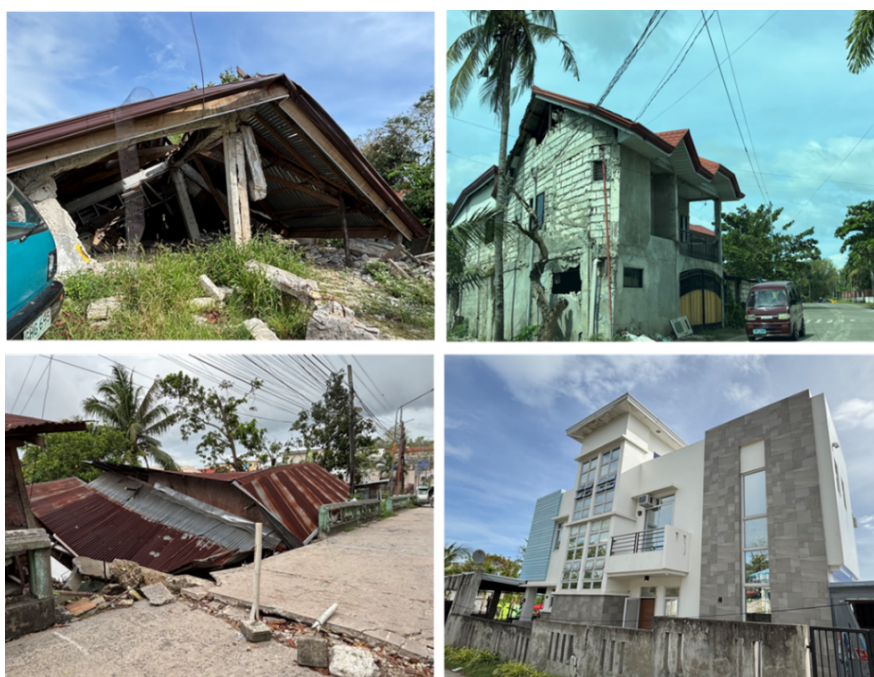
Figure 11 Photos of “totally damaged” houses (left), and photos of “partially damaged” houses (right) based on visual observation only

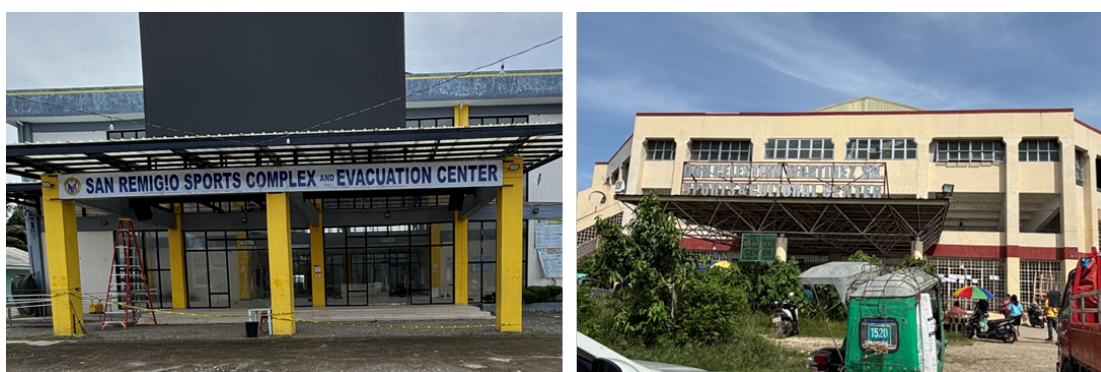
Figure 12 Sports complex in San Remigio (left), Sports center in Bogo City (right)
