# Restoration efforts of the Aso Bridge District affected by a massive landslide

Sand control group, Kumamoto branch office, Kumamoto earthquake counterplan office, Kyushu Regional Development Bureau, MLIT

## Overview of the landslide

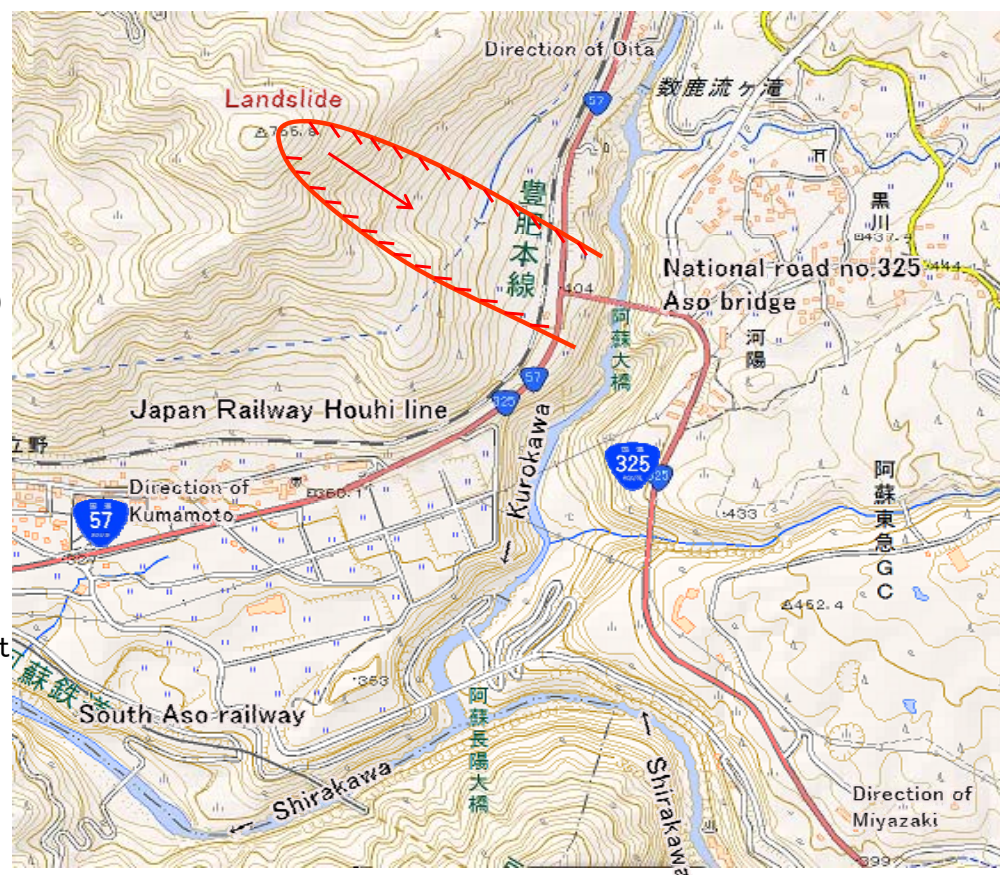
### <Scale of landslide>

- Length of landslide approx. 700m
- Width of landslide approx. 200m
- Volume of earth and sand approx. 0.5 million m<sup>3</sup>  
(Estimation by aerial laser measurement soon after the quake)

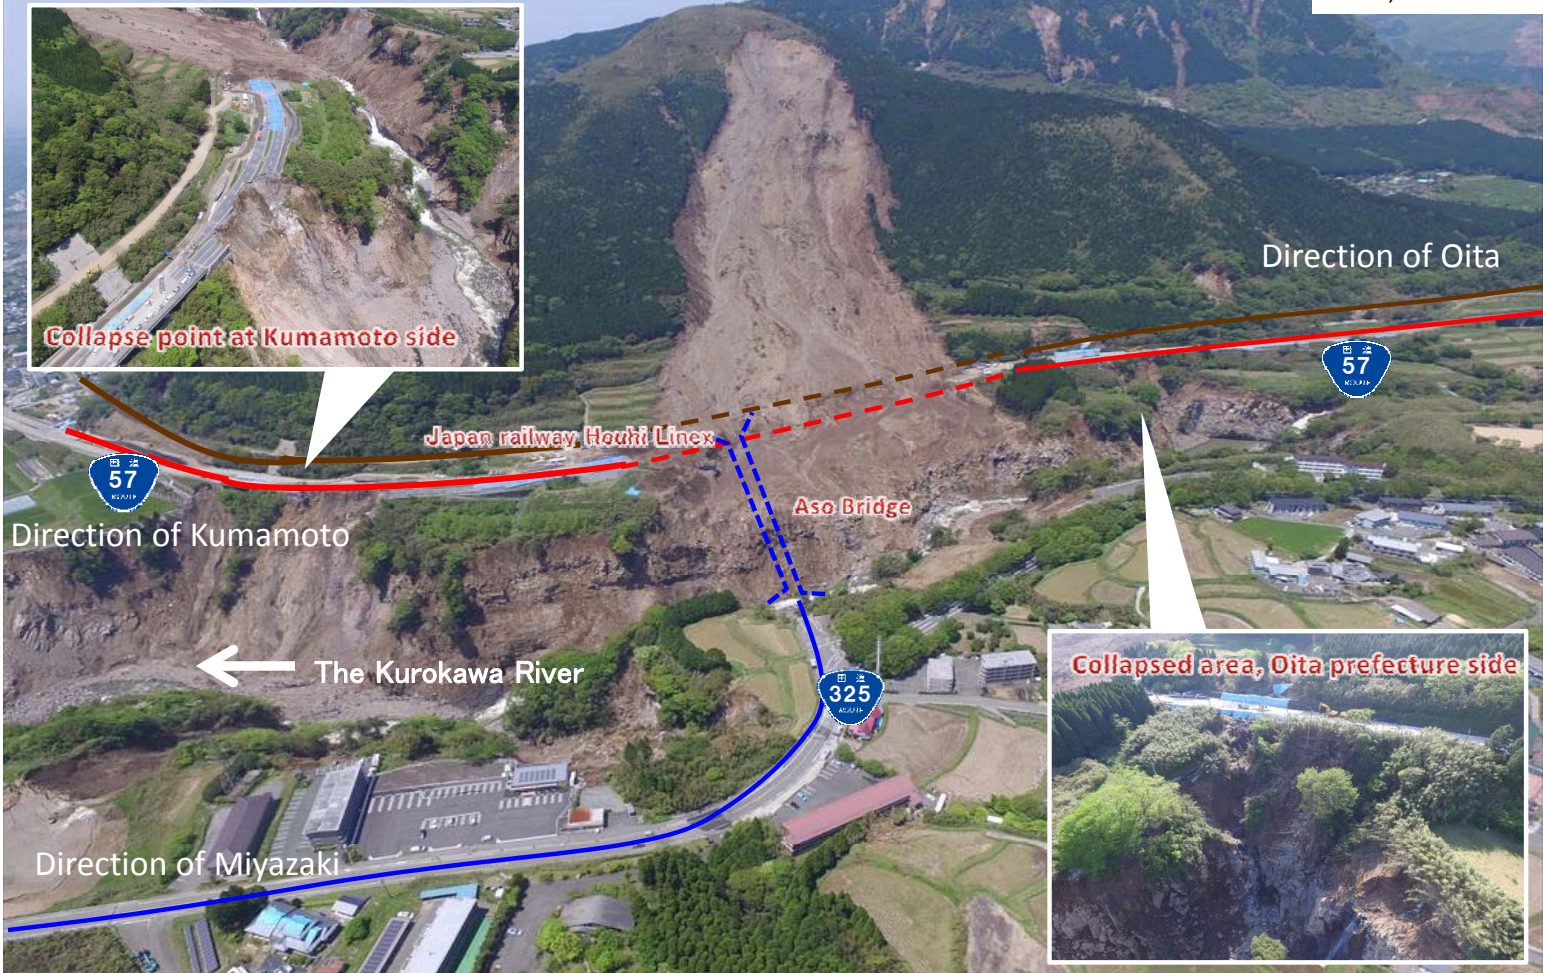
# Damages by the collapse at Aso Bridge area

- Public infrastructure
  - National Road no. 57 (Aso bridge area)
  - National road 325 Aso Bridge
  - Japan Railway Houhi Line

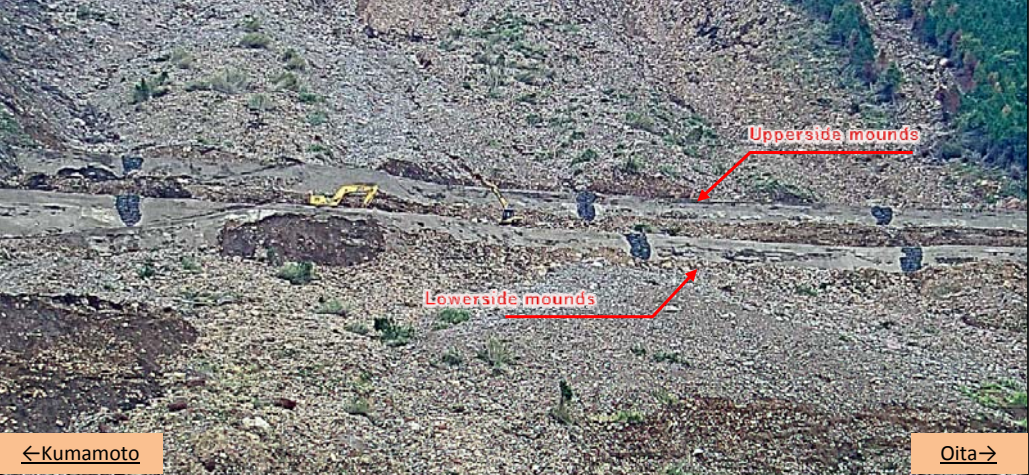
**Overview of the mounds, photographed on October 31th**

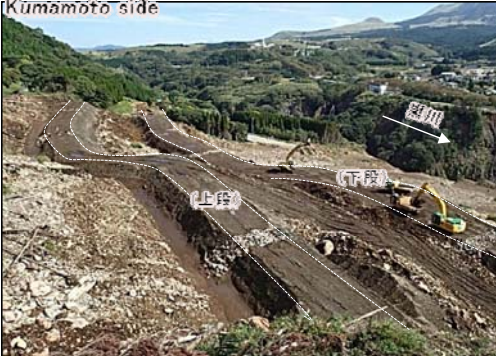
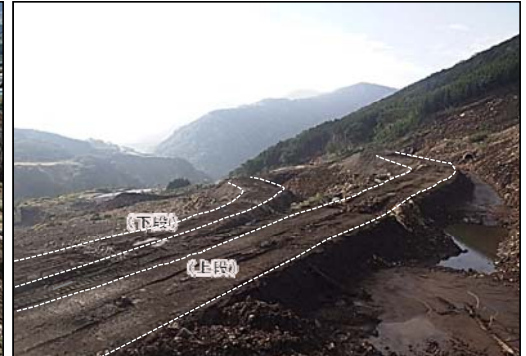
**Mounds**

Status of the mound, October 27<sup>th</sup> from Kumamoto side

Status fo the mound, October 30<sup>th</sup> from Oita side

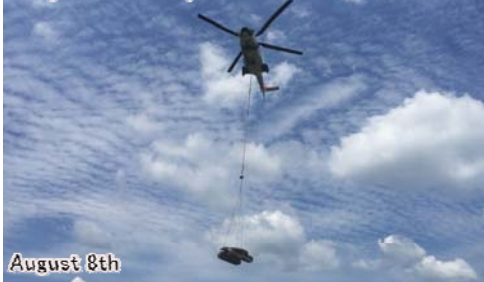
August 8th

Airlift of separated slope power shovel at height to the top area

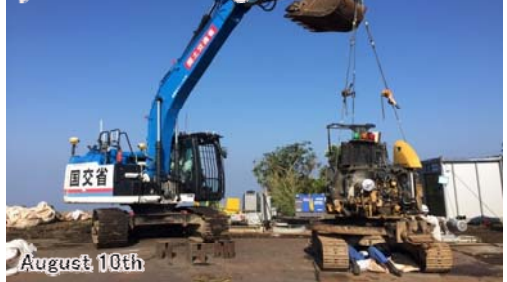
August 10th

Assembly of the separated slope power shovel at height

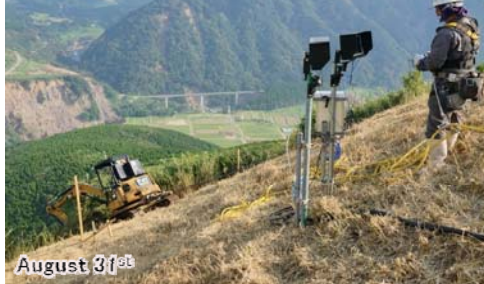
August 31st

Operation of slope power shovel at heights

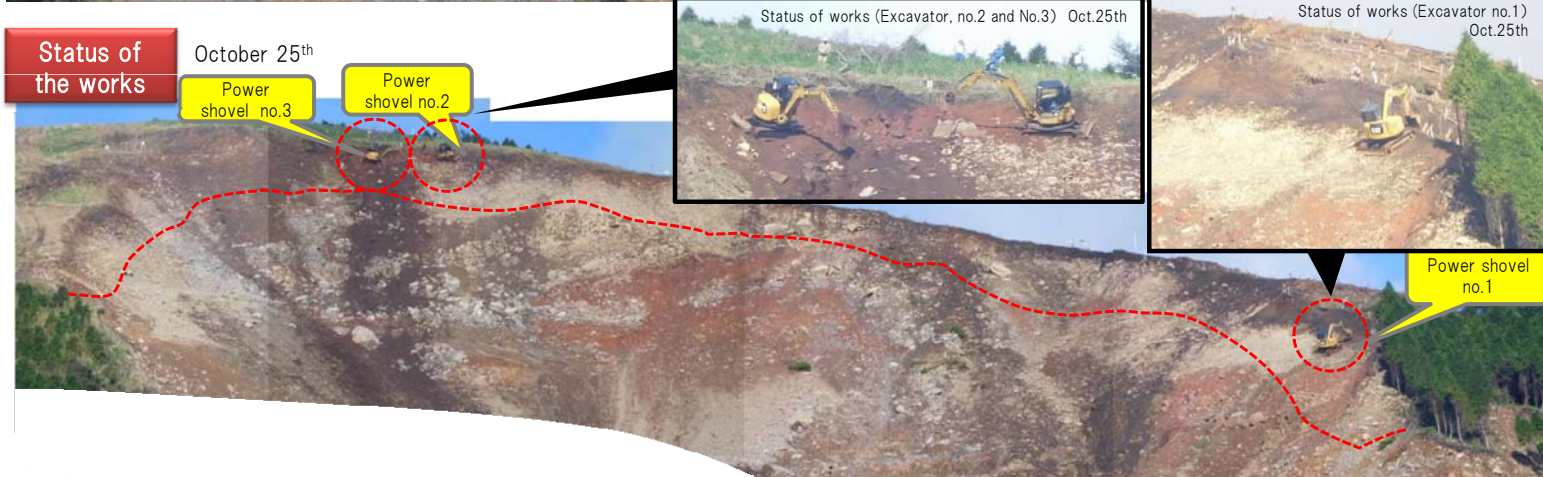
October 25<sup>th</sup>

Status of works (Excavator, no.2 and No.3) Oct.25th

Status of works (Excavator no.1) Oct.25th

- Elimination of unstable sands, stones that may trigger falling of stones
- Start of works: August 31th by using three slope power shovel at height
- Completed in two months and half on November 10<sup>th</sup>
