**Wind Induced Damage to Roofs and Mitigations: A Comparative Study on
Roofs in Bhutan and Japan**

A final research report presented

Yeshey Lotay

Asian Disaster Reduction Center

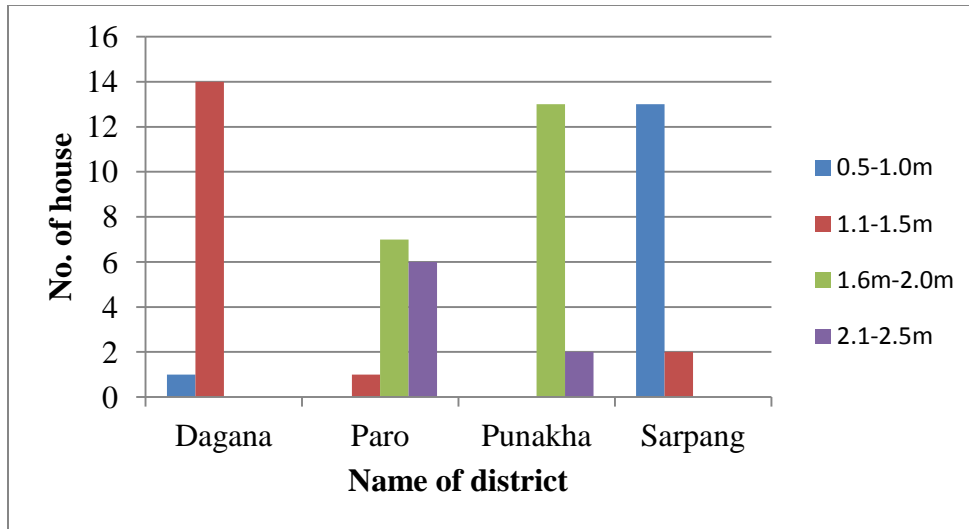
Figure 50: Graph showing the roof overhang in the four districts in Bhutan

Paro and Punakha is the district located in the western part of Bhutan, Dagana is located in the central part of Bhutan and Sarpang located in the southern part of Bhutan. It was observed that the large roof overhang (<1.5m) found in the western part of Bhutan as compared to the southern part of Bhutan. In Sarpang, roof overhang is between 0.5m – 1.0m as shown in

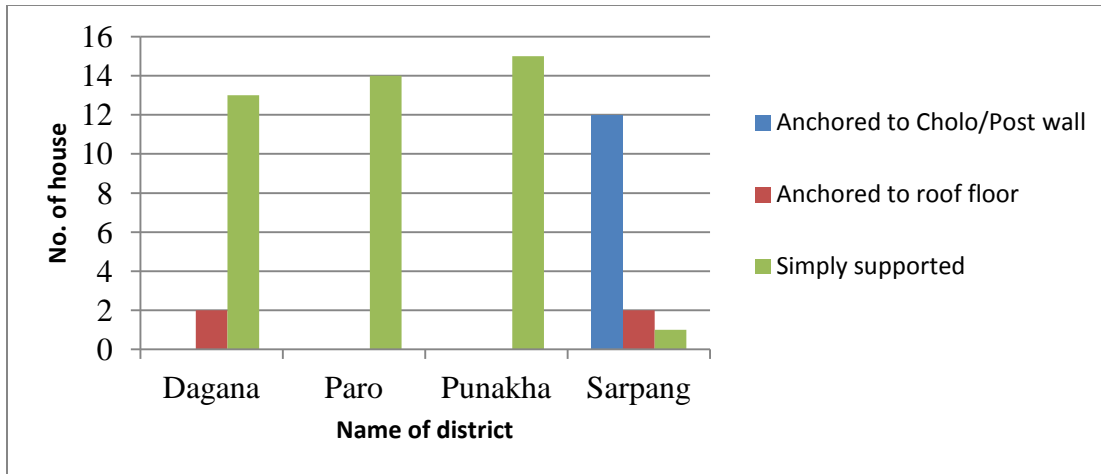
Figure 53: Graph showing the different type of roof-to-wall connection

causing the roof damage. As described in the graph (Figure 53), most of the rural home roofs in the western and central part of Bhutan are simply supported

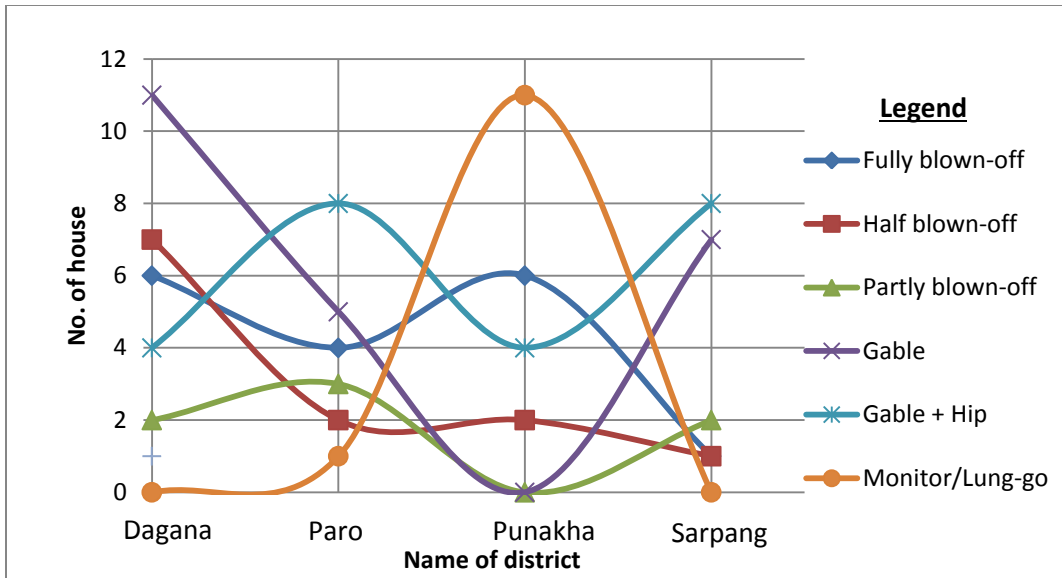
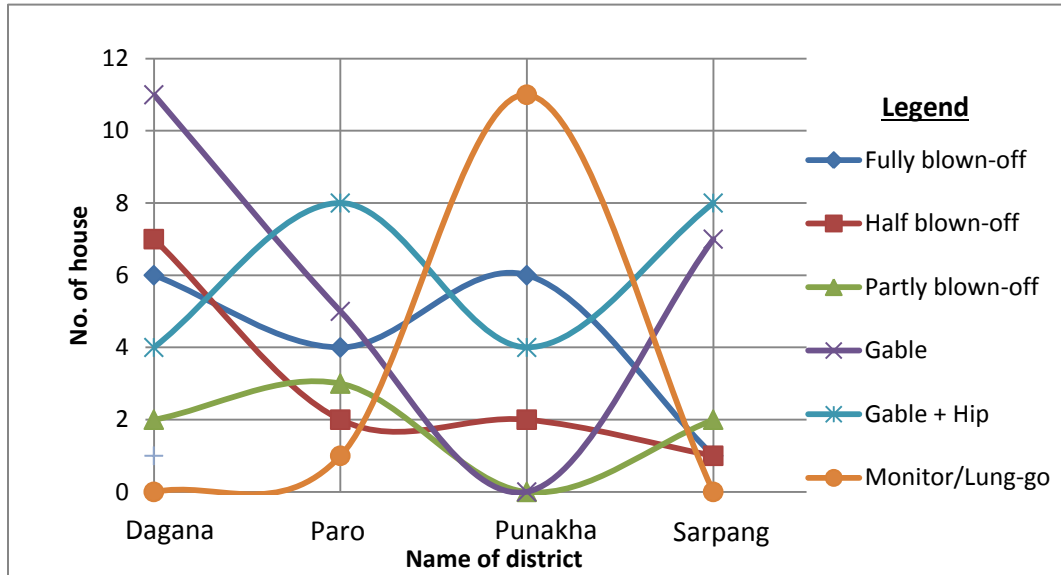
Figure 54: Graph showing the windstorm damage vs the type of roof in four districts

As described in the section 2.1.1, gable roof is one of the most common roofs in Bhutan, gable + hip combine (usually called hip in Bhutan) and lung-go roof. It was observed that lung-go roof and gable + hip roof were commonly used in the western part of Bhutan. The gable and gable + hip roof were commonly used in the western, central and southern part of Bhutan. In the case of roof damages during the 2011 & 2013 windstorm, it was observed that the most damage was observed in the Punakha district with maximum full blown-off damage followed by Dagana

Figure 54. As shown in the Figure 55, Punakha district has maximum simply supported roof followed by Paro and Dagana district, which suffered full blown-off during the windstorm. Also, the large roof overhang create a huge uplift pressure at the roof edges, which lead to the failure of the roofs at the edges causing full blown-off or half blown-off in the rural home roof during the windstorm. Most of the western part of Bhutan rural homes have large roof overhang as compared to the central and southern part of Bhutan roofs.

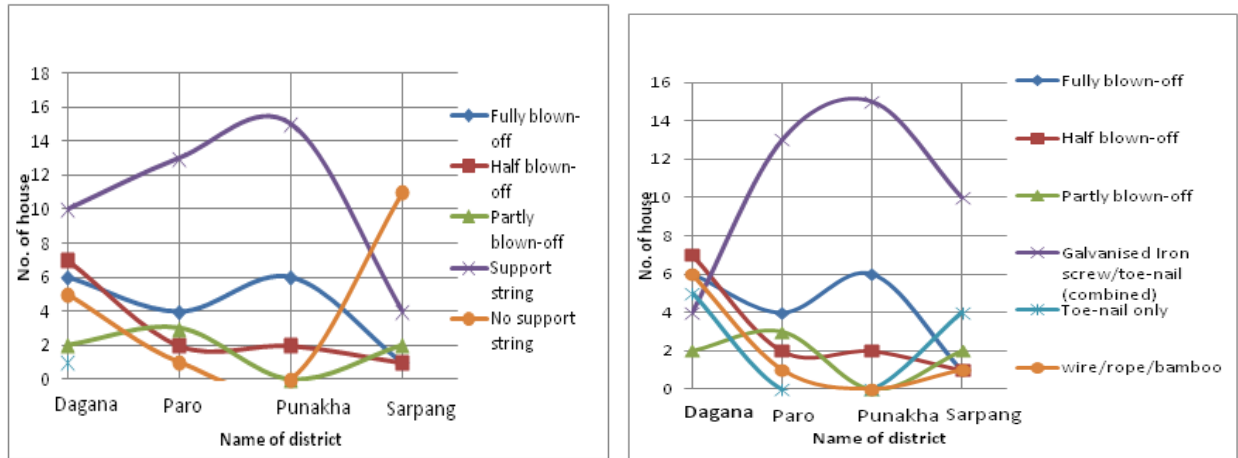
Figure 56: Graph showing the damage vs support string (L) and damage vs connection (R)

In the case of the use of support strings and different types of connection materials used in the rural home roofs. It was observed that most of the western and central part of Bhutan roofs used the support strings as compared to the southern part of Bhutan roofs. The roofs in the southern part of Bhutan were anchored to the wall or post, therefore there do not use the support strings as shown in Figure 56. Also most of the connection between the Corrugated Galvanized Iron (CGI) sheet metal and the purlin members are connected using galvanized iron (GI) screws. The connection between purlins and rafters are done by single toe-nails of 4 - 6 inches long and observed that most of the connections are not done properly as described in

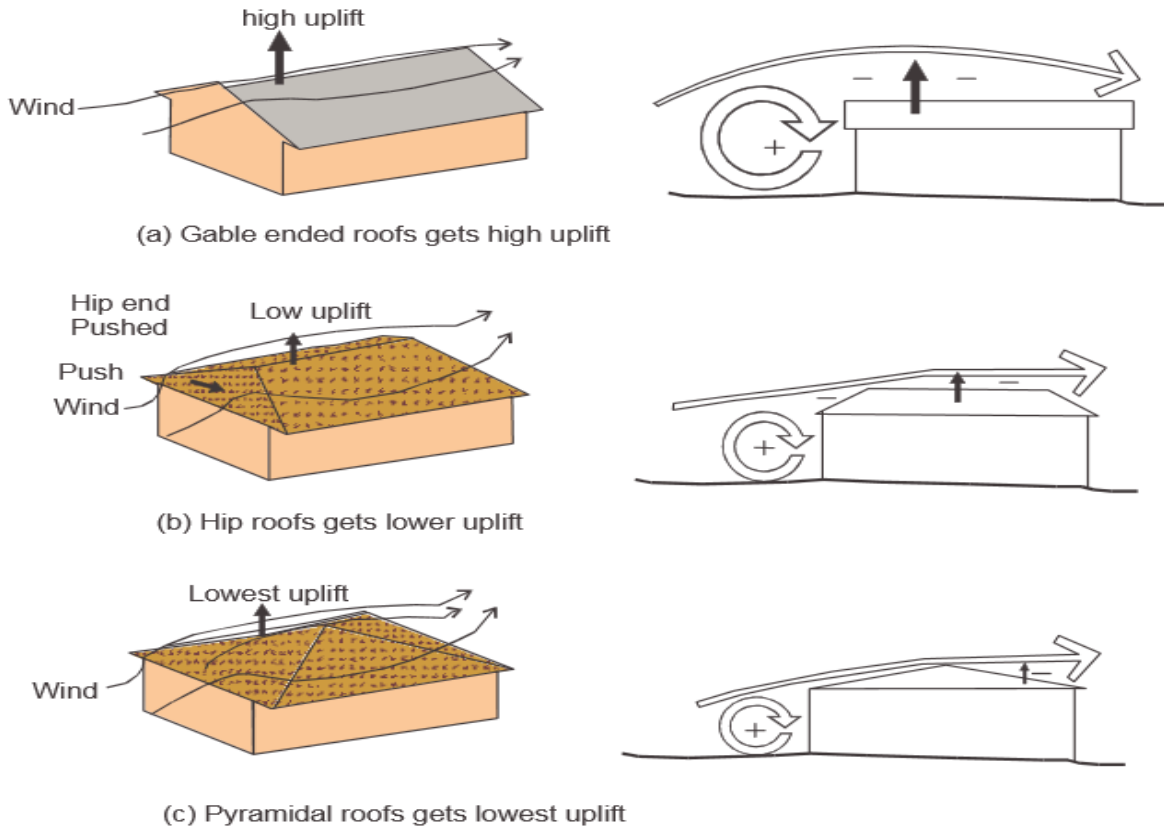
Figure 57: Roof type effect on uplift pressure (Bhandari et al., 2005)

gets the low uplift pressure, which performance good during strong wind as compared to other roof types as shown in figure 57.

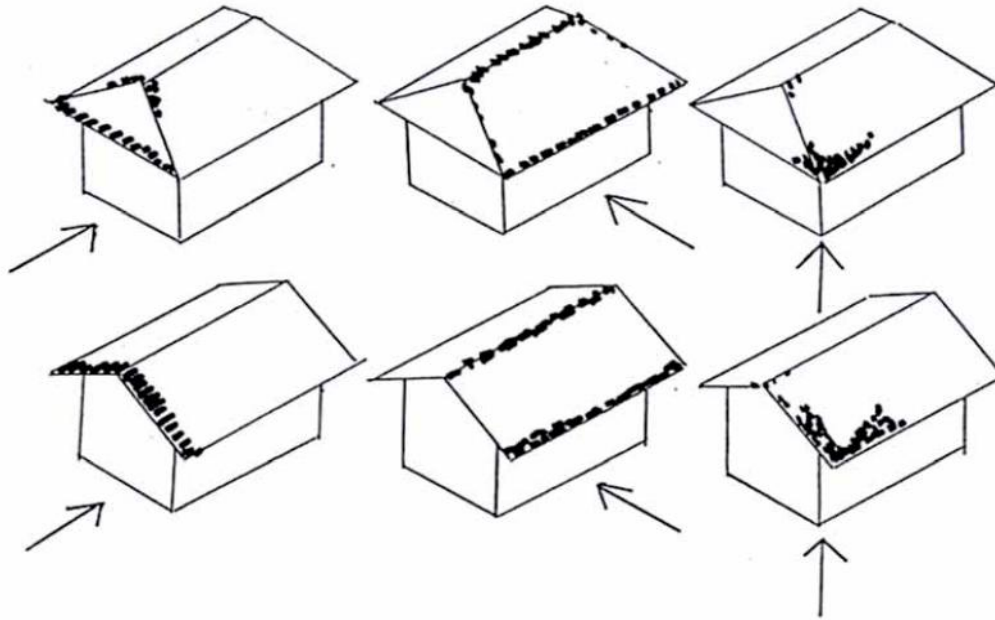
Figure 60: Most likely locations of roof damages (Source: Points to Note for Wind Resistant Design in Philippines, Tamura)

As you can see from the Figure 60, most likely locations of roof damages during the strong wind are at the gable end, corners and roof ridge. Therefore, it is important to fix these locations to reduce the damages during the strong wind. Following the few mitigation measures:

1. Use of gable end, corner and roof ridge stiffener as shown in Figure 62
2. Bracing the roof members as shown in Figure 62
3. Bracing the large roof overhangs $> 450\text{mm}$ or avoid large roof overhang
