# PREPAREDNESS TO EARTHQUAKE AFTER THE CATASTROPHE OF AUGUST 17TH

**Zeki Hasgür (PhD)**

*ALTINBAŞ University, Department of Civil Engineering*

- Turkey's Seismicity and Studies
- August 17th Earthquake Effects-Damages
- New Settlements, New Constructions
- Retrofitting Damaged and/or Undamaged Buildings
- Retrofitting Viaducts, Suspension Bridges
- The Roles of IISEE, Contributions of Japanese Professors and Promotion of Earthquake Engineering in Turkey
- Challenging Projects-Suspension Bridges ,The Marmaray

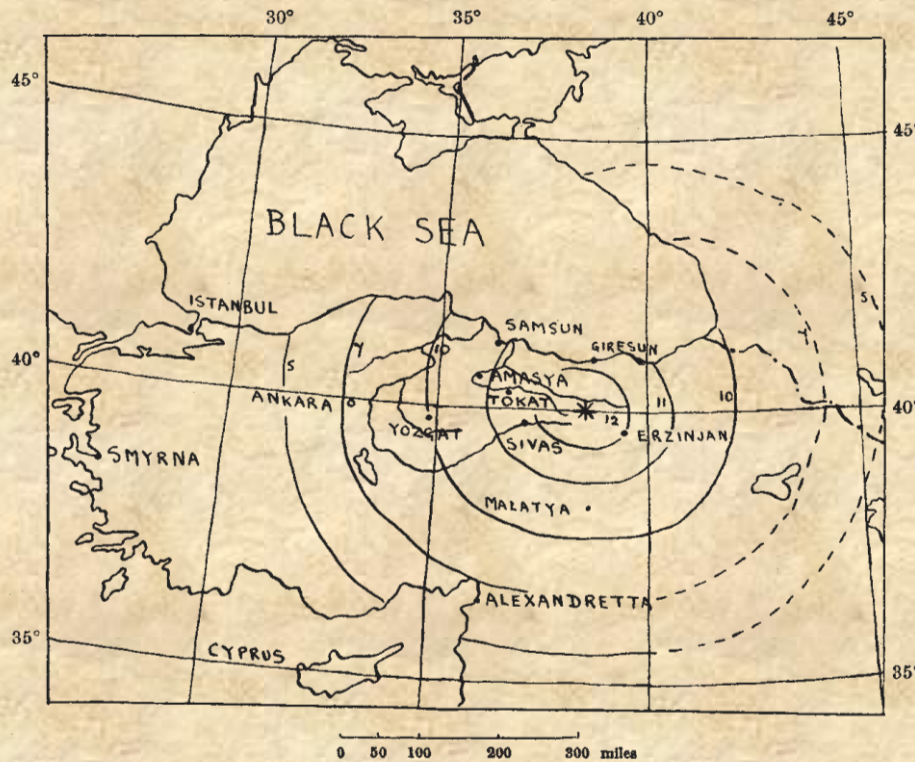
SKETCH MAP SHOWING THE APPROXIMATE EPICENTRE AND ISOSEISMAL LINES (MODIFIED MERCALLI SCALE OF 1931) OF THE ERZINCAN EARTHQUAKE OF DECEMBER 27, 1939.

\*, EPICENTRE; —10—, ISOSEISMAL LINE.

Epicenter & Isoseismal Lines  
(Modified Mercalli Scale of 1931)  
Fault Length:  $L=350\text{km}$   
 $h=20\text{km}$

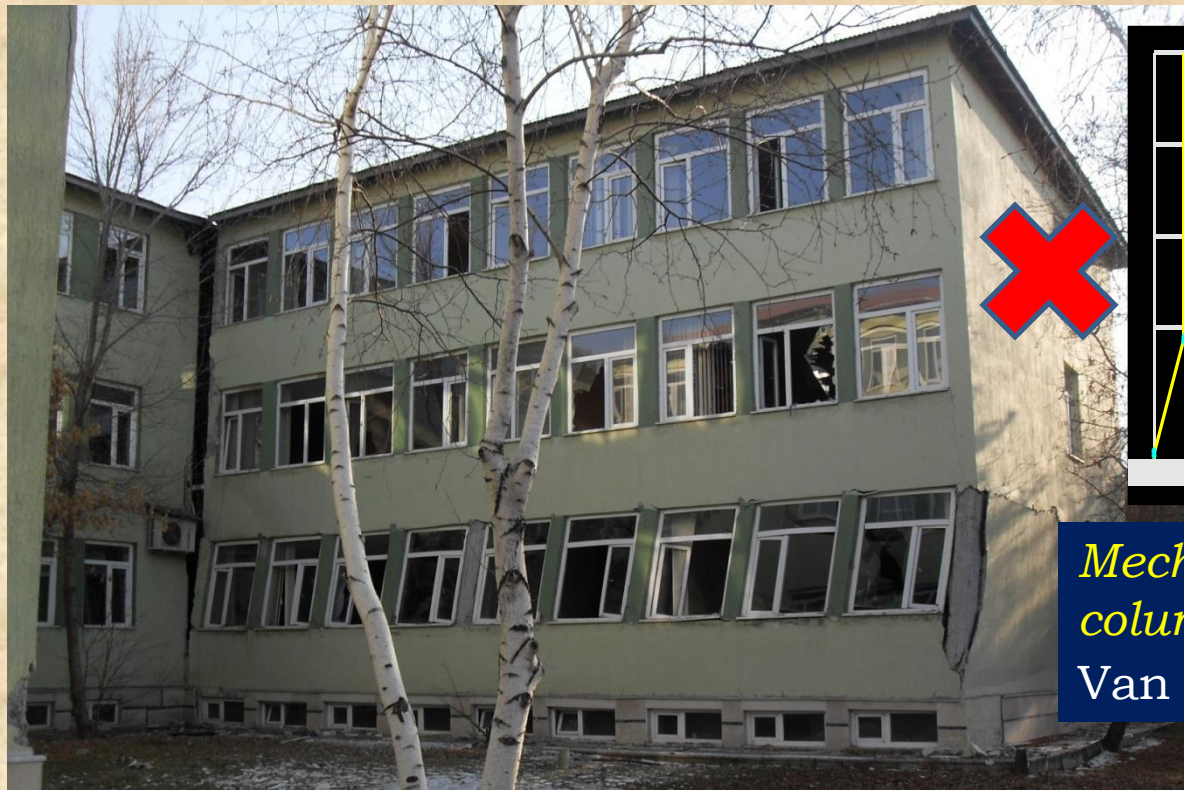
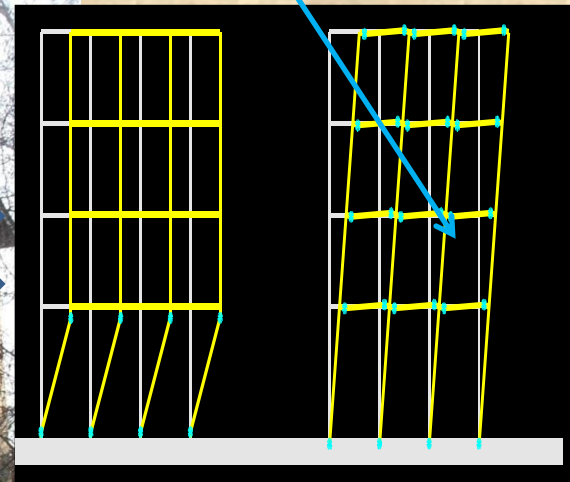
DSİ Van Regional Directorate Building:  
Column-Mechanism in the Ground Floor

“ductile behavior” with their  
elements

*Mechanism in columns*      *Mechanism in beams*

Van Earthquake 2017  $M_w=7.2$

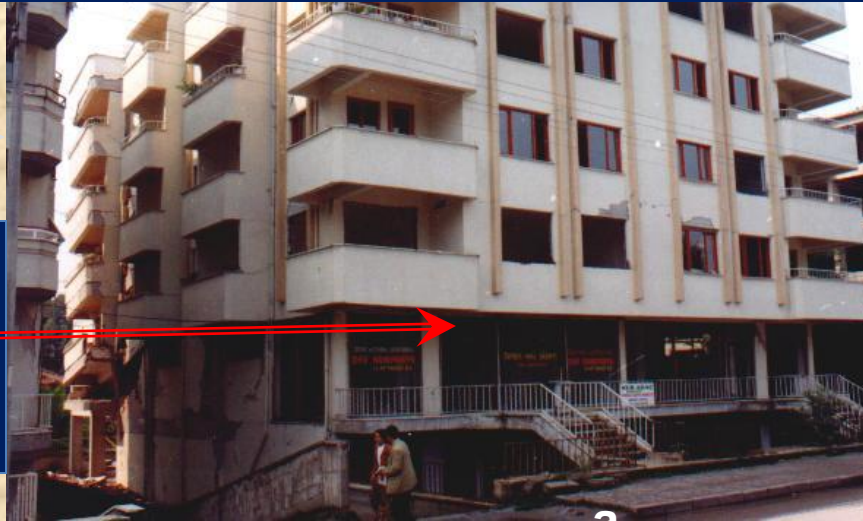
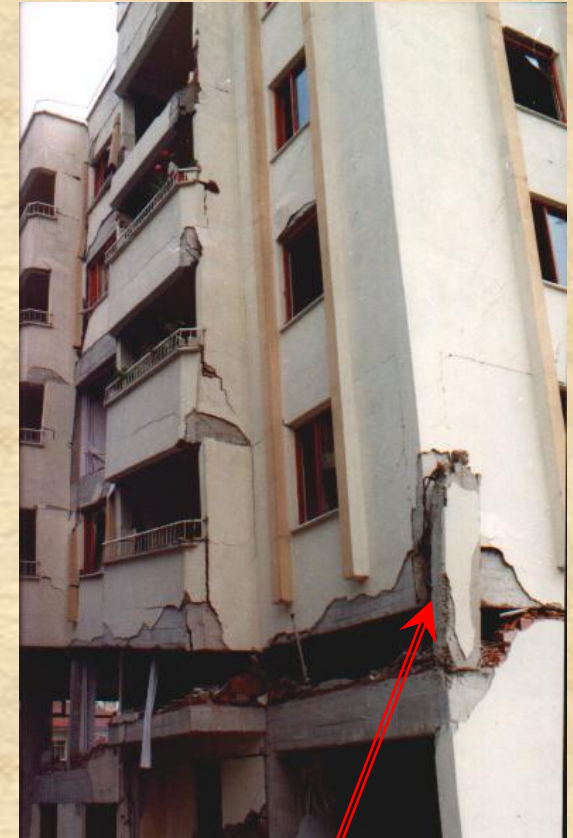
# Bearing system irregularities in plan and vertical direction

Almost No Damage In Front of Building

Heavy Damage Behind the Building

Shear Wall

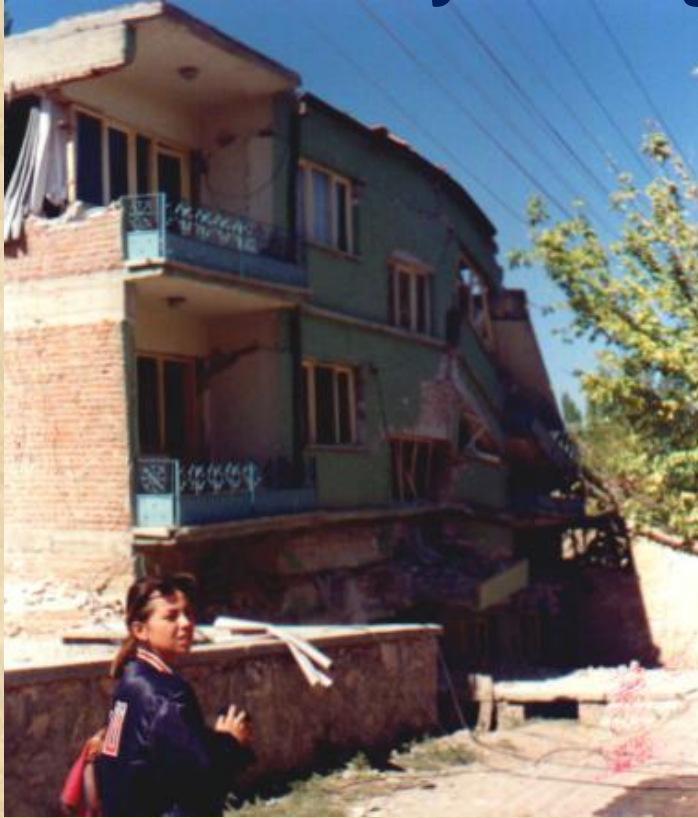
Especially  
for  
**Masonry  
Structures**  
Irregular &  
Big  
Openings

*Adana 1998*

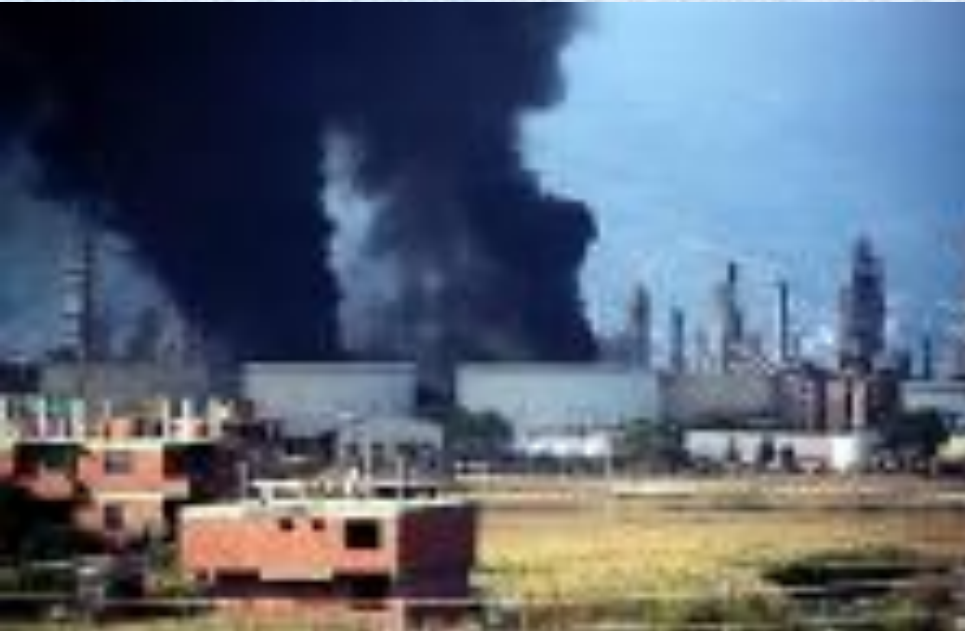
TÜPRAŞ Refinery Fire

- First, a 90 m high and 10 m diameter reinforced concrete chimney in the crude oil unit fell into the middle of the units, causing a fire.
- The second one, unlike the crude oil unit, was caused by sparks in Nafta tanks.
- These fires could only be controlled within three days.

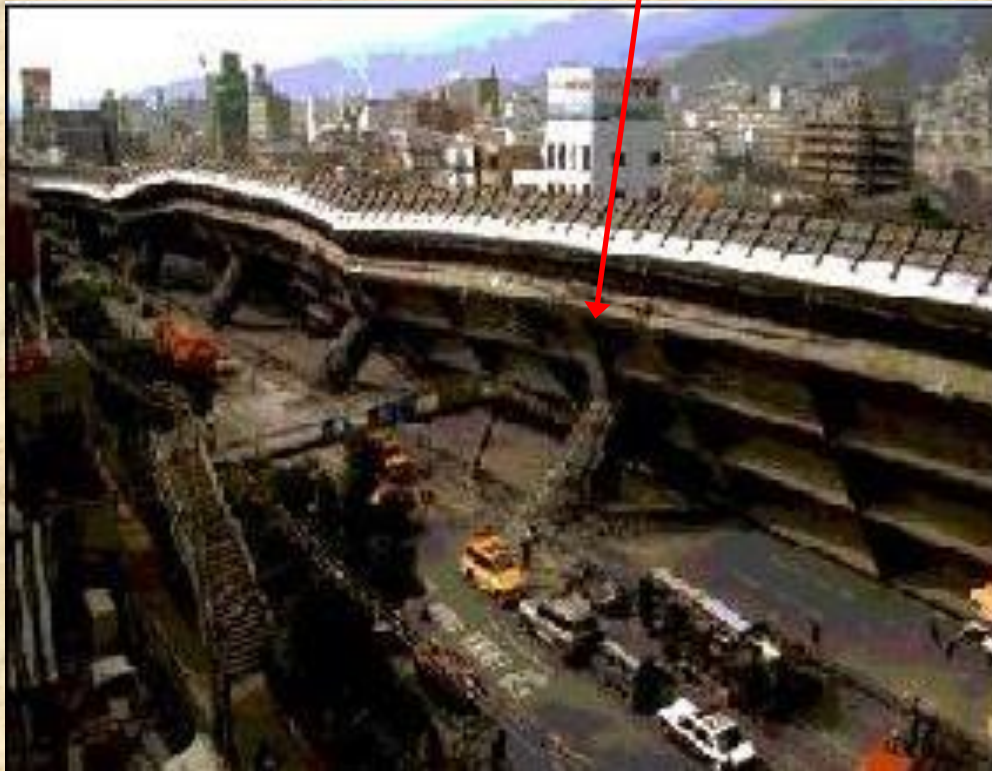
Overtaken Viaduct in Kobe with the 630m Length

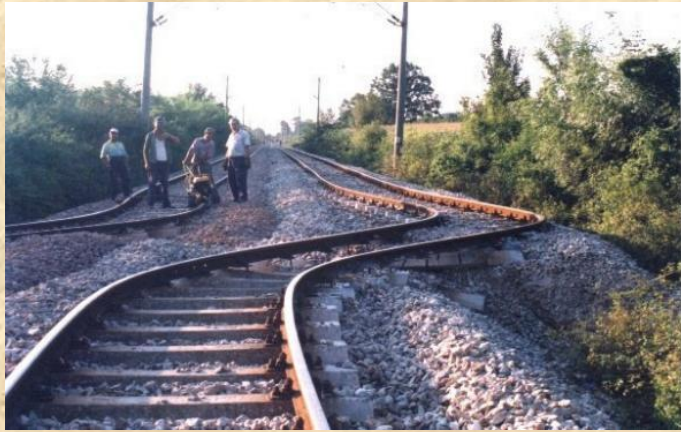
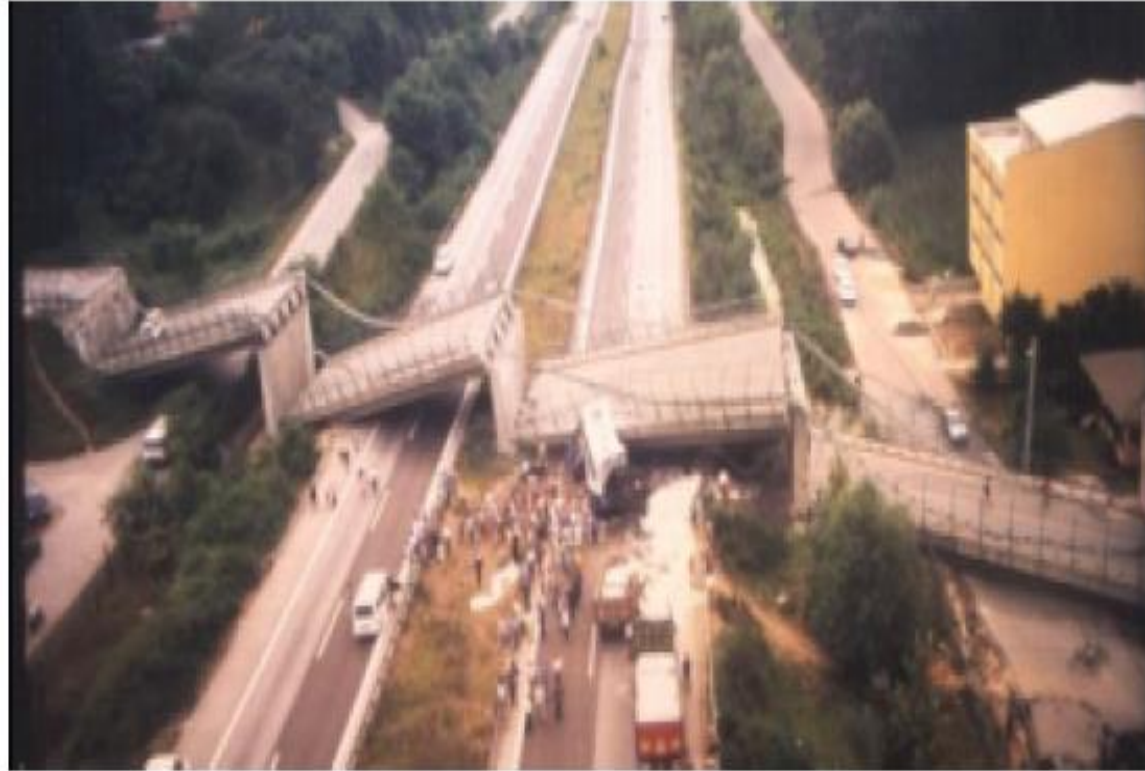
**Collapses of TEM Highway, Arifiye Grade Separation in Kocaeli Earthquake**

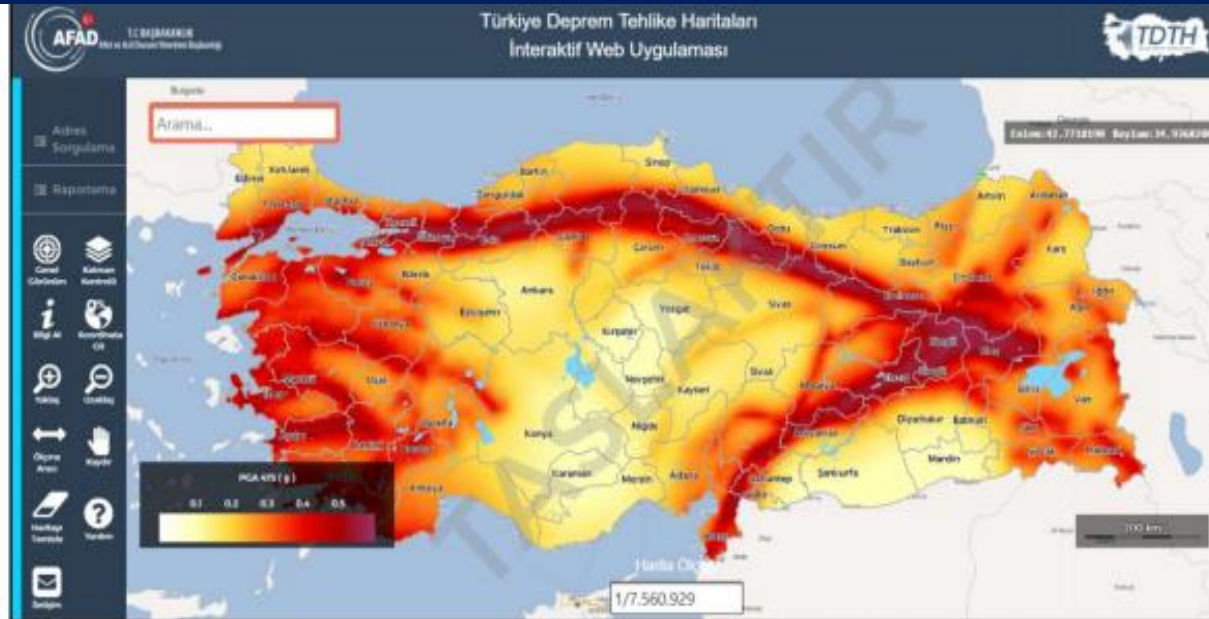
Interactive  
Web  
Application

- It is planned to present “Earthquake Hazard Maps of Turkey”, which are also developed consistent with “Turkish Building Earthquake Code”.
- Earthquake hazard maps in terms of peak ground acceleration, peak ground velocity, 5%-damped pseudo-spectral accelerations at 0.2 sec and 1.0 sec periods for return periods of 43, 72, 475 and 2475 years (68%, 50%, 10%, 2% probability of exceedance in 50 years, respectively)

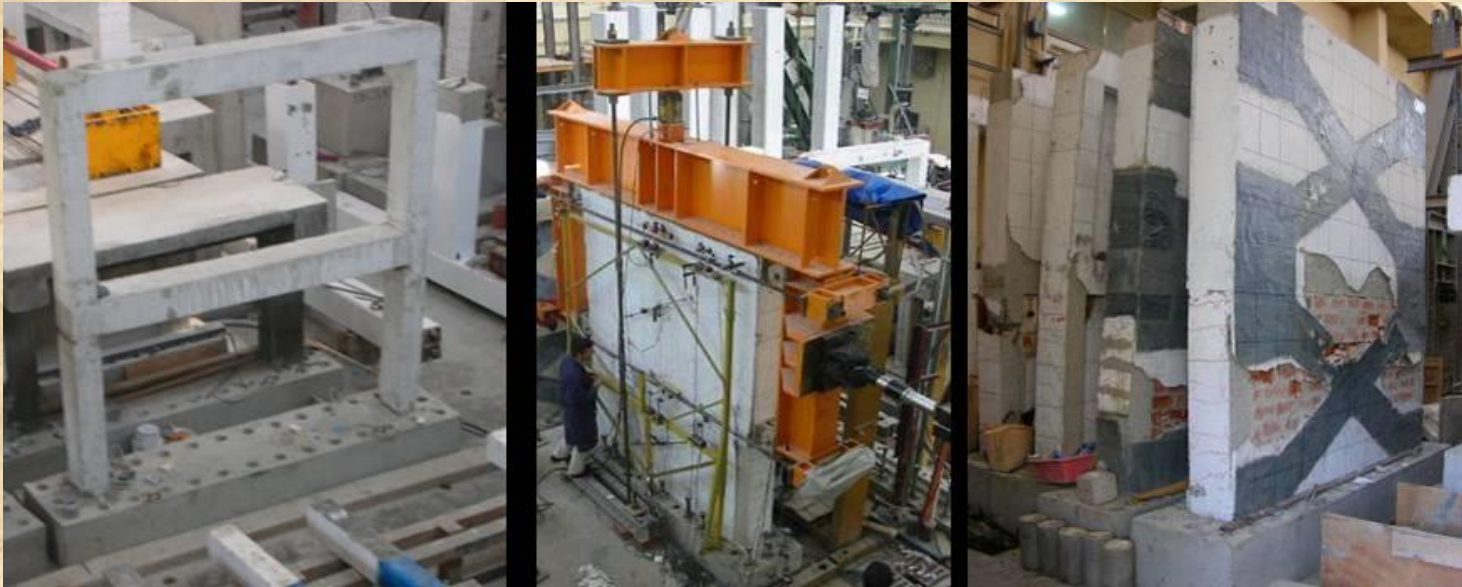
# Establishment of ITU Structural and Earthquake Engineering Laboratory is Supported by Prof. Yarar & Prof. Kubo

Pseudo dynamic experiments for model structural elements is being carried out.

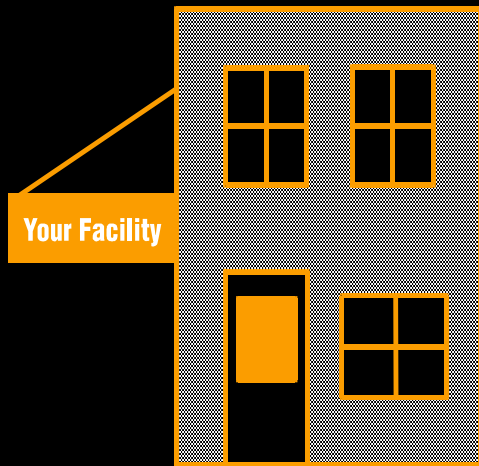
Immediate Occupancy

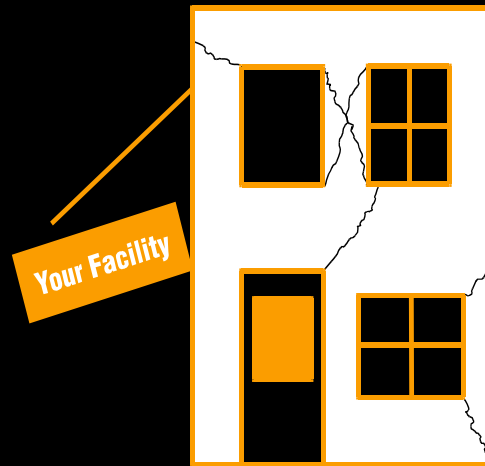
Life Safety

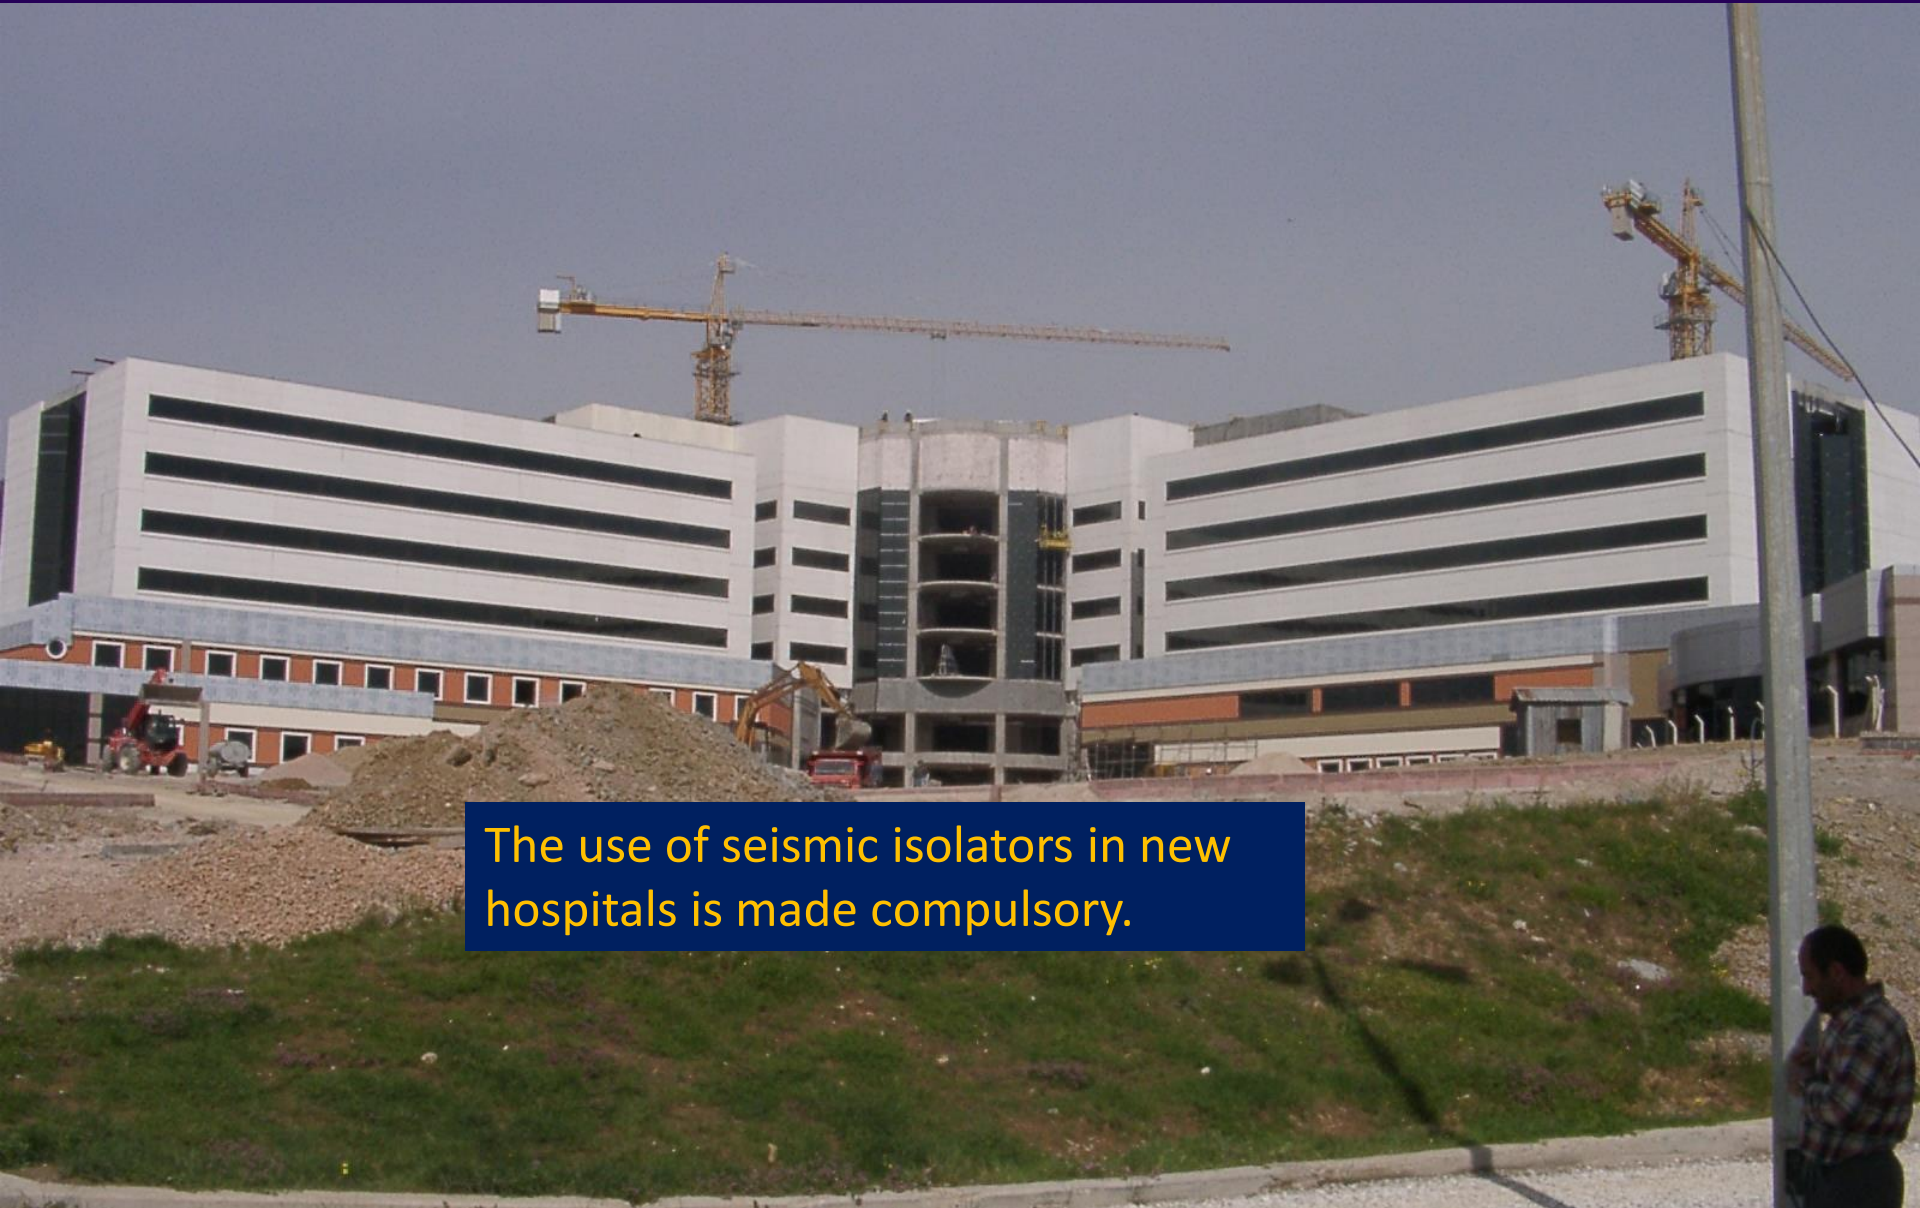
# Seismic Isolation Example - Turkey

The use of seismic isolators in new hospitals is made compulsory.

Faculty of Medicine Hospital -Kocaeli University

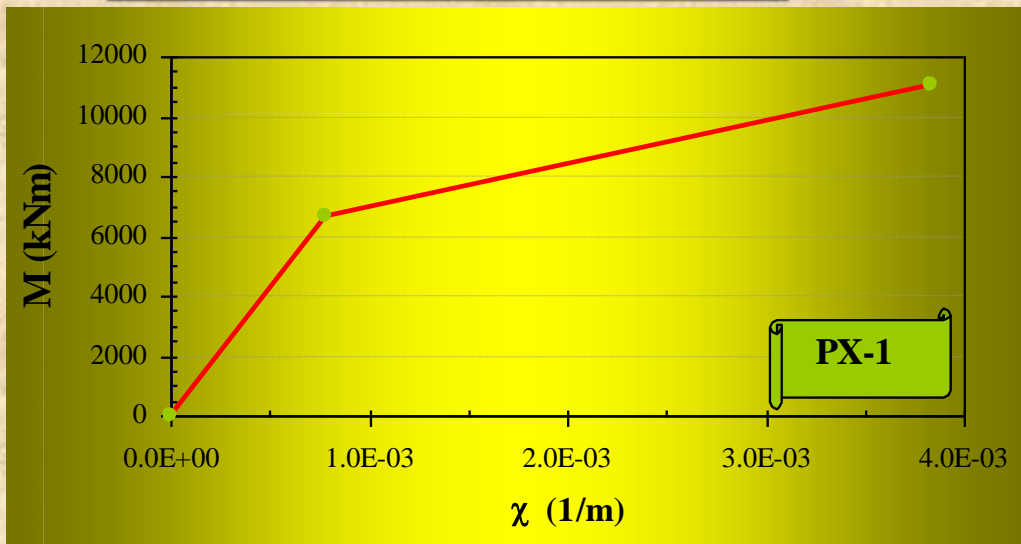
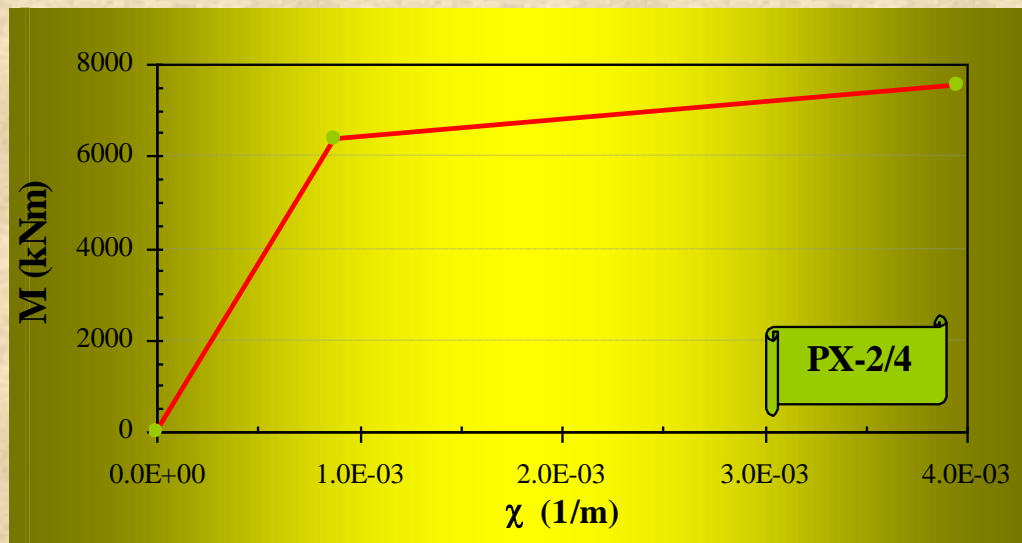
# EXAMPLE- R-C BUILDING -B08

## AFTER RETROFITTING

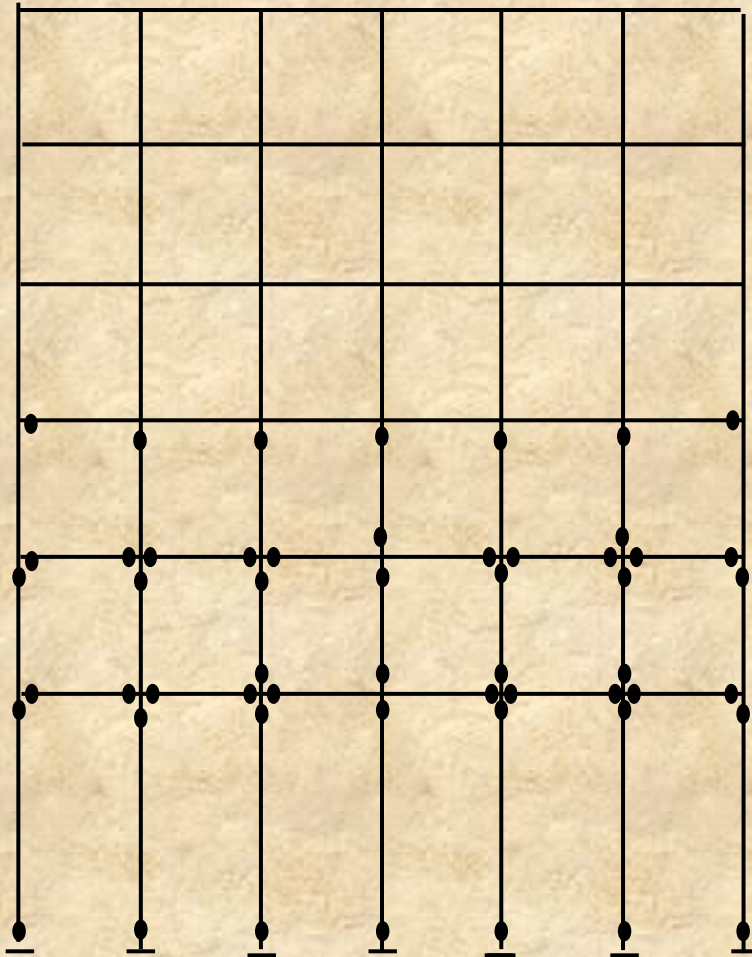
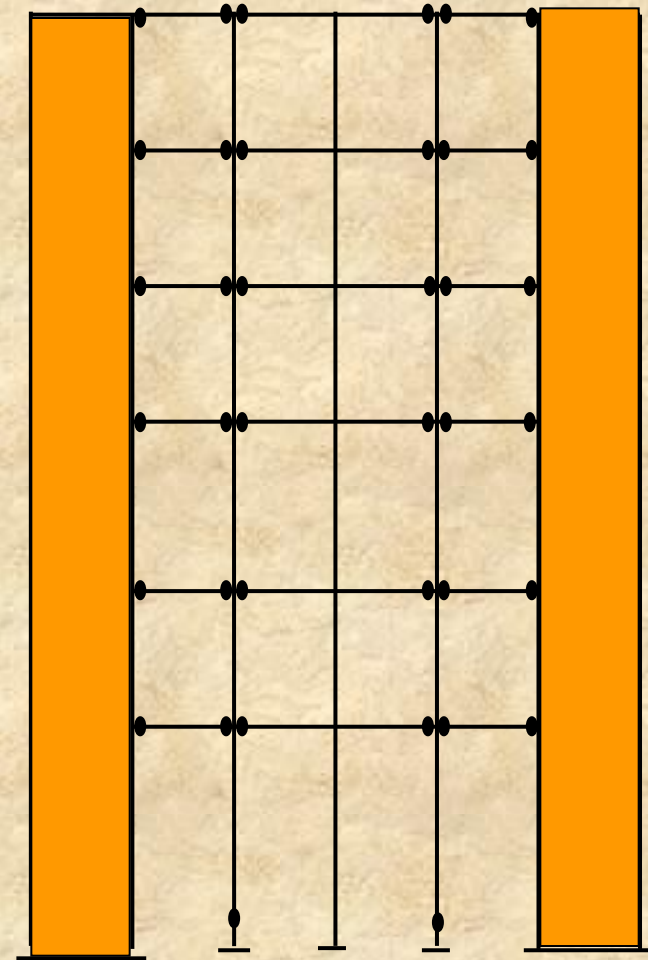
# Plastic Hinges Distribution in 2-2 Axes

**Before Retrofitting**

**After Retrofitting**

Nonlinear Time Domain Analysis Solutions for the Sample Building,  
under the Sakarya-EW 1999 Acceleration Record.

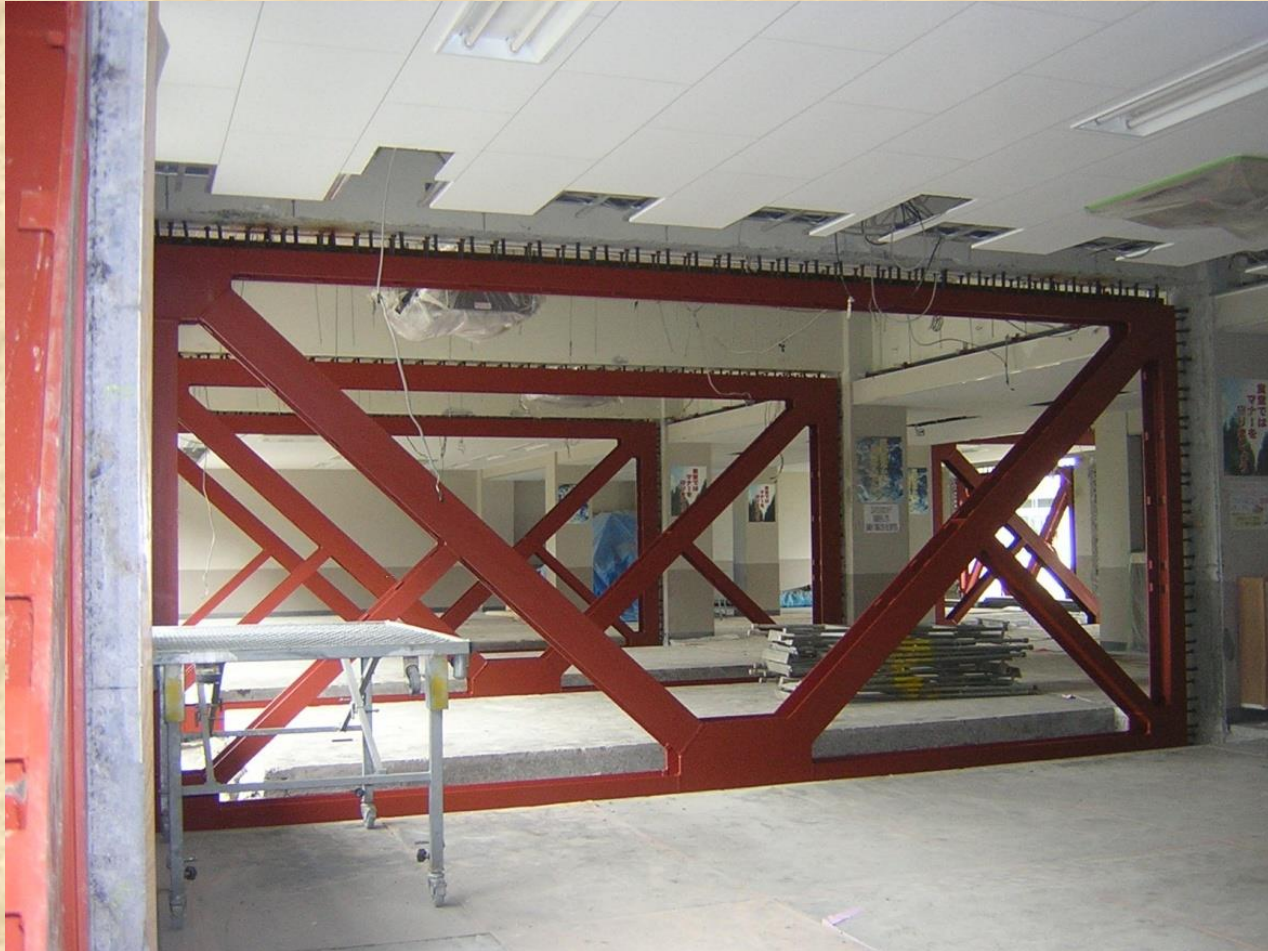
# Strengthening Tokai University Shimizu Campus

## -Steel Trusses

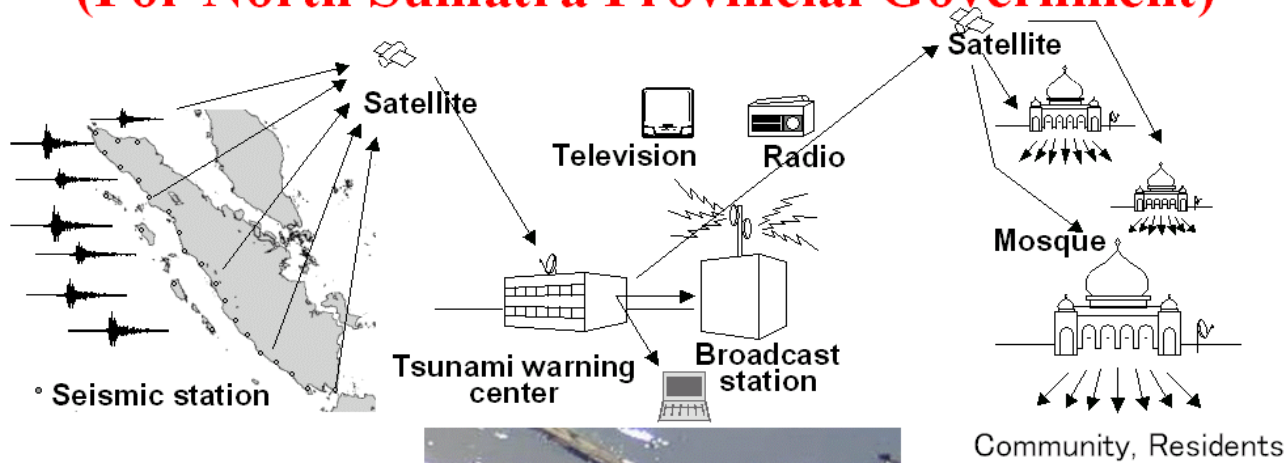
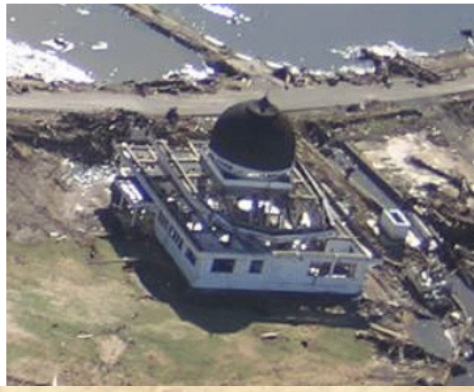
## Plan for Regional Tsunami Warning System by JSCE (For North Sumatra Provincial Government)

Tsunami system proposed by  
Prof. M. Hamada for Sumatra

Japanese Tsunami Warning System

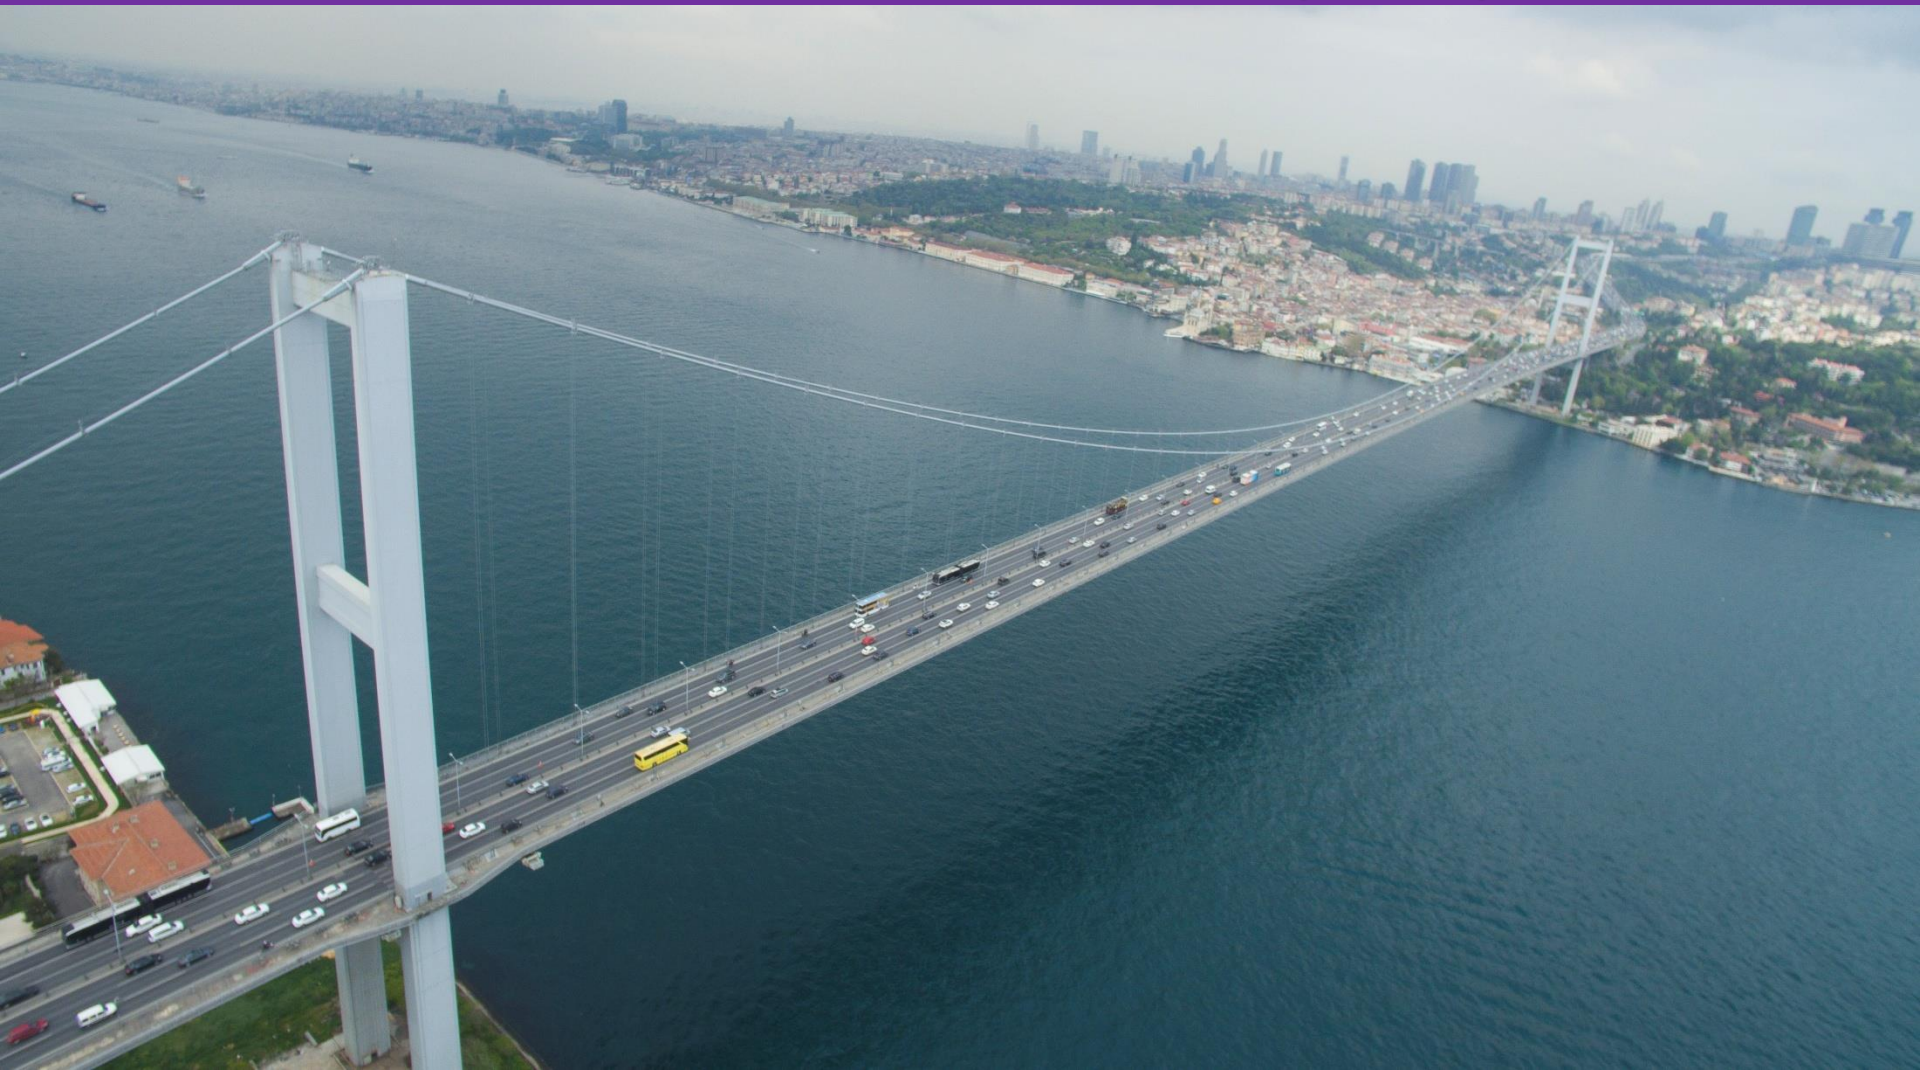
**BOSPHOROUS SUSPENSION BRIDGE-(1973) L=1.560KM**

**Oldest Suspension Bridge Closest to North Anatolian Fault**

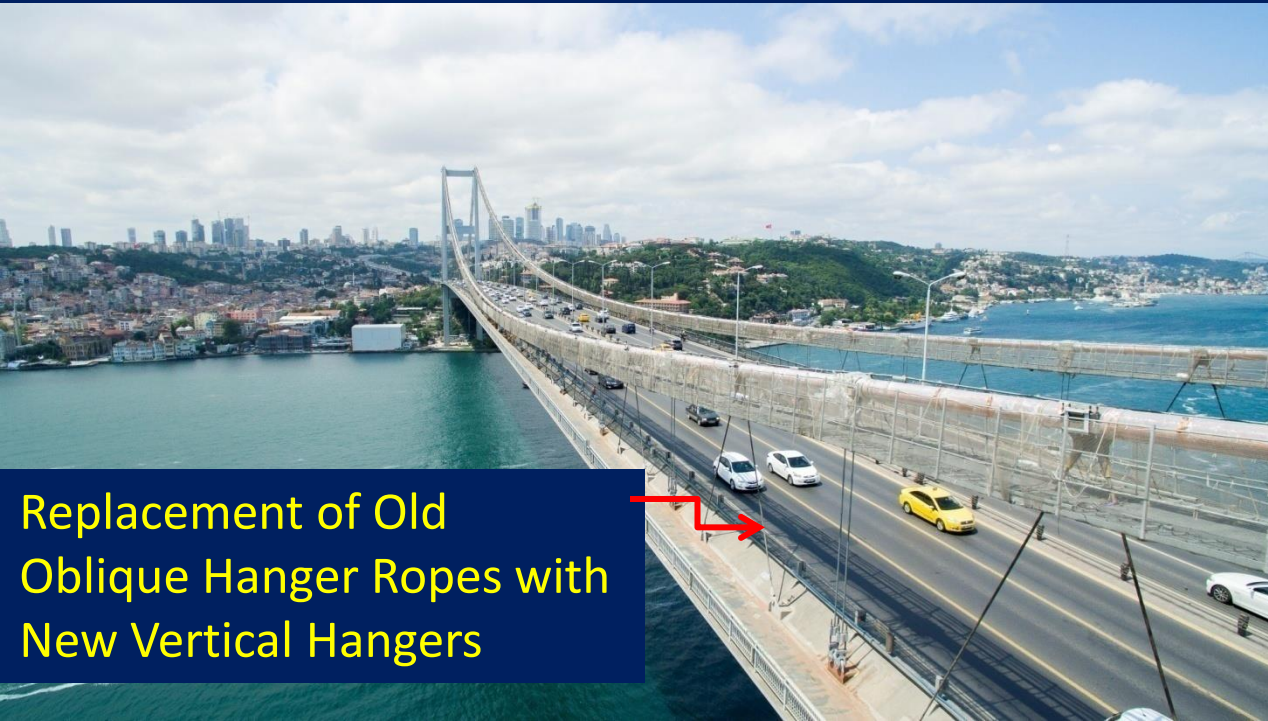
# Important Maintenance of the Bosphorus Suspension Bridge in the 40th Year

Replacement of Old Oblique Hanger Ropes with New Vertical Hangers

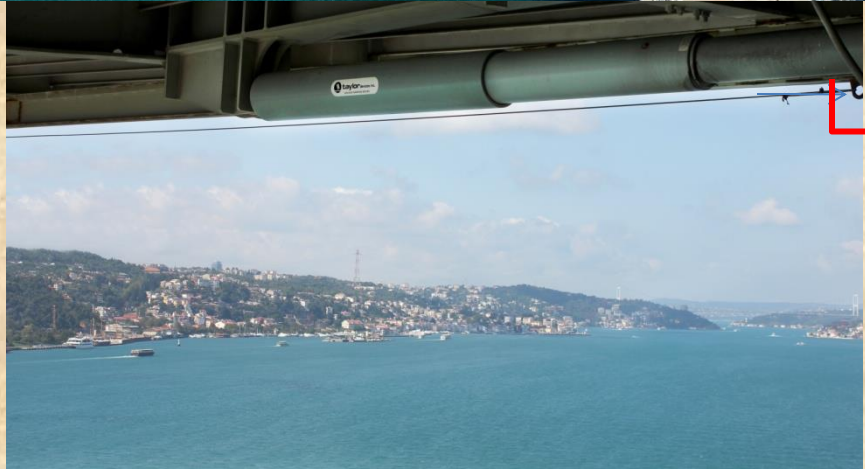
4 New Viscous Dampers

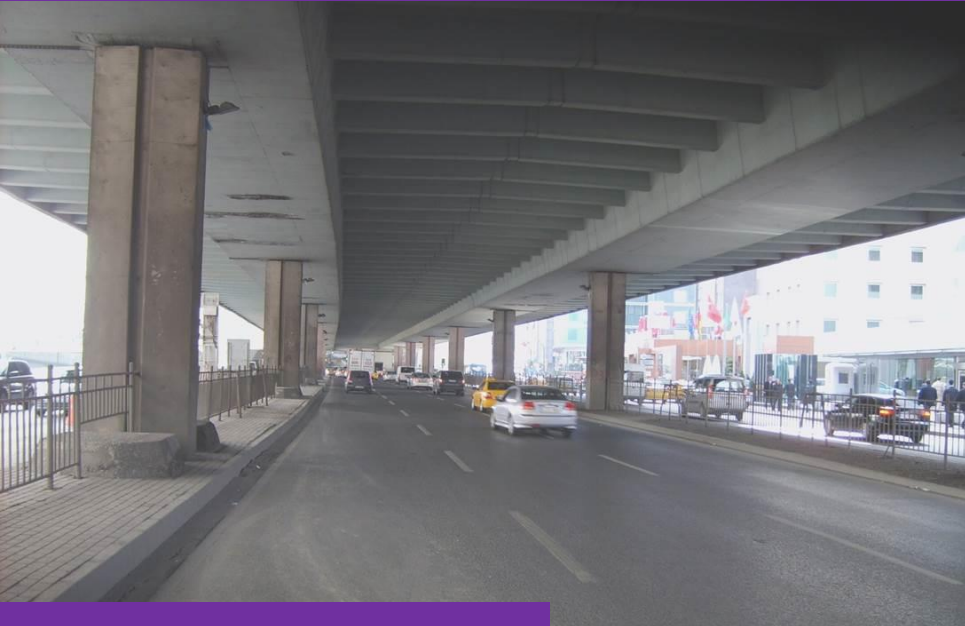
Before Retrofitting

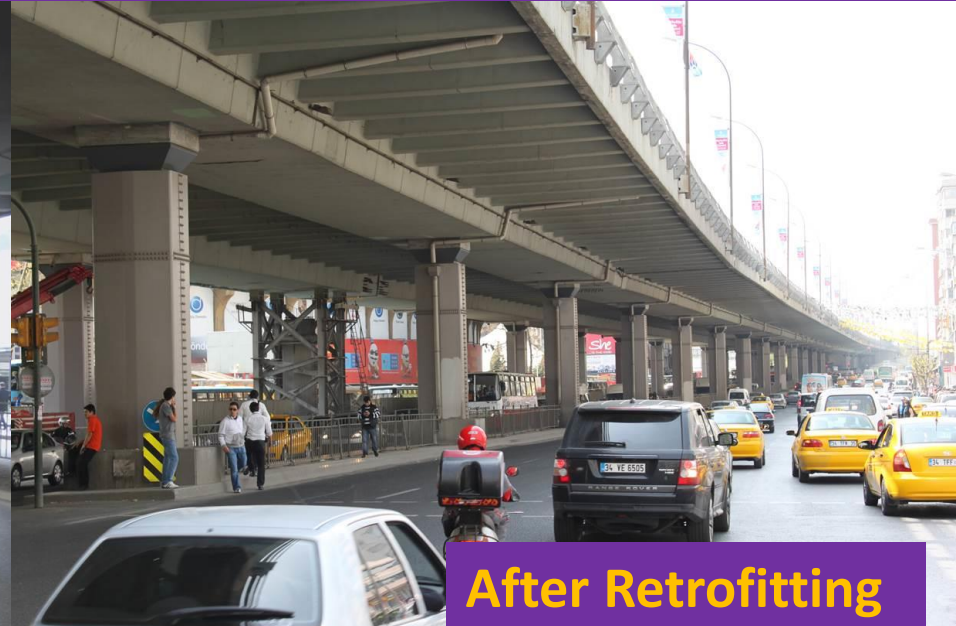
After Retrofitting

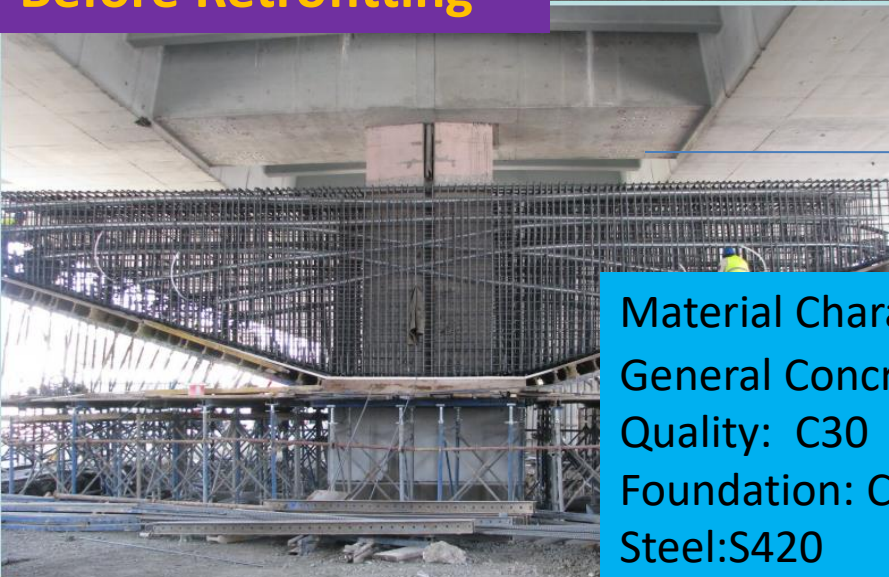
Material Characteristics  
General Concrete  
Quality: C30  
Foundation: C25  
Steel: S420

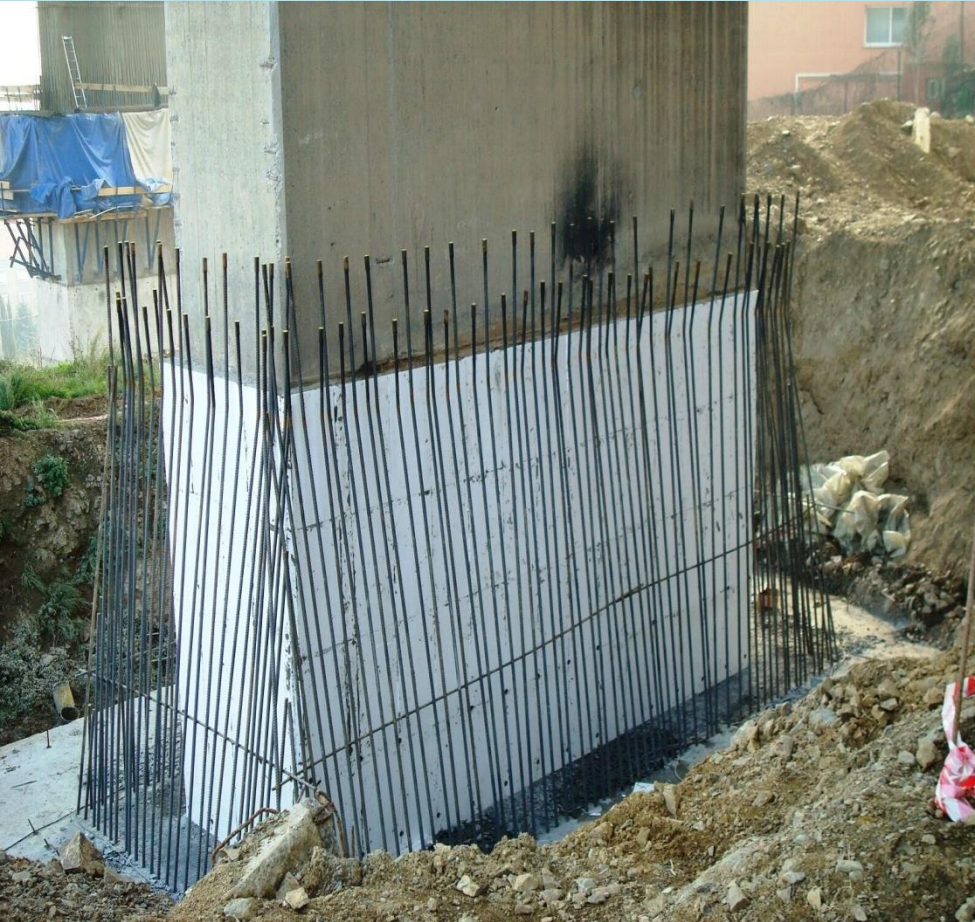
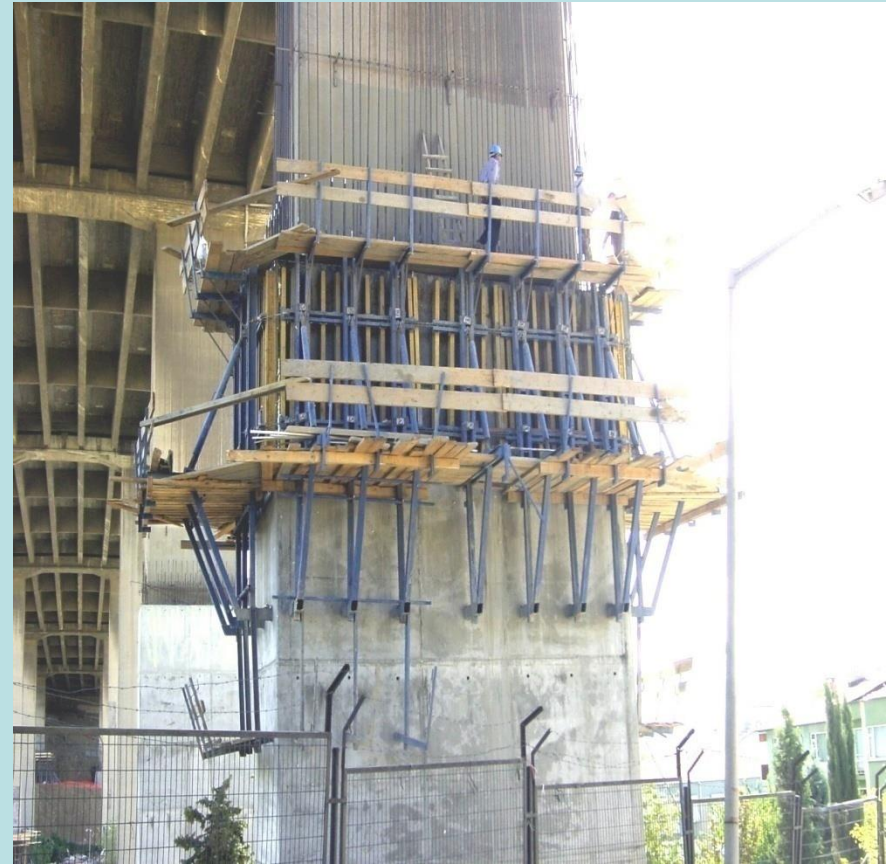
# ORTAKÖY – V408

(RETROFITTING THE VIADUCT PIER)
