# PREPAREDNESS TO EARTHQUAKE AFTER THE CATASTROPHE OF AUGUST 17TH

**Zeki Hasgür (PhD)**

*ALTINBAŞ University, Department of Civil Engineering*

- Turkey's Seismicity and Studies
- August 17th Earthquake Effects-Damages
- New Settlements, New Constructions
- Retrofitting Damaged and/or Undamaged Buildings
- Retrofitting Viaducts, Suspension Bridges
- The Roles of IISEE, Contributions of Japanese Professors and Promotion of Earthquake Engineering in Turkey
- Challenging Projects-Suspension Bridges ,The Marmaray

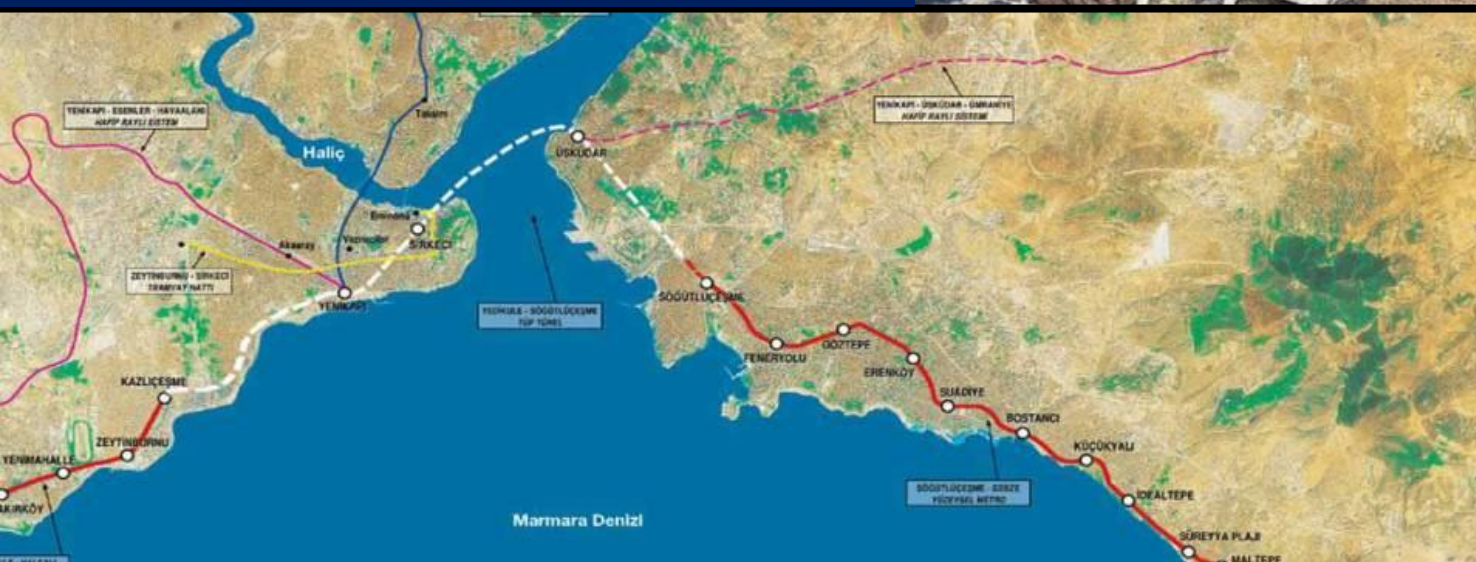
# Immersed Tube Tunnel in Bosphorus

## The minimum performance requirements

- Damage should be repaired easily and would not result in a loss of function or lives;
- The tunnel would remain watertight;
- The facility would remain operational following the earthquake

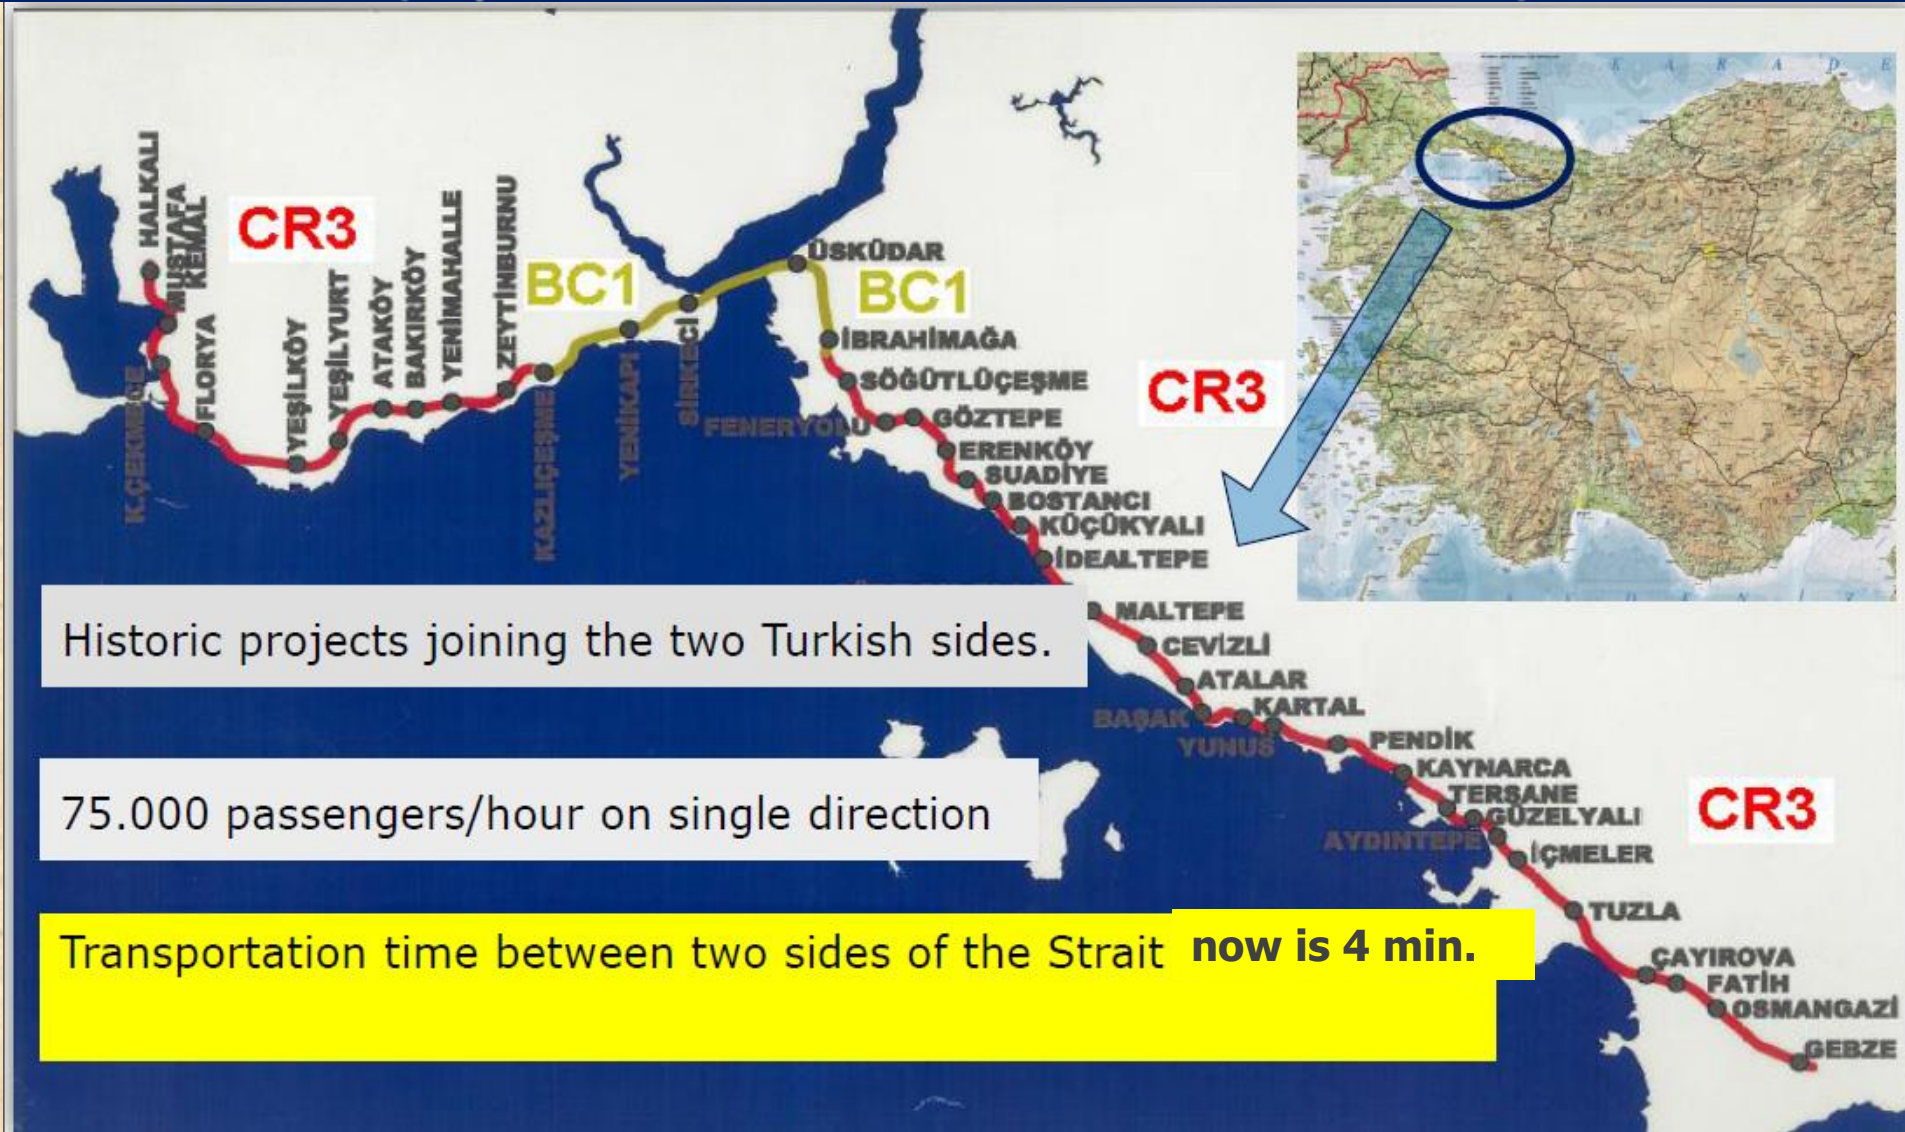
# The Marmaray Immersed Tube Tunnel (Opened in 29<sup>th</sup> of October 2013)

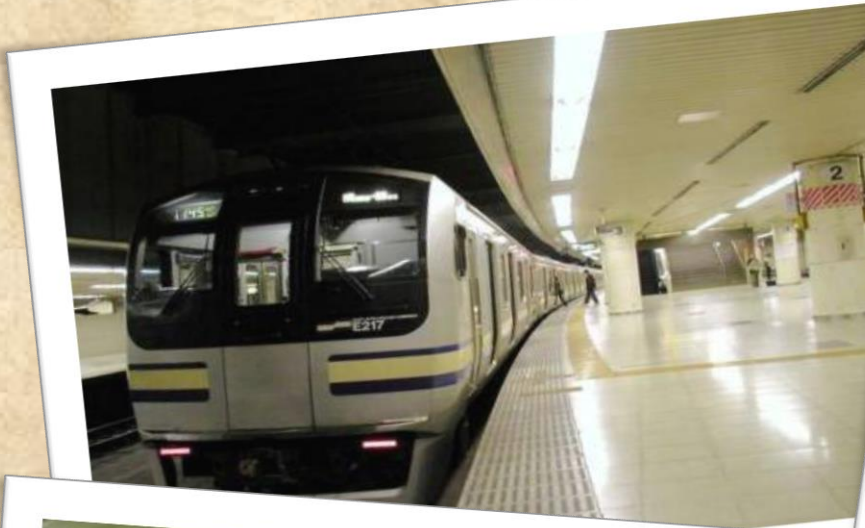
# THE CONTEMPORARY, SAFE AND MODERN RAILWAY SYSTEM THAT IS AIMED WITH THE MARMARAY PROJECT

■ Following the earthquake require not more than a few days for inspection and adjustment of the rail alignment

■ Repair work could be performed with minimum disruption to the operation of the facility

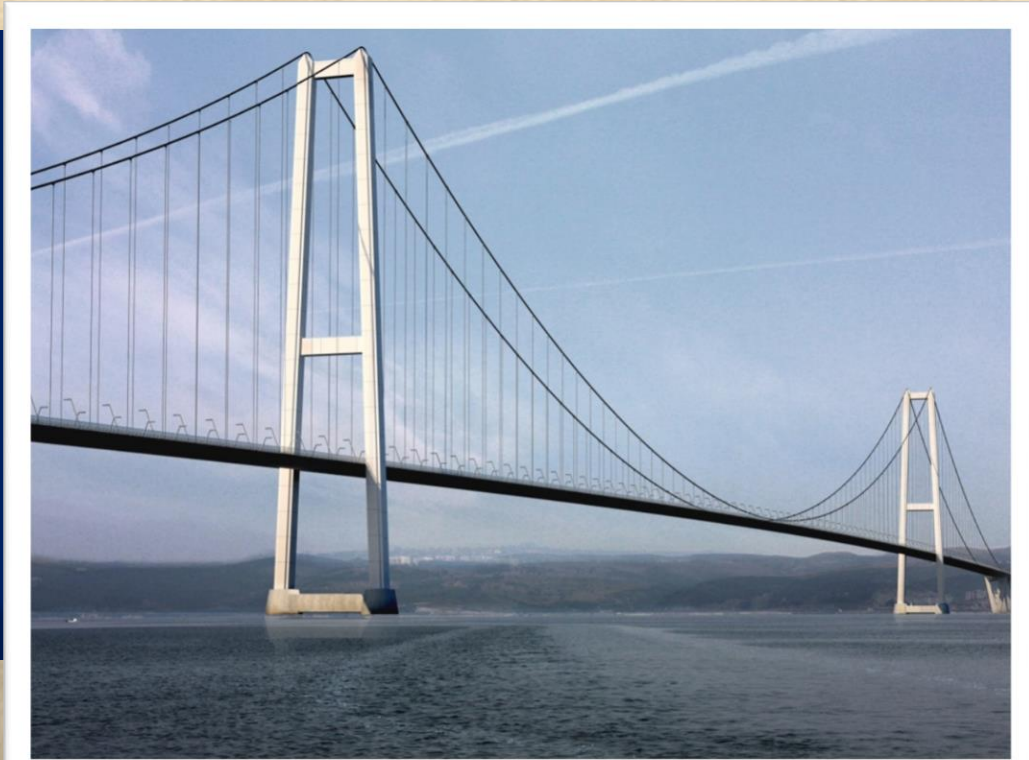
# (Osman GAZI) İZMİT BAY SUSPENSION BRIDGE

- The Izmit Bay Suspension Bridge is completed as world's fourth longest suspension bridge, by length of central span.
- The total length of the bridge is 3.3 kilometers, with a main span of 1580 meters

Newest Suspension Bridge Closest to North Anatolian Fault

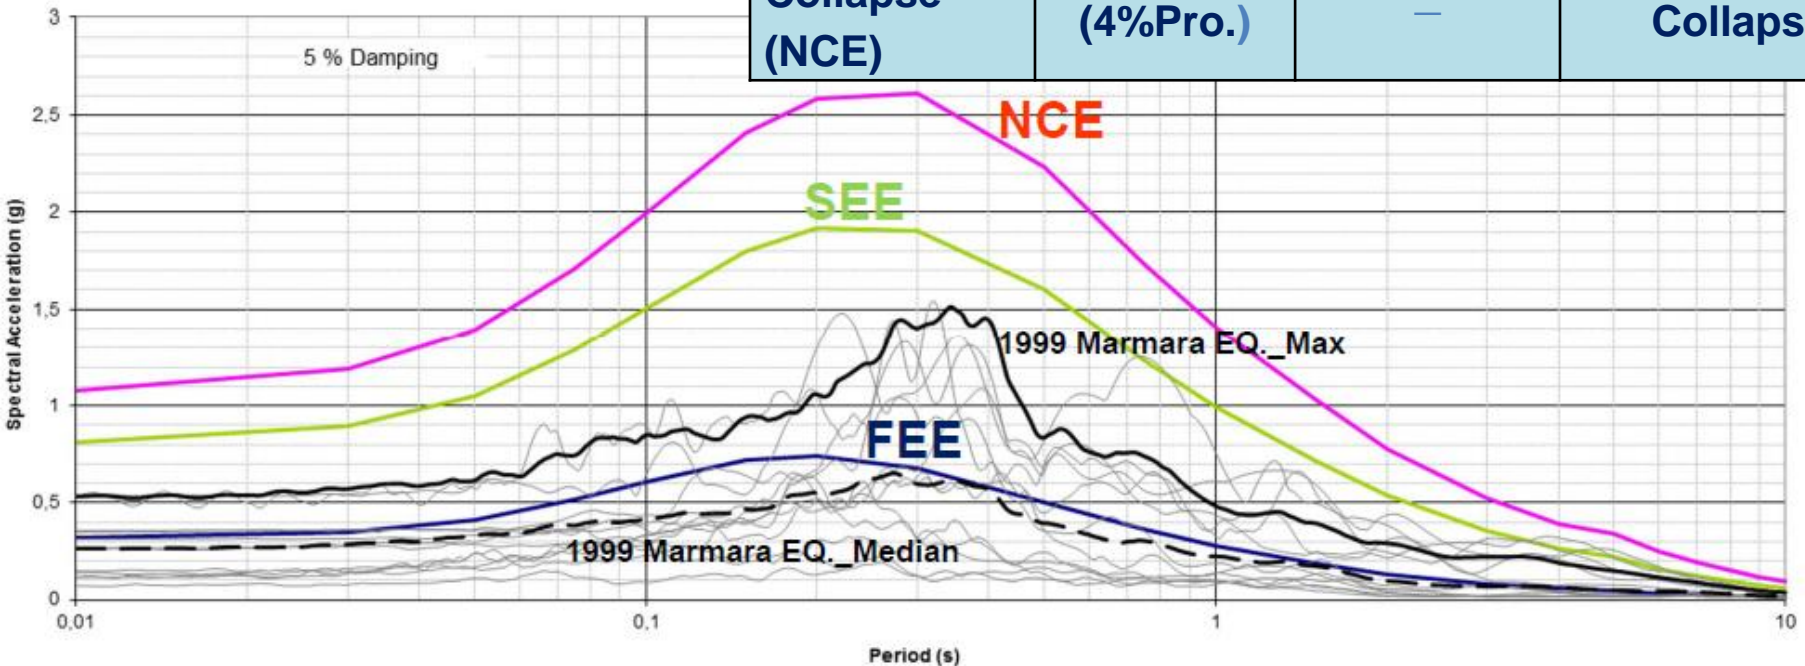
# Suspension Bridge Earthquake Acceleration Spectra Comparison with the 1999 Marmara Earthquake Data

**Economic Life-100 Year**

Seismic Event	Return Period	Service P. Level	Damage Level
Functional (FEE)	150 Year (50% Pro.)	Instant Access	No Damage
Safety (SEE)	1000 Year (10% Pro.)	Limited Access	Repairable Damage
Non-Collapse (NCE)	2475 Year (4% Pro.)	—	No Collapse
