## 4-2-2. Disaster Prevention Investigation Mission in Sri Lanka

### 1) Summary

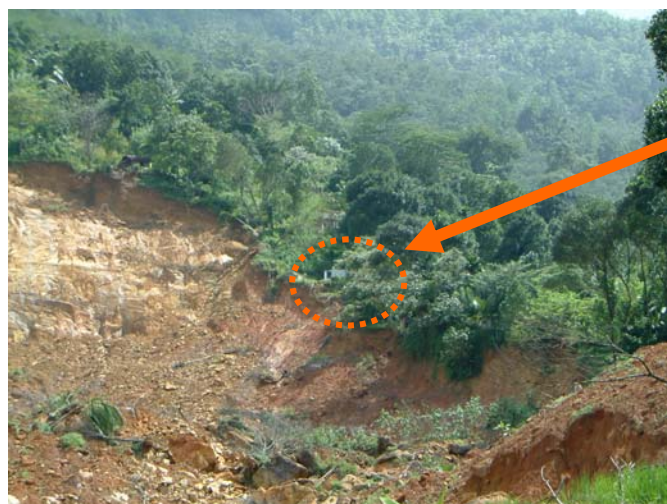
Fig. 4-2-2-2 Landslide Site

House resisted  
the landslide

(The whole area was designated as a hazard area. The occupants of the house had already moved out)

Compulsory relocation of residents had already been under way in the hazardous spots (designated by the Government) around the sediment disaster areas. Evacuees were temporarily staying at refugee camps while waiting for their houses at new locations to be completed.

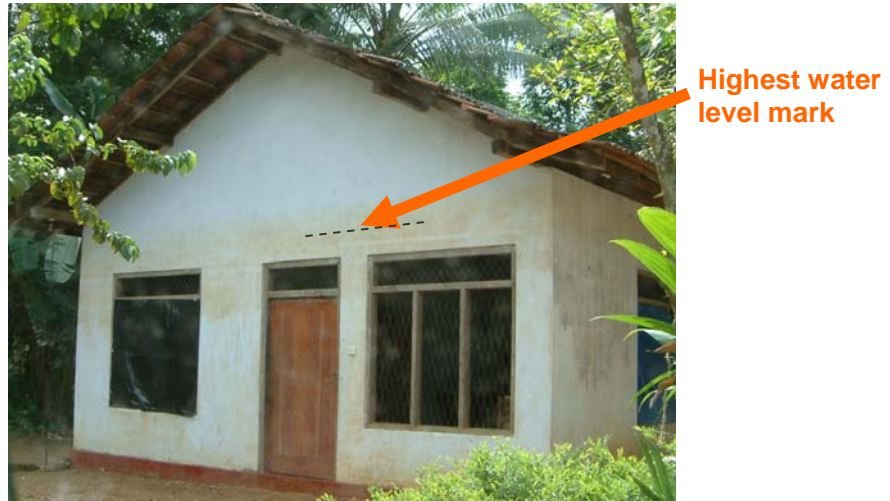
Fig. 4-2-2-3 A house with the highest water level marked on its wall
